## 2014–15 RLX: Judder from the Torque Converter Lock-Up Clutch

### AFFECTED VEHICLES

Year	Model	Trim	VIN Range
2014–15	RLX	ALL	ALL

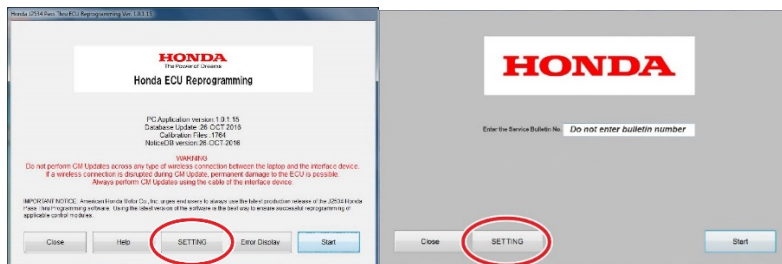
To change this, click on either of the **SETTING** selection buttons at the bottom of the J2534 initial screens as shown.
