LTB00900NAS2

TECHNICAL BULLETIN

Engine MIL Illuminated With DTC P205B-84, P205-85, and/or P249C-00 Stored

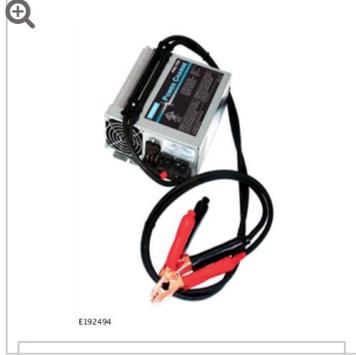
Jaguar Land Rover-approved
Midtronics battery
power supply

- A Jaguar Land Rover-approved Midtronics battery power supply must be connected to the vehicle battery during diagnosis / module programming.
- Make sure all ignition ON/OFF requests are carried out; failure to perform these steps may cause damage to control modules in the vehicle.

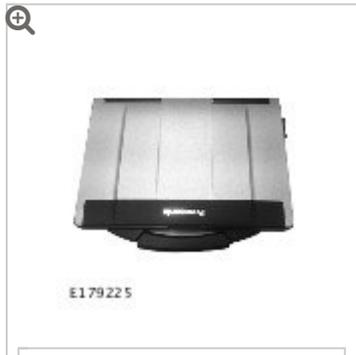
Jaguar Land Rover-approved diagnostic
tool with latest SDD
software, Calibration
File

- 7 Select **continue**.
- 8 Select the **Recommendations** tab and then select **Run** to perform the **Configure existing module - Powertrain control module** option.
- 9 Follow all on-screen instructions to complete this task, ensuring all diagnostic trouble codes (DTC) are cleared.
- 10 Exit the current session.
- 11 Disconnect the diagnostic tool and battery power supply from the vehicle.
