# TECHNICAL BULLETIN

303-00

Engine Misfires/MIL Illuminated With Coolant Temperature 75°C Or Lower

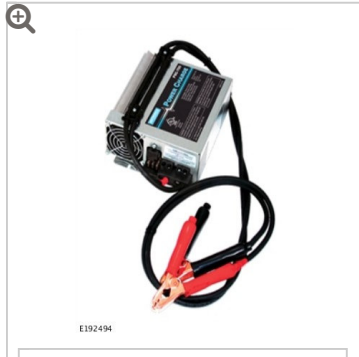
Jaguar Land Rover-approved  
Midtronics battery  
power supply

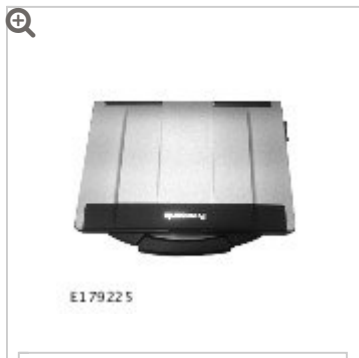
Jaguar Land Rover-approved diagnostic  
tool with latest SDD  
software, Calibration  
File
