EMISSIONS RECALL

AA2N0 PM SENSOR & ENGINE ECU SOFTWARE ENHANCEMENT

Subject:	PM Sensor & Engine ECU Software Enhancement
Date:	7-12-2016
Bulletin No.:	RCB-004-16
Recall No.:	AA2N0
Affected Models:	Certain 17MYCOE Trucks equipped with a J05 engine

Certain 2017MY Hino COE trucks (155, 155h, 195 or 195h) equipped with a J05 engine.

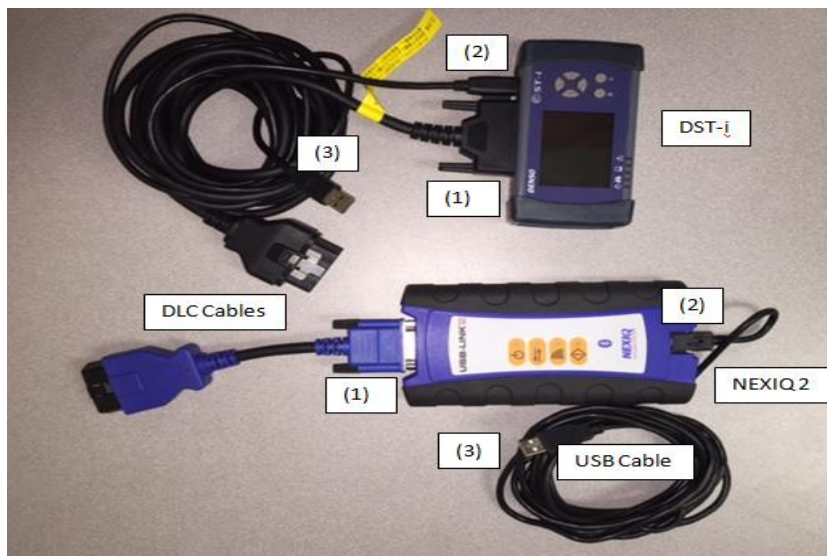
1. It is acceptable to use the DST-i (Software Version 2.0 or later) or the NEXIQ USB-Link™ 2 as an interface to perform this reprogramming procedure. To assemble the interface cable, perform the following steps.

- (1) Connect the DLC (Diagnostic Link Connector) cable to the interface.
- (2) Connect the USB Cable to the interface.
- (3) Connect the USB connector to the USB port on your computer.

NOTICE: DST-i with a software version below 2.0 will not work for this reprogramming procedure. Also, the original “NEXIQ USB-Link” interface will not work for this reprogramming procedure.

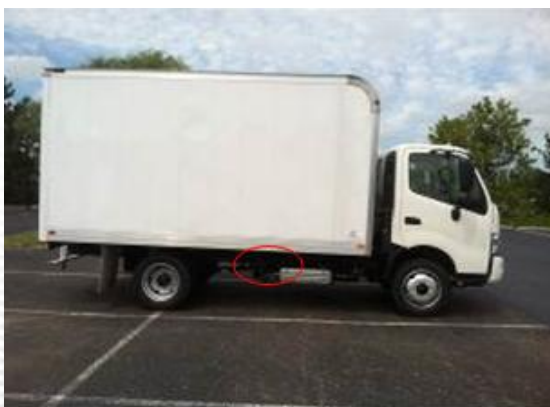
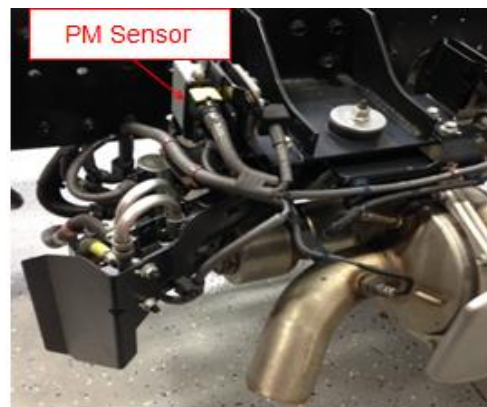
2. Locate the PM sensor on the passenger side frame rail, above the tailpipe.

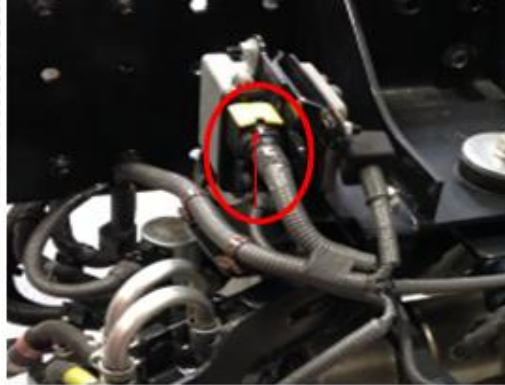
3. Disconnect the electrical connector to the PM sensor by pulling the yellow locking tab up then pulling the connector out.

NOTICE: To prevent damage to the PM sensor, make certain the key is removed from the ignition switch prior to disconnecting the PM sensor.

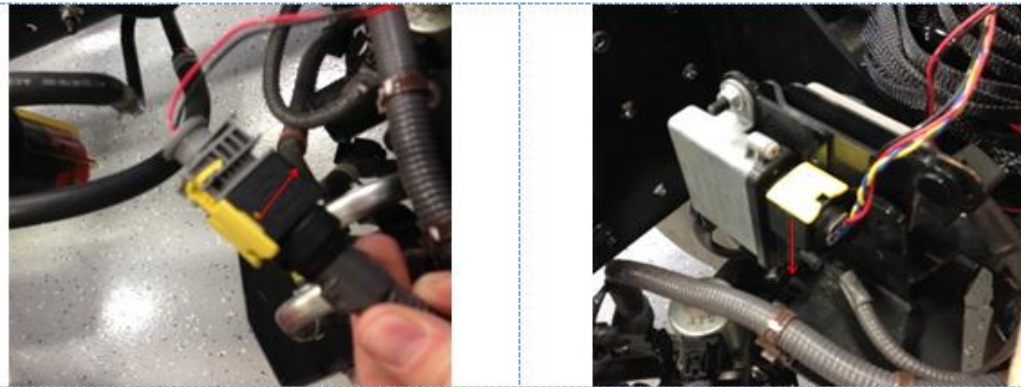
4. Connect the male end of the PM sensor reprogramming harness to the vehicle harness connector. Ensure the yellow locking tab is engaged. Connect the female end of the PM sensor reprogramming harness to the PM sensor. Ensure the yellow locking tab is engaged.

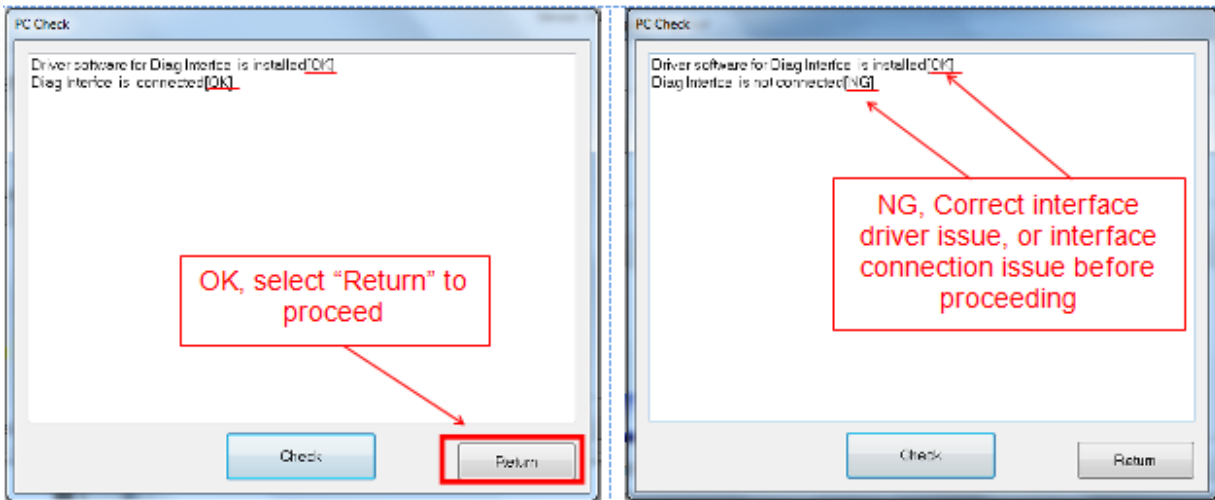
16. The PM sensor can be reprogrammed if “[OK]” is displayed on both top and bottom rows as shown on the left, below. If OK, select the “Return” icon.

“[NG]” will be displayed on the top row if the driver of the interface device is not installed.

Install the driver as per the manual for the interface and then perform the “PC Check” again.

“[NG]” will be displayed on the bottom row if the interface device is not properly connected.

Ensure that the cables are connected and the interface device is turned on (DST-i has an ON/OFF switch). Ensure that the correct device is selected for “Used device” under “Configuration” (step 7, above). Select the “Return” icon to go back to the main menu.

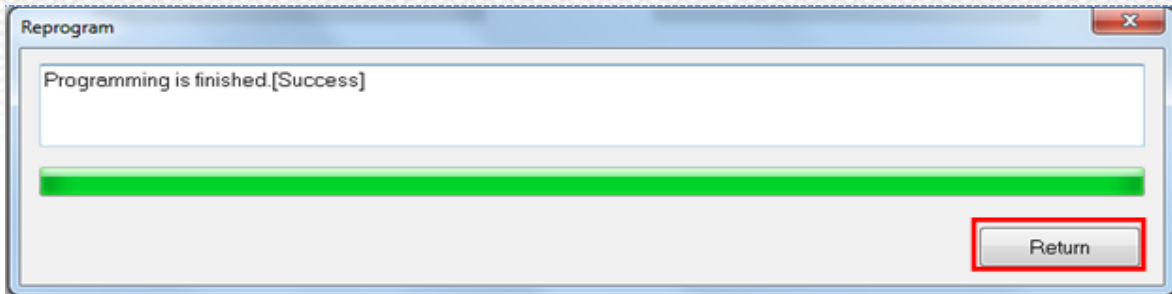
23. Monitor the programming progress bar. If the progress bar reaches 100% and no errors are shown, select the “Return” icon and proceed to step 24, below.

”Writing error [Time out]” will be displayed if the programming fails. Close the window and proceed to step 23a, below.

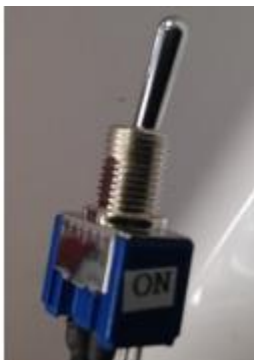
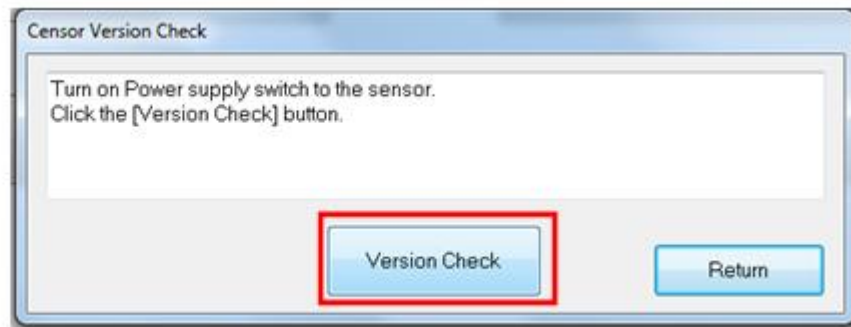
26. Turn the power switch on the PM sensor reprogramming harness to the “ON” position and select the “Version Check” icon.

NOTICE: If a communication failure message is displayed after selecting the “Version Check” icon, repeat steps 24 through 26, to validate the sensor version.

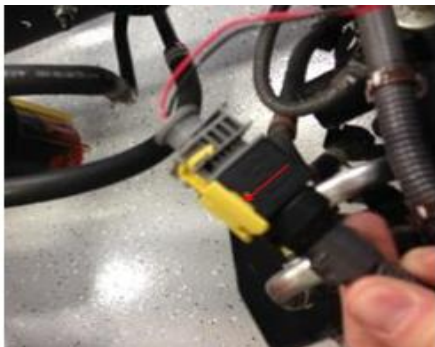
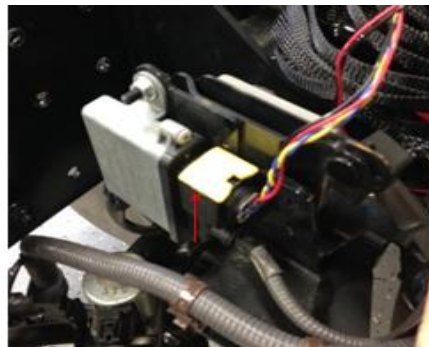
29. Disconnect the PM sensor reprogramming harness from the vehicle harness connector by releasing the yellow locking tab. Disconnect the PM sensor reprogramming harness from the PM sensor by releasing the yellow locking tab.

NOTICE: To prevent damage to the PM sensor, make certain the key is removed from the ignition switch prior to disconnecting the PM sensor.

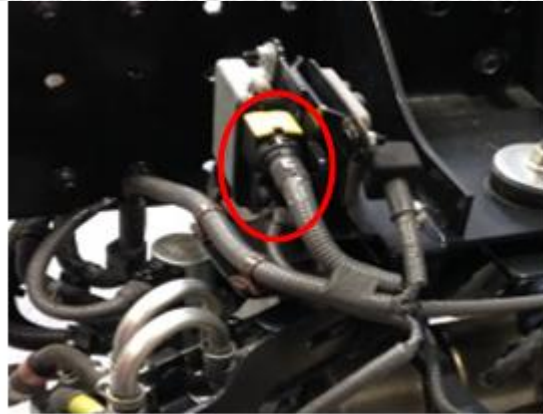
30. Connect the electrical connector to the PM sensor. Ensure the yellow locking tab is pushed down to lock the connector in place.

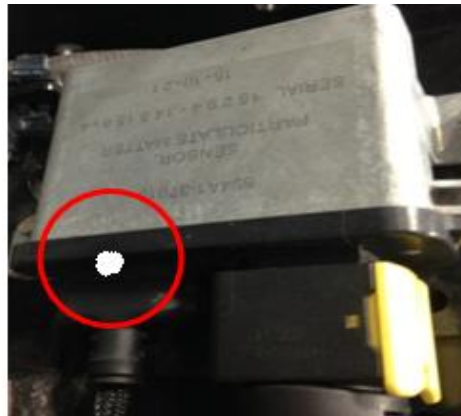
31. The preferred method to show the recall has been performed is to install a white paint mark on the PM sensor housing as shown in the photograph below.

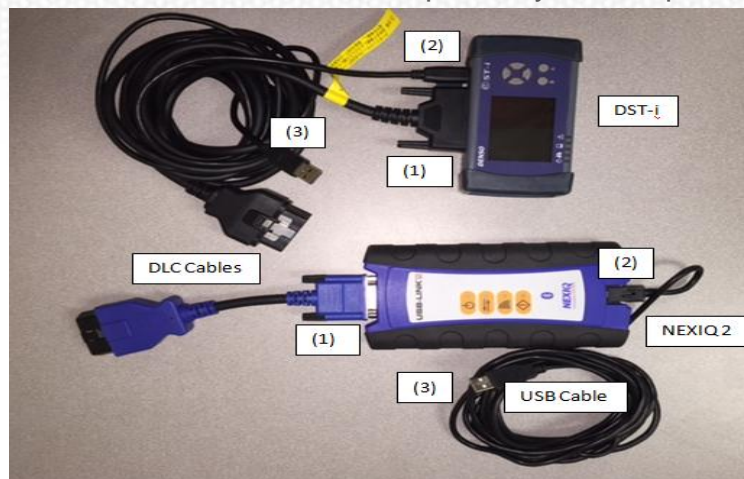
1. It is acceptable to use the DST-i or the NEXIQ USB-Link™ 2 as an interface to perform this reprogramming procedure. To assemble the interface cable, perform the following steps.

- (1) Connect the DLC (Diagnostic Link Connector) to the interface.
- (2) Connect the USB Cable to the interface.
- (3) Connect the USB connector to the USB port on your computer.

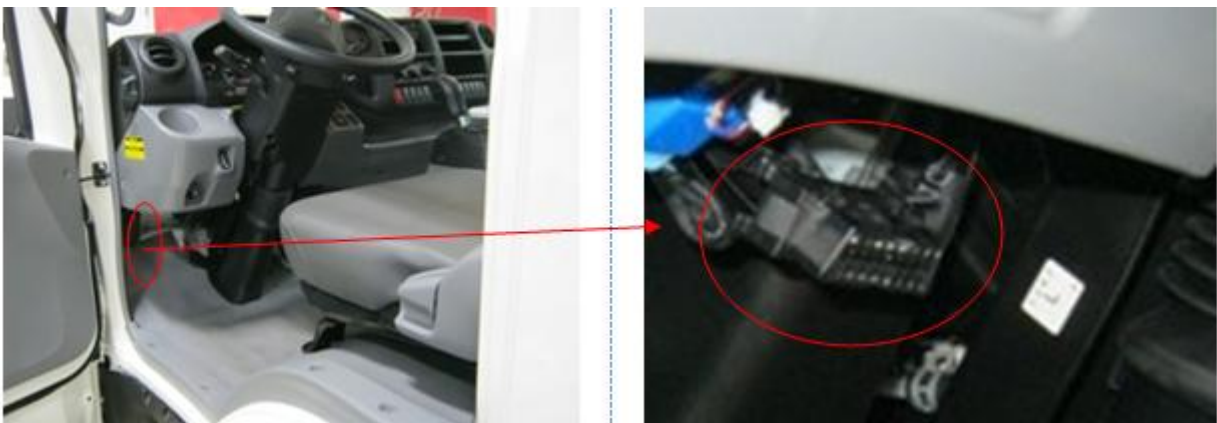
2. Connect the DLC cable to the vehicle's DLC connector. The DLC connector is found under the dash on the left side of the steering column.

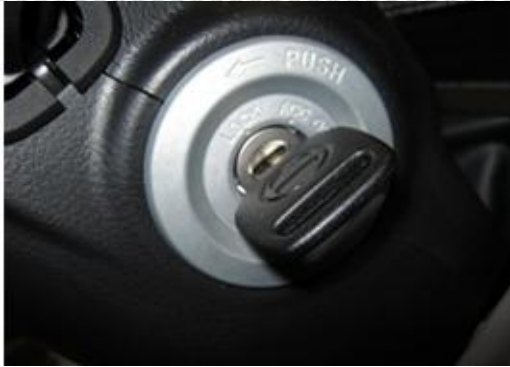
5. Insert the ignition key into the starter switch and turn the key to the “ON” position.

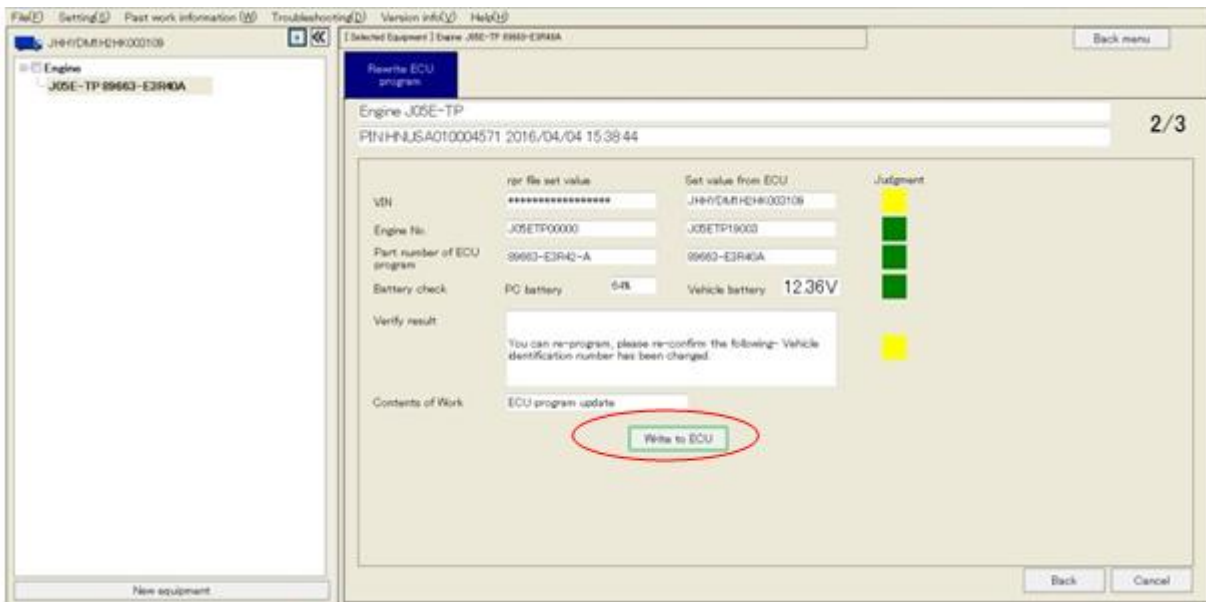
13. Select the “Write To ECU” icon.

Note: The “Judgment” should be the color green or the color yellow. If the color red is shown, reconfirm your software versions and battery status for the vehicle and laptop.

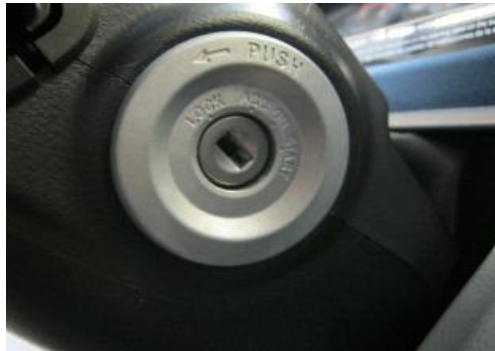
15. Turn the starter switch to the “LOCK” position and remove the key.

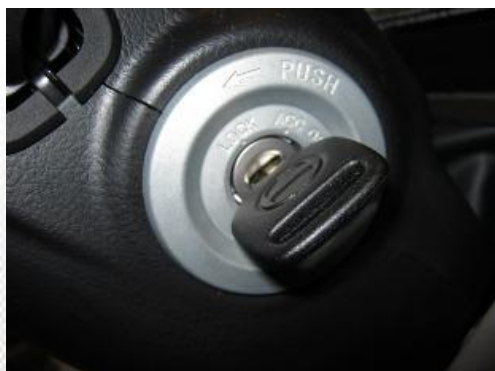
16. Insert the ignition key into the starter switch and turn the key to the “ON” position.

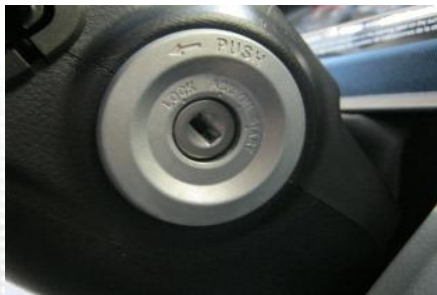
24. Turn the starter switch to the “LOCK” position and remove the key.
