Subject: **Special Service Program (SSP) A6  
2016 CX-5 Passenger Frontal Air Bag Concern**

Mazda Motor Corporation has decided to conduct a Special Service Program (SSP) on certain 2016 CX-5 vehicles built from November 1, 2014 through May 13, 2016.

The purpose of this SSP is to reprogram the Sophisticated Air Bag Sensor (SAS) unit with modified software. Bosch will ship a Mazda Diagnostic Reprogramming Tool Kit (MDRT3-1) to all dealers on November 28, 2016. Please refer to the Repair Procedure document posted on MS3 for details.

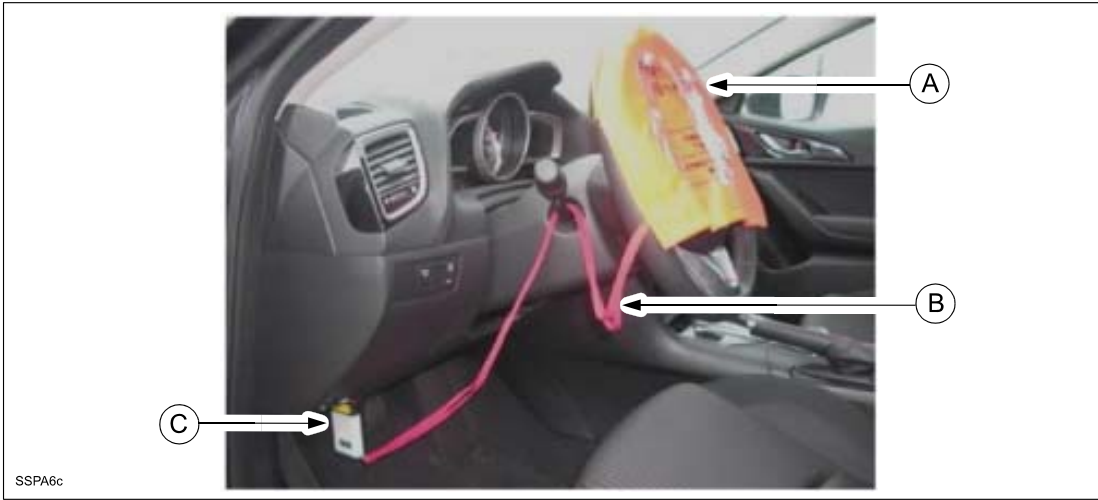
| MDRT TOOL KIT | |
| A | Steering Wheel Cover |
| B | Strap |
