Service Bulletin

Bulletin No.: 15-NA-081

Subject: Radio Locks Up and/or Resets, Bluetooth® Pairing, iPhone Loses Pairing, Bluetooth Connection And Audio Concerns, Street Names Flickering, TBT Routing Screen Displayed After Download is Finished, XM Weather Alerts Cannot Be Selected Off, Voice Recognition and Navigation Updates, Various Rear Vision Camera Concerns, Podcast Will Not Play, Cannot Edit Device List

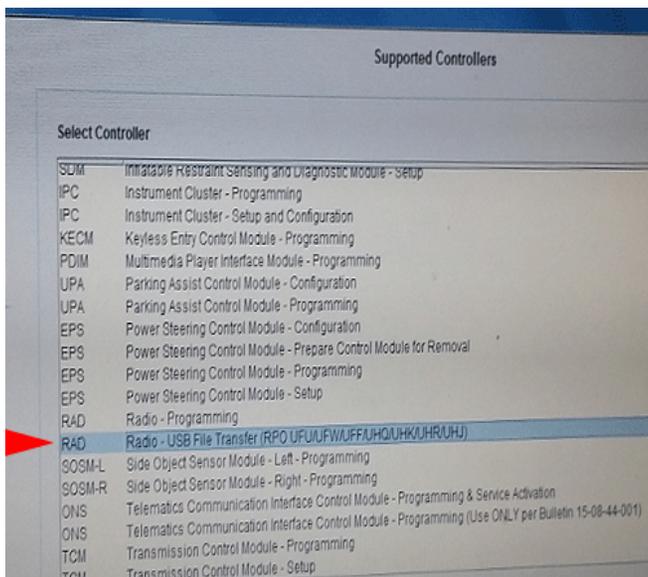
4520348

Note: Example of Equinox Supported Controllers Menu

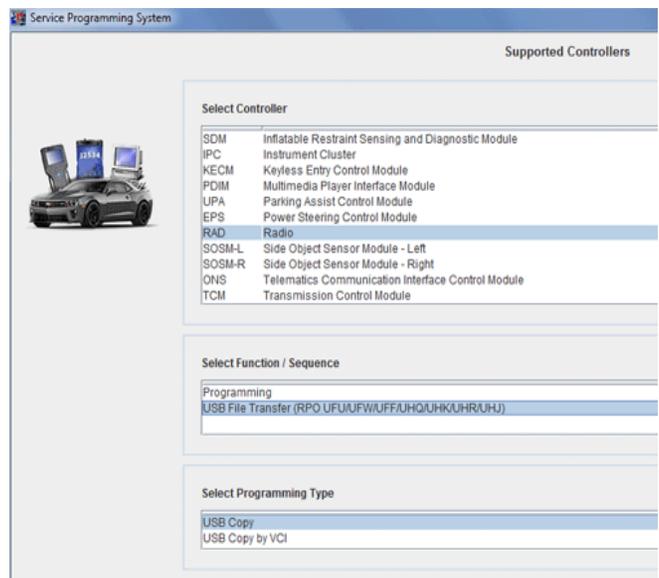
4520663

Note: Example of Cruze Supported Controllers Menu

5. Select: RAD/A11 – “RAD/A11 - USB File Transfer - Programming” from the Supported Controllers screen and follow the on-screen instructions carefully.

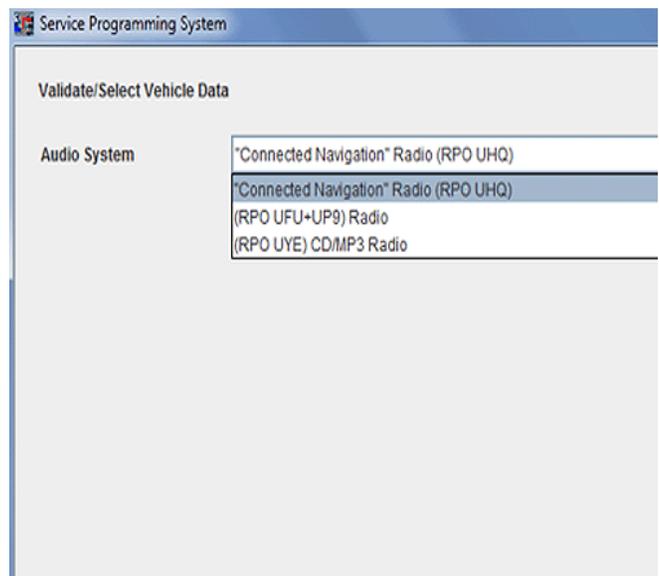
4520352

6. At this point, you *may* be required to select the proper RPO choices for the vehicle you are servicing. Refer to the vehicle SPID label or the vehicle build information in GWM (Global Warranty Management - VIS) to find the specific RPOs that the vehicle is equipped with. Once you have selected the proper vehicle options, click “Next.”

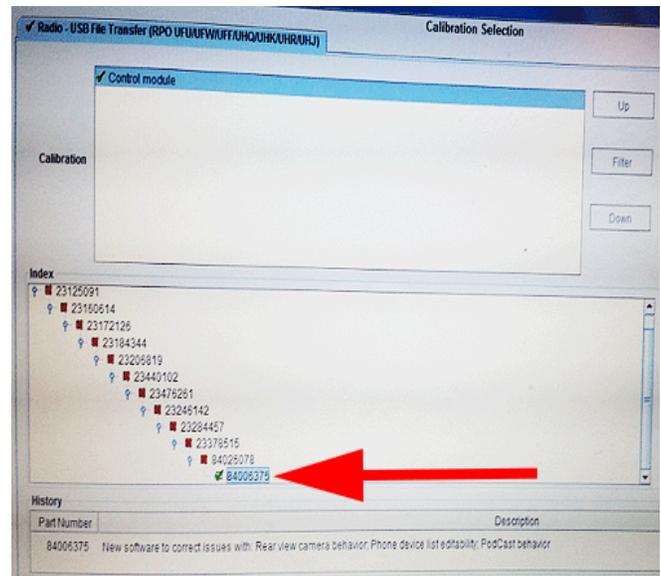
4522814

7. On rare occasions, the screen above may be displayed at this point if the radio part number cannot be read for some reason when TIS2web interrogates the radio via serial data. If this occurs, close TIS2web, turn off the ignition, open the driver's door, close the driver's door, wait at least 60 seconds, and go back to step 2 to start the USB programming process again. If this still happens, close TIS2web, connect your GDS2 scan tool, navigate to the radio information screen (Module Diagnostics>> Radio>> Identification Information), and note the "End Model Part Number" parameter that is listed, which is the radio part number. Once noted, close GDS2, open TIS2web again, select this part number from the list of TIS2web part numbers, and click next to proceed with USB programming. This will allow TIS2web to install the correct USB programming files. DO NOT pick a random number from the list or the wrong USB programming files will be installed. If the "End Model Part Number" is not available in GDS2 or your "End Model Part Number" is not listed in the TIS2web dropdown list, contact Techline (TCSC) at 1-800-828-6860 (English) or 1-800-503-3222 (French) for programming assistance.

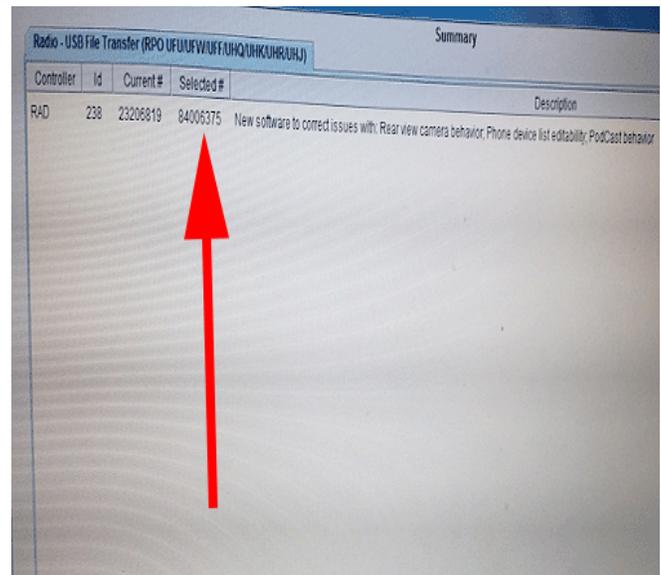
4522815

9. Select: NEXT from the TIS2web Calibration Selection and Summary screens as shown above, which will automatically download the latest USB calibration files to your USB flash drive.

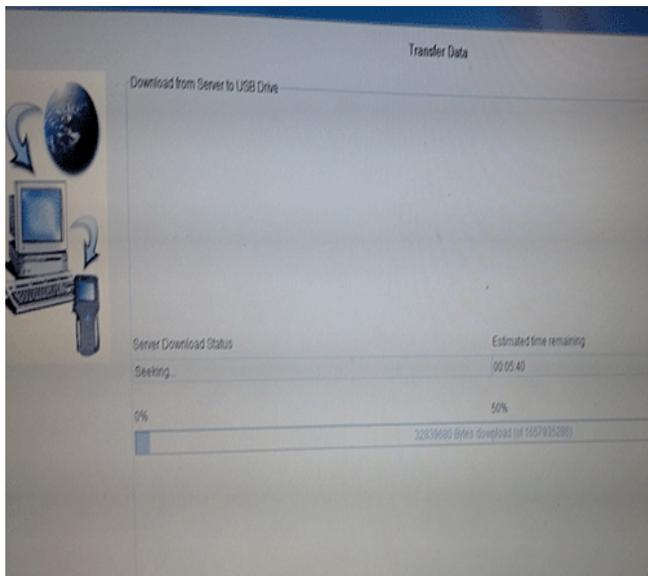
4520363

- Monitor the Progress Status bar at the bottom of the TIS2web Transfer Data screen.

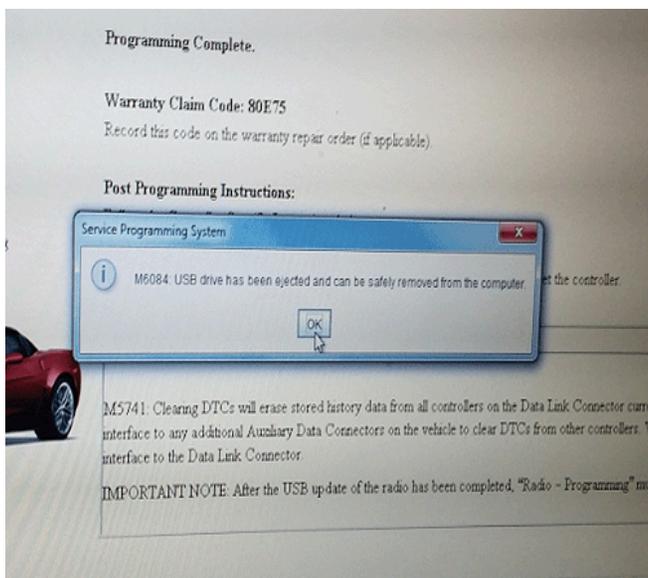
4520366

- Once the Progress Status bar is complete/full and a message like the one above is displayed to indicate that the USB download is complete, remove the USB flash drive from the computer.
- Delete any paired devices in the Paired Phones List (Home>> Config>> Phone Settings>> Bluetooth) to prevent potential interruptions during the USB and SPS programming events outlined below.
- Insert the USB flash drive into the vehicle USB port with ignition and radio ON, and engine off.

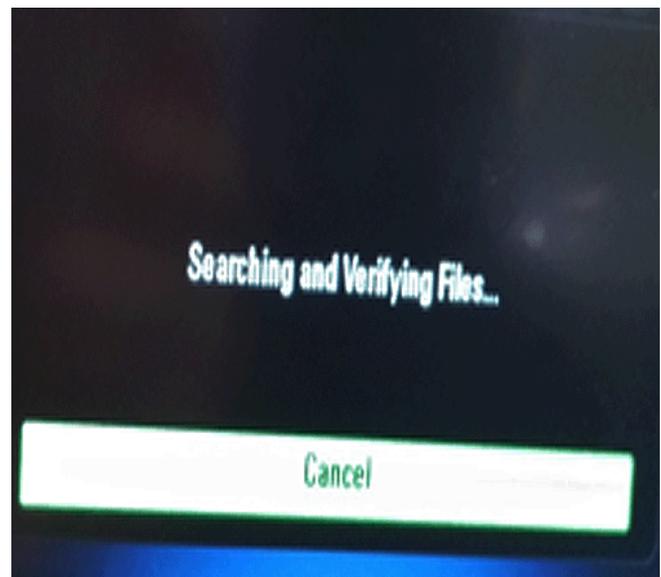
4520369

- A "Searching and verifying" message will be displayed for up to 20 minutes, this is normal. Once the searching and verifying message is gone, any combination of the screens shown below in steps

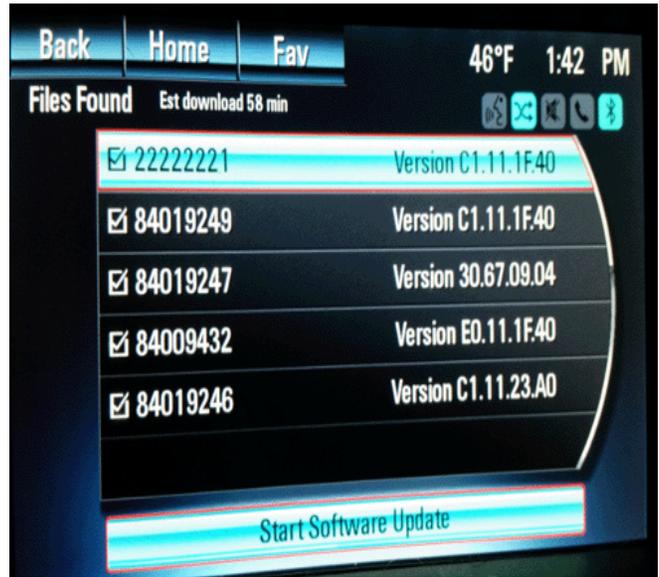
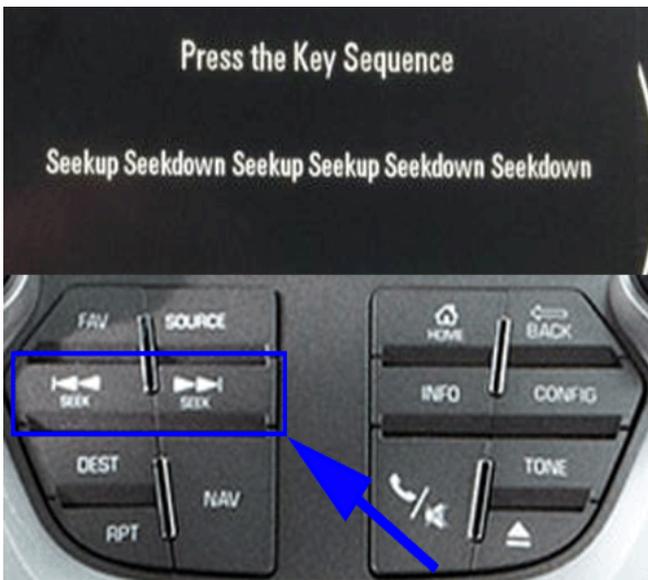
Legend

- (1) Seekup = Arrow Right
- (2) Seekdown = Arrow Left

17. If the "Press the Key Sequence" screen above is displayed, DO NOT press Cancel if displayed. It is important to press the displayed button press sequence on the screen to start the update. This requires the displayed button press sequence to be followed in proper order. Please note that each button press requires a momentary press of the right "seek up" or left "seek down" button (shown in the photo above).

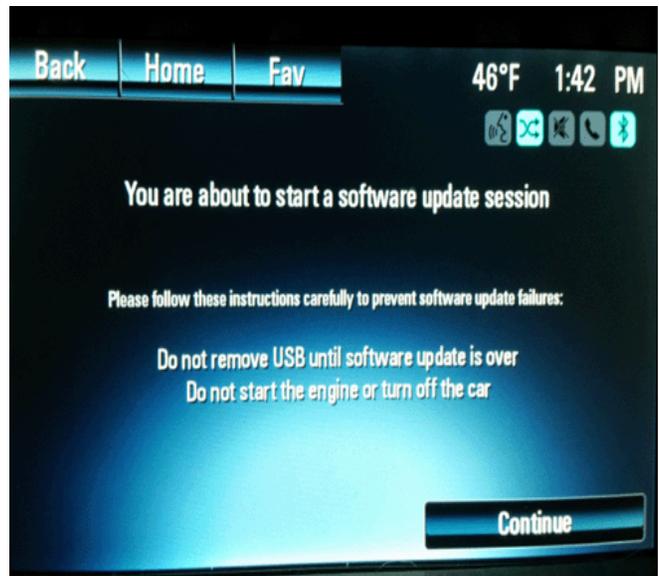
4520373

19. If the screen above is displayed and the update does not start automatically, note the instructions on the screen and press "Continue."

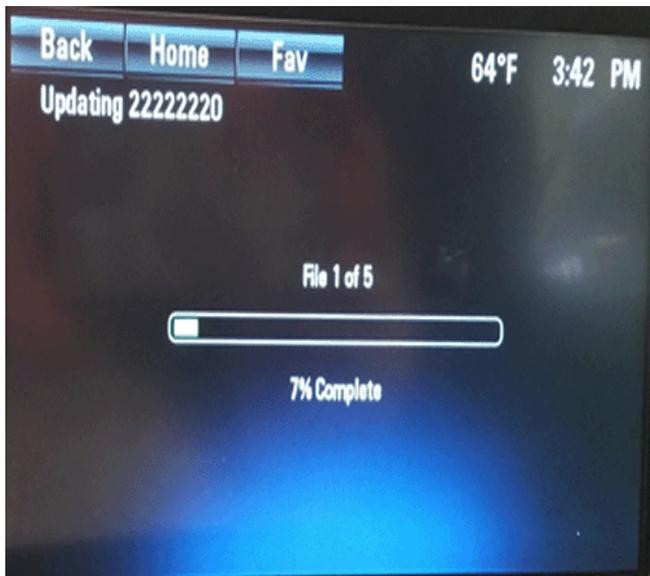
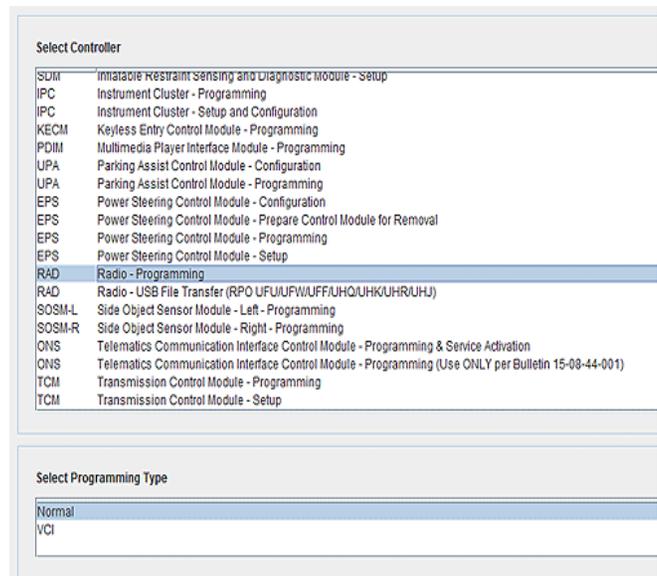
Important: Once the USB programming starts, the technician will see a series of files being installed as shown above and evidenced by a progress bar and “file 1 of 5, file 2 of 5, etc.” messages or similar messages depending on year, model, and software. As these files are installing, it is normal to experience a momentary blank screen, loss of audio, and/or “splash screen” after/during installation of file 4 of 5. Do not interrupt programming if this is noted – please be patient and allow programming to completely finish as described below. Typically this step will take 30-60 minutes to complete as USB files 1-5 are installed into the radio.

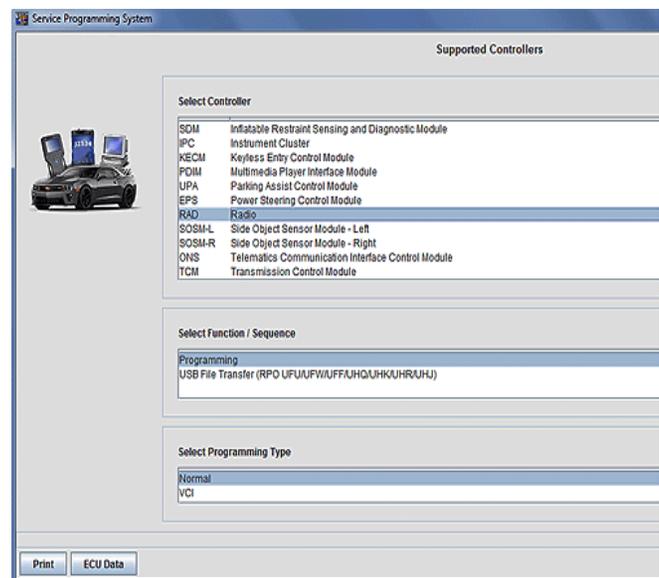
4526725

Note: Example of Cruze Supported Controllers Menu

22. Select RAD/A11: Radio – Programming from the “Supported Controllers” screen, click “Next”, and follow the on-screen instructions carefully.

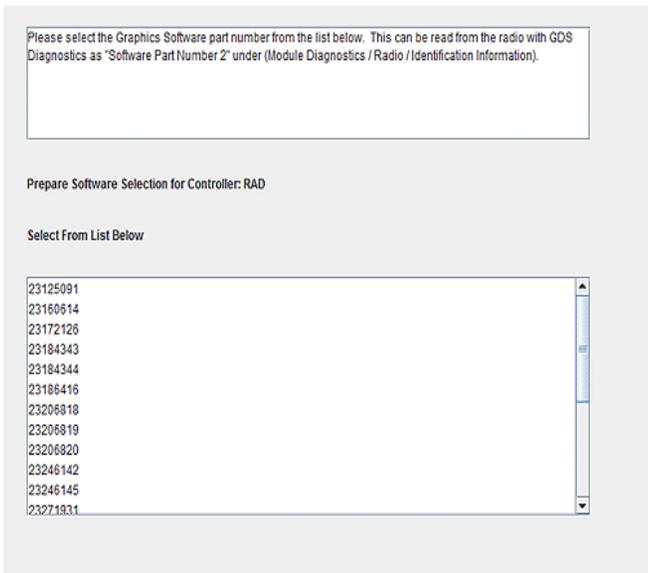
4520380

- On rare occasions, the screen above *may* be displayed at this point if the USB calibration part number that was just installed cannot be read for some reason when TIS2web interrogates the radio via serial data. If this occurs, close TIS2web, turn off the ignition, open the driver's door, close the driver's door, wait at least 60 seconds, turn the ignition back on with the engine off, and go back to step 21 to start the SPS programming process again. If this still happens, close TIS2web, connect

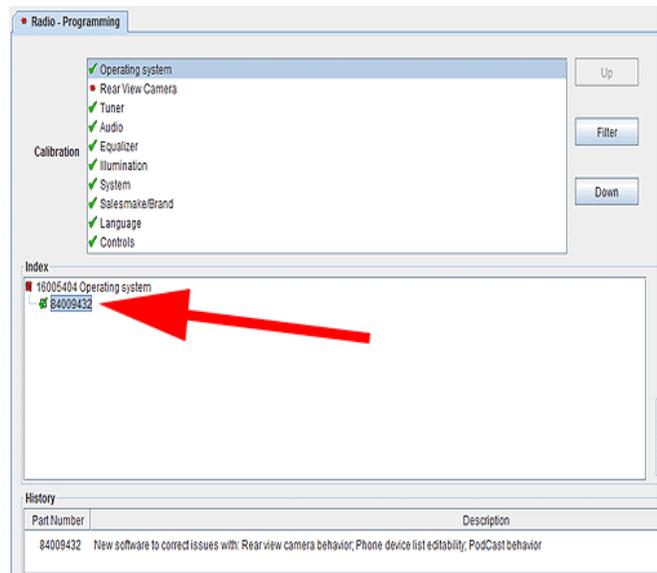
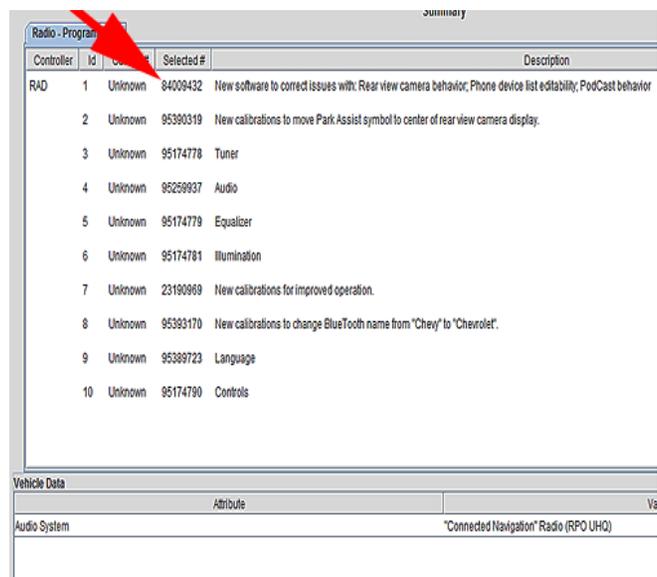
25. Select: NEXT from the TIS2web Calibration Selection and Summary screens as shown above to automatically install the latest SPS calibrations that are designed to address this concern.

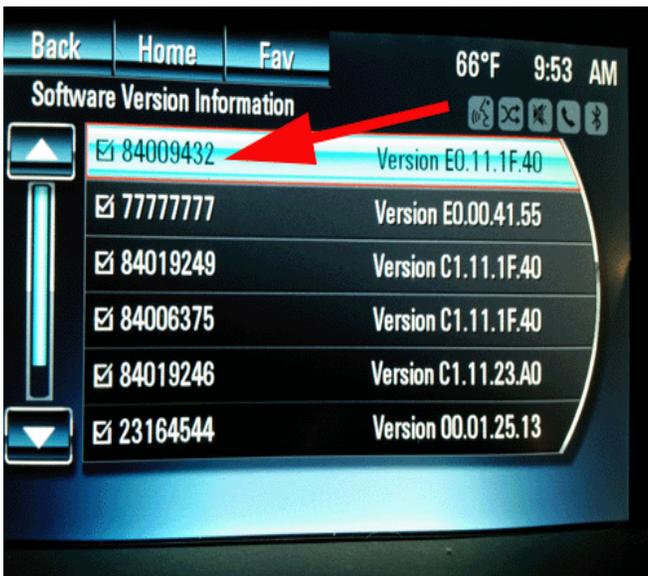
4522820

SPS Calibration Summary Screen
