I N F I N I T I

2G Telematics Hardware Replacement Client Satisfaction Initiative

Reference: PC451, PC452, PC454

M37, M56, & Q70 Telematics Control Unit Replacement

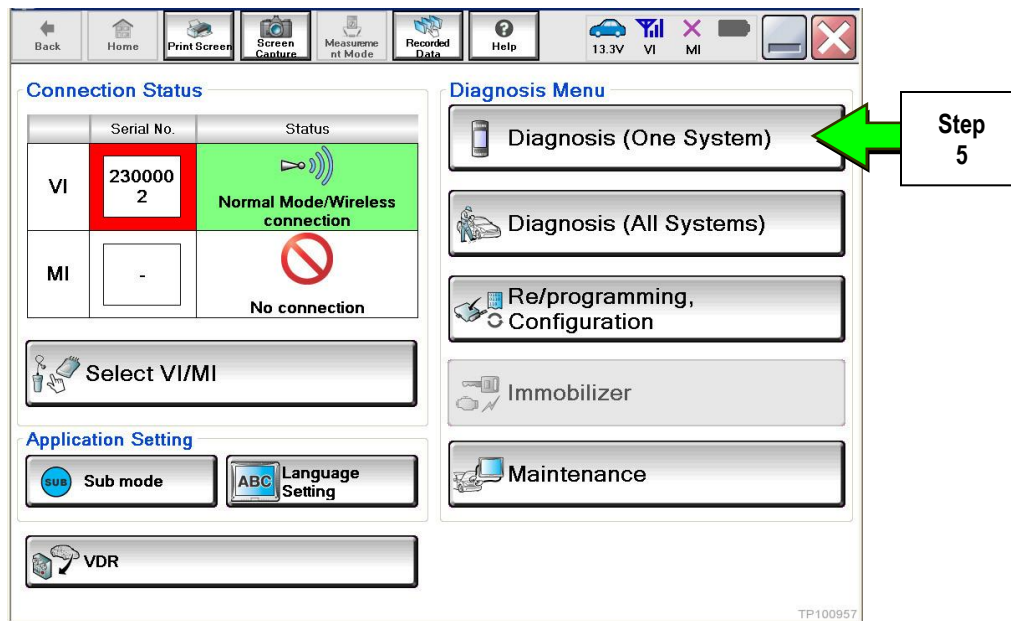
Figure 1

1. Connect the C-III plus VI to the vehicle.
2. Set the parking brake.
3. Turn the Ignition ON, but do not start the vehicle.
4. Launch C-III plus on the CONSULT PC.
5. Select **Diagnosis (One System)**.

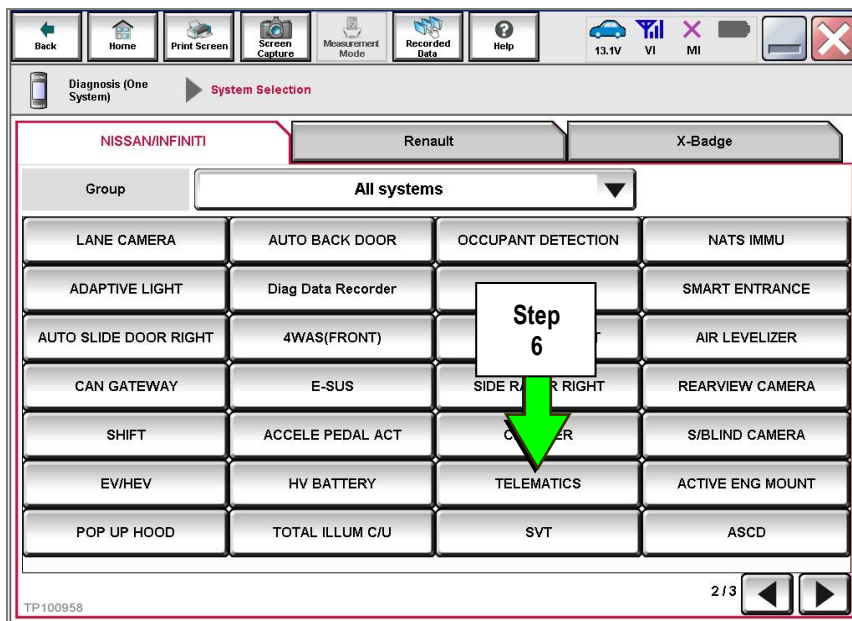
Figure 2

6. Select **TELEMATICS** on page 2 of the “All systems” list.

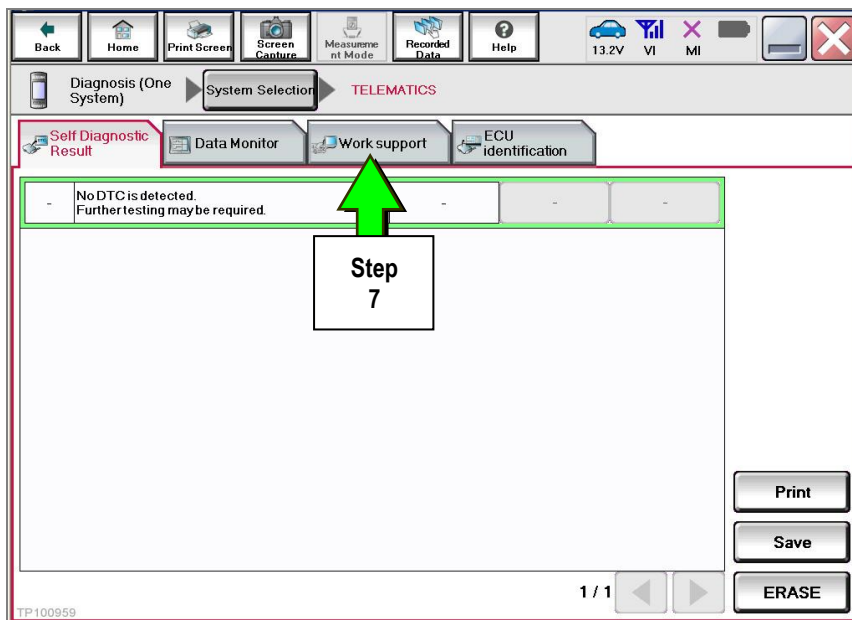
Figure 3

7. Select **Work support**.

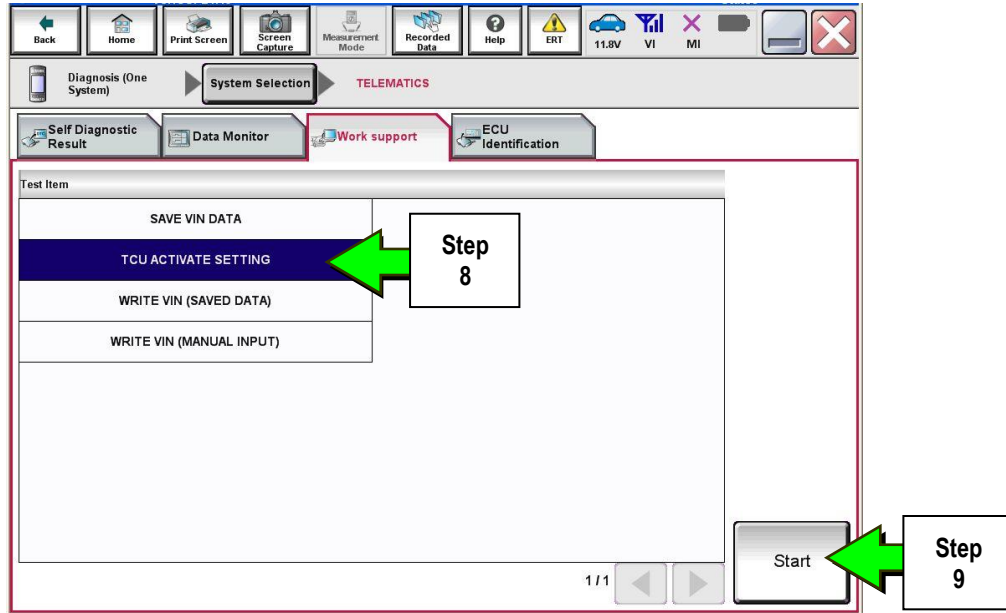
Figure 4

8. Select **TCU ACTIVATE SETTING**.

9. Select **Start**.

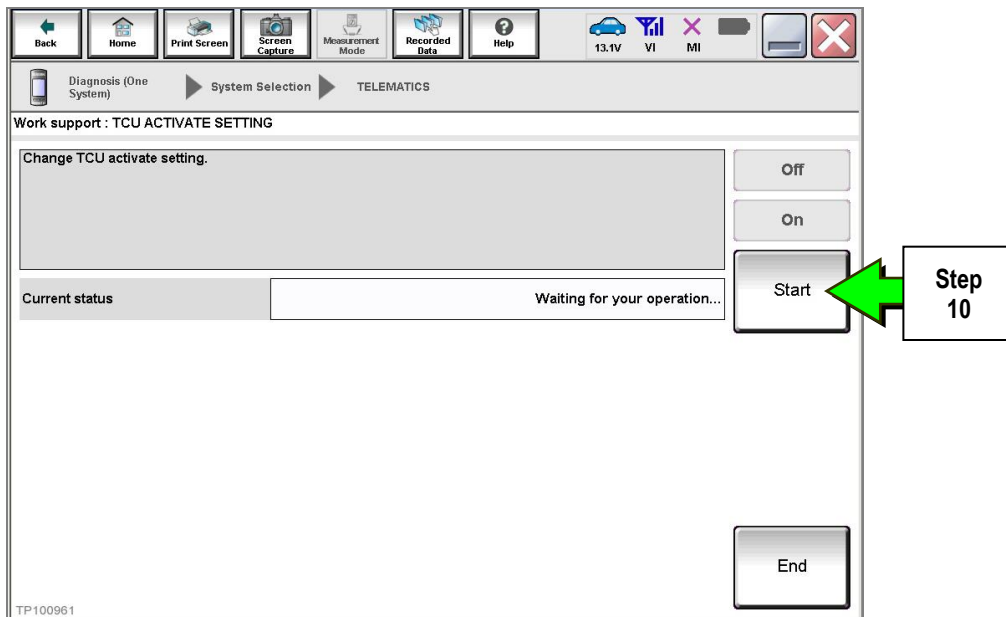
Figure 5

10. Select **Start**.

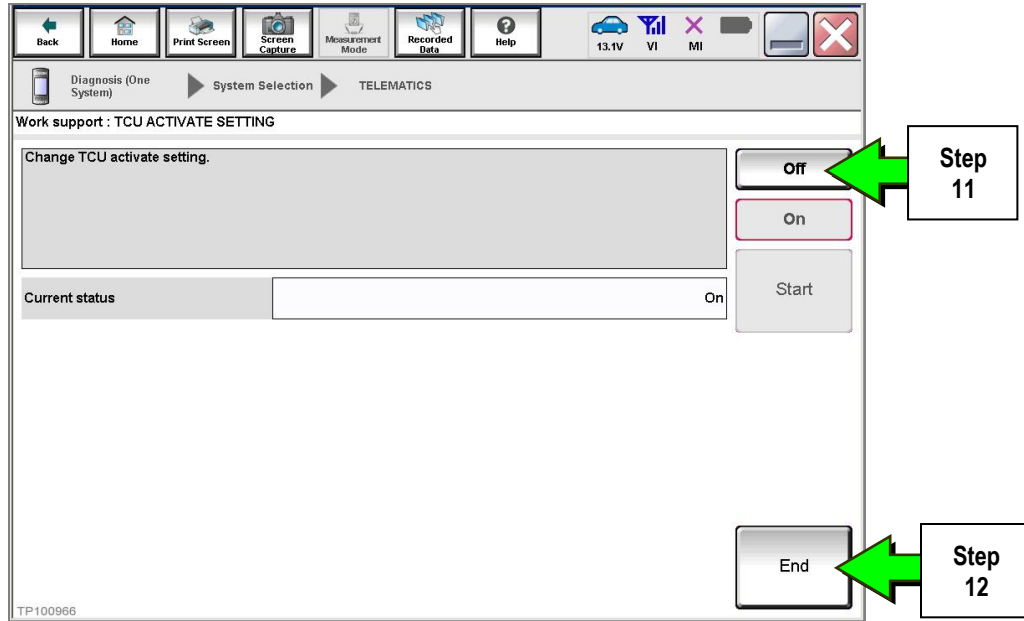
Figure 6

11. Select **Off** to turn OFF the TCU.

12. Select **End**.

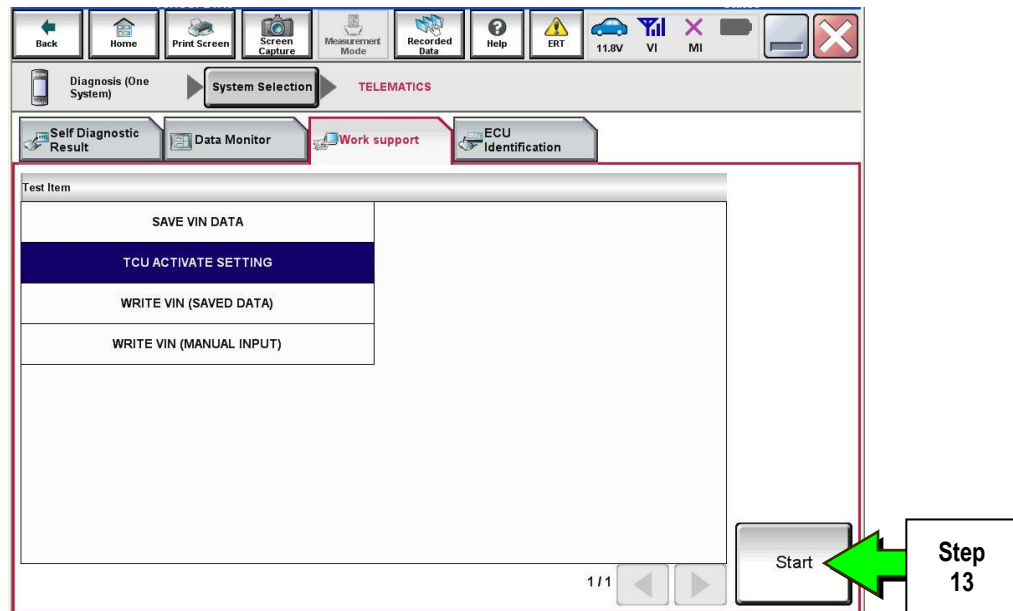
Figure 7

13. Select **Start**.

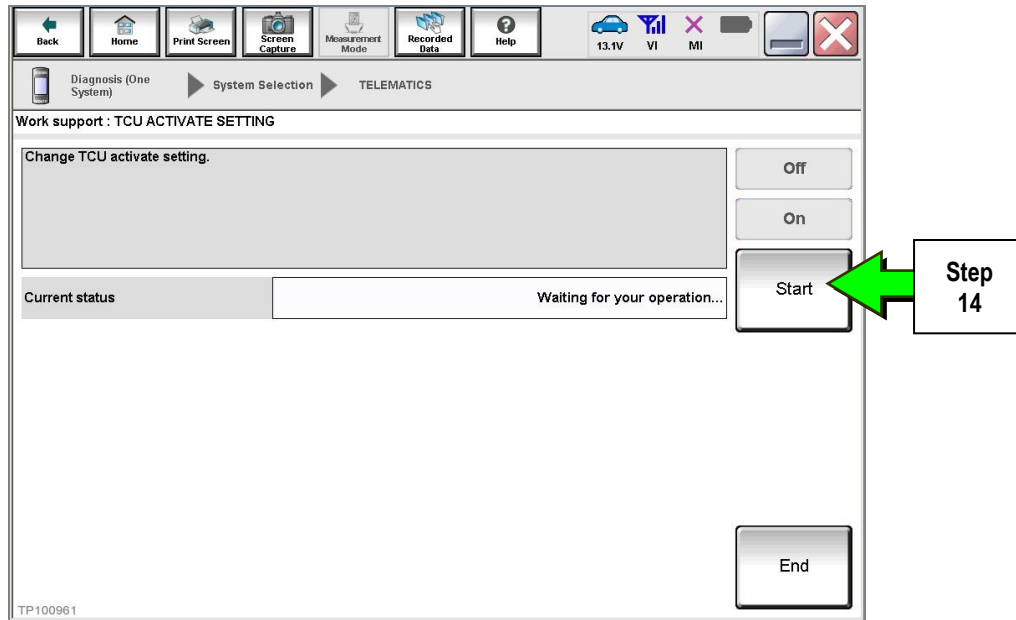
Figure 8

14. Select **Start**.

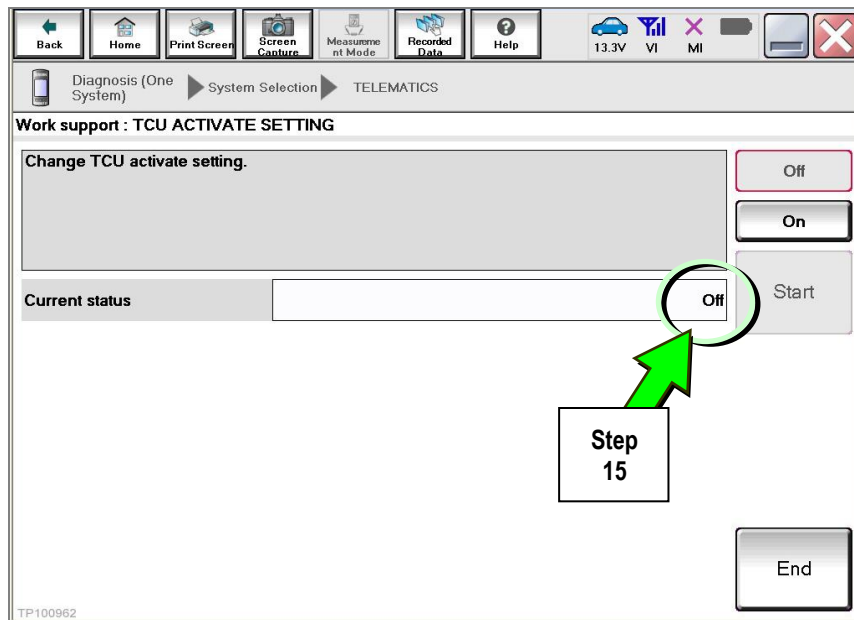
Figure 9

15. Confirm "**Off**" is displayed in the **Current status** field.

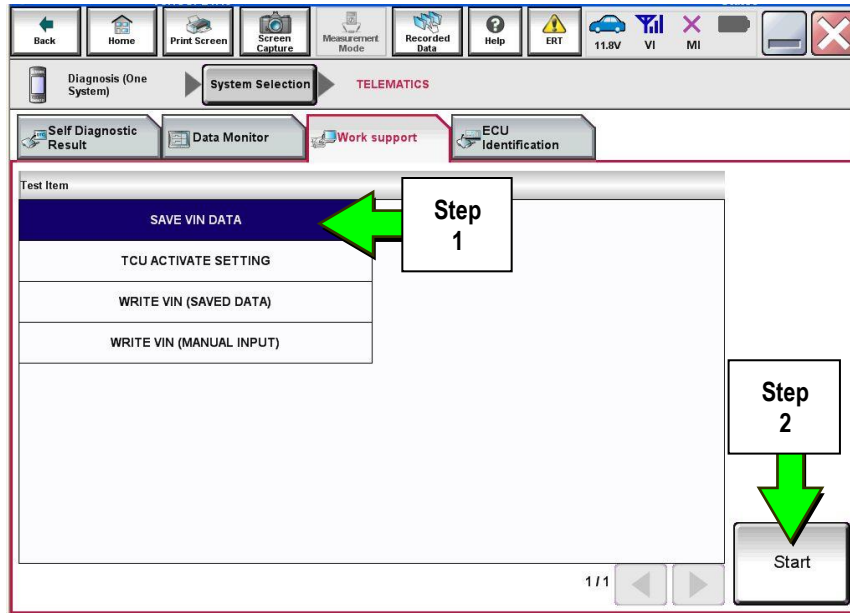
Figure 10

1. Select **SAVE VIN DATA**.
2. Select **Start**.

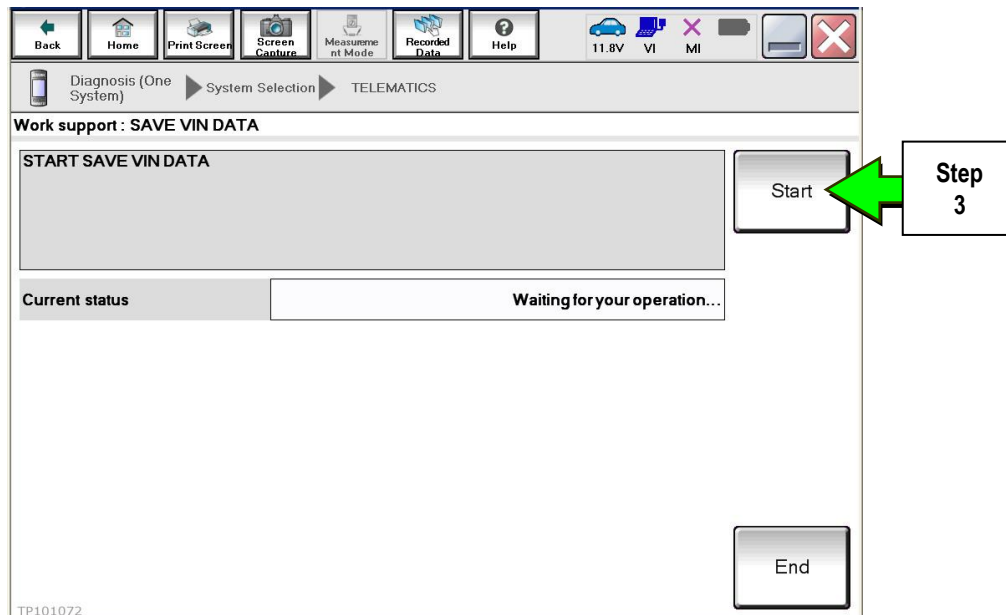
Figure 11

3. Select **Start**.

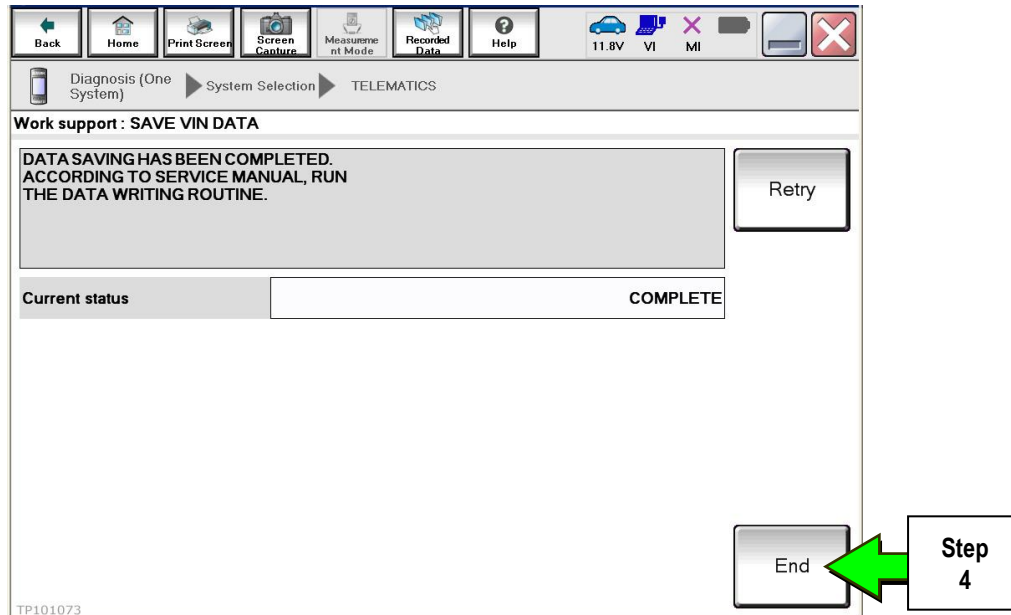
Figure 12

4. Select End.

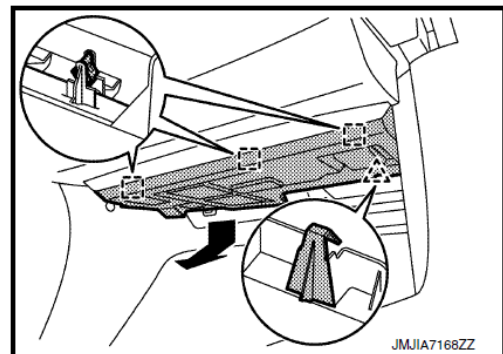
Figure 13

1. Remove the instrument lower cover.
 - a. Pull downward and disengage fixing pawl and metal clips.
 - b. Pull back instrument lower cover.
 - c. Disconnect foot lamp RH harness connector and TCU harness connector.

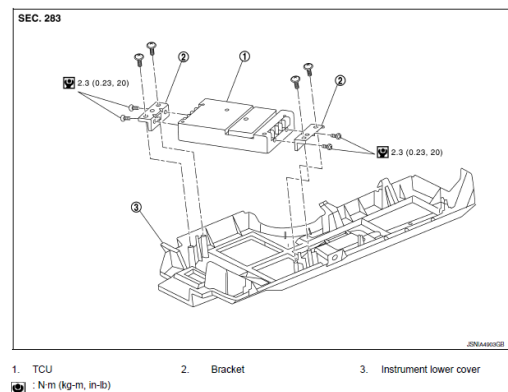
Figure 14

2. Remove the mounting screw and disconnect the connector, and then remove them together with the bracket from instrument lower cover.
3. Remove the bracket mounting screw and remove the bracket from TCU.

1. TCU
2. Bracket
3. Instrument lower cover
☑ : N·m (kg-m, in-lb)

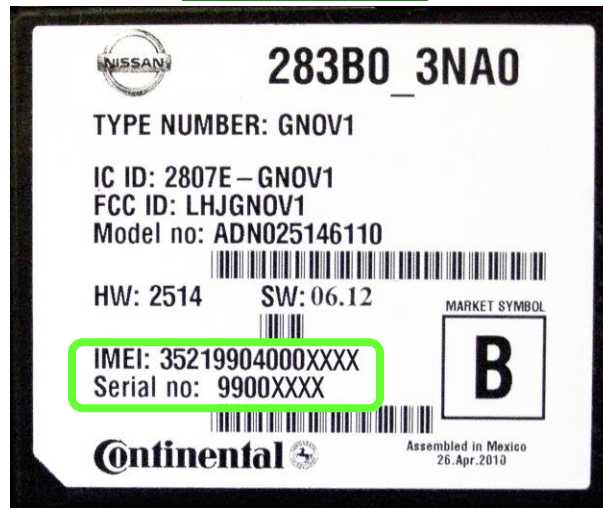
Figure 15

1. Collect and have ready the following information:
 - VIN.
 - International Mobile Equipment Identity Number (IMEI) of the original TCU. This number is located on the TCU.
 - IMEI Number of the replacement TCU. This number is located on the TCU.
 - Serial Number of the replacement TCU. This number is located on the TCU.

LABEL ON TCU

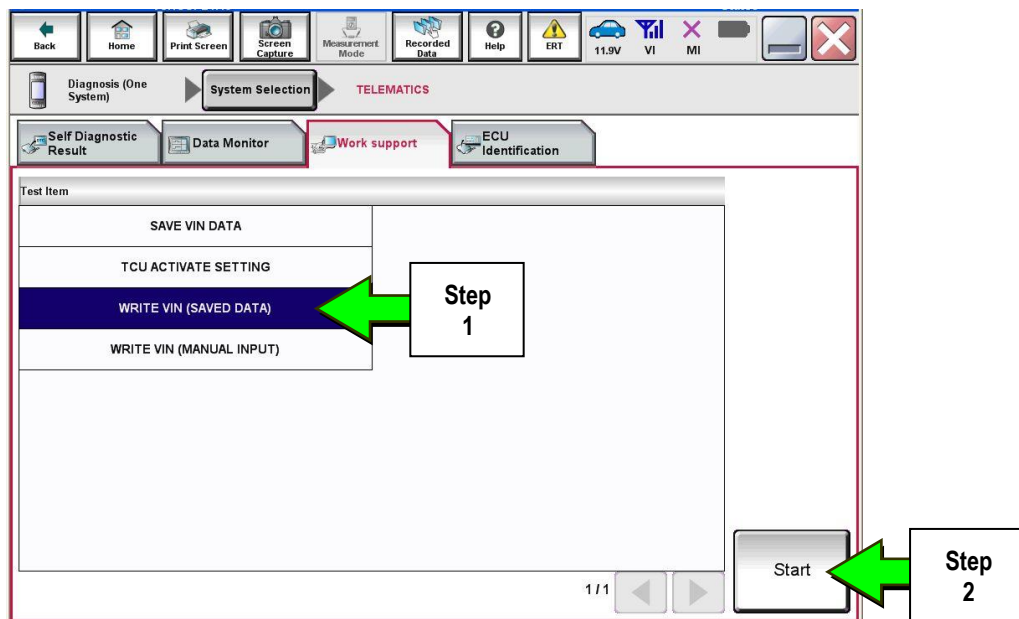
Figure 16

1. Select **WRITE VIN (SAVED DATA)**.
2. Select **Start**.

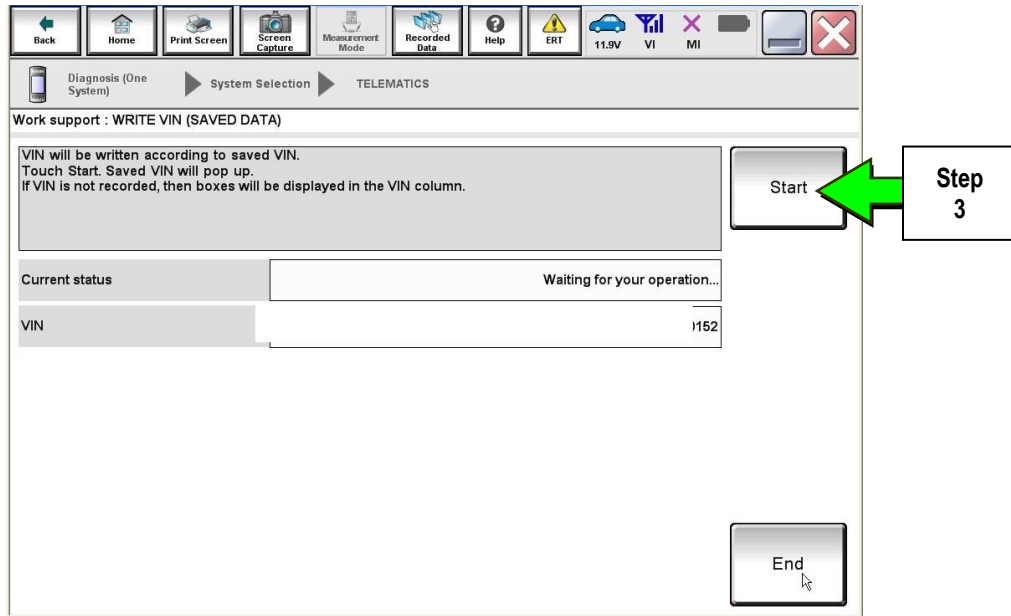
Figure 17

3. Select **Start**.

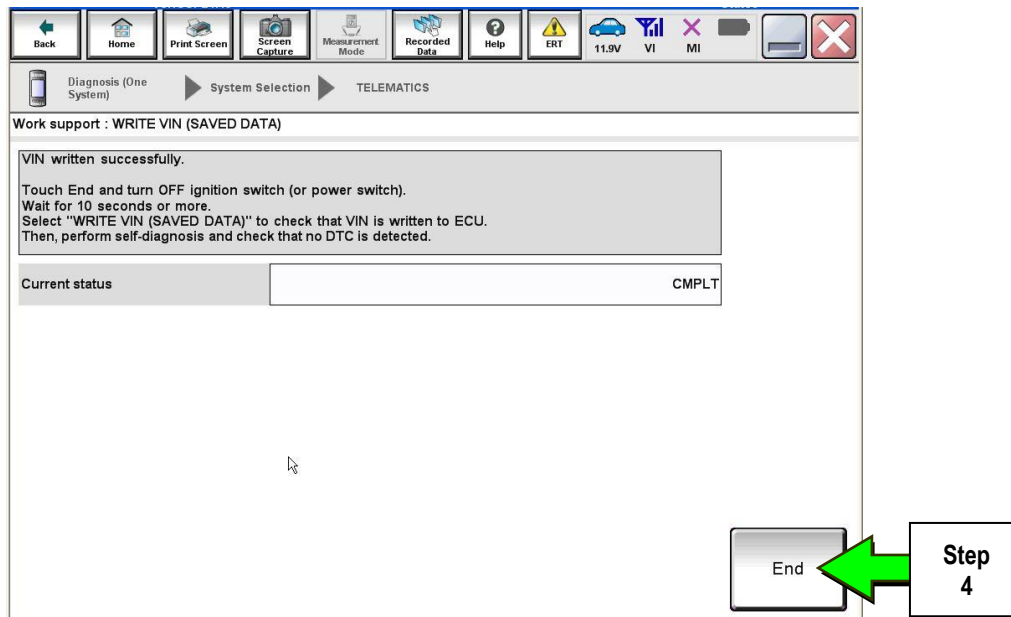
Figure 18

4. Select **End**.

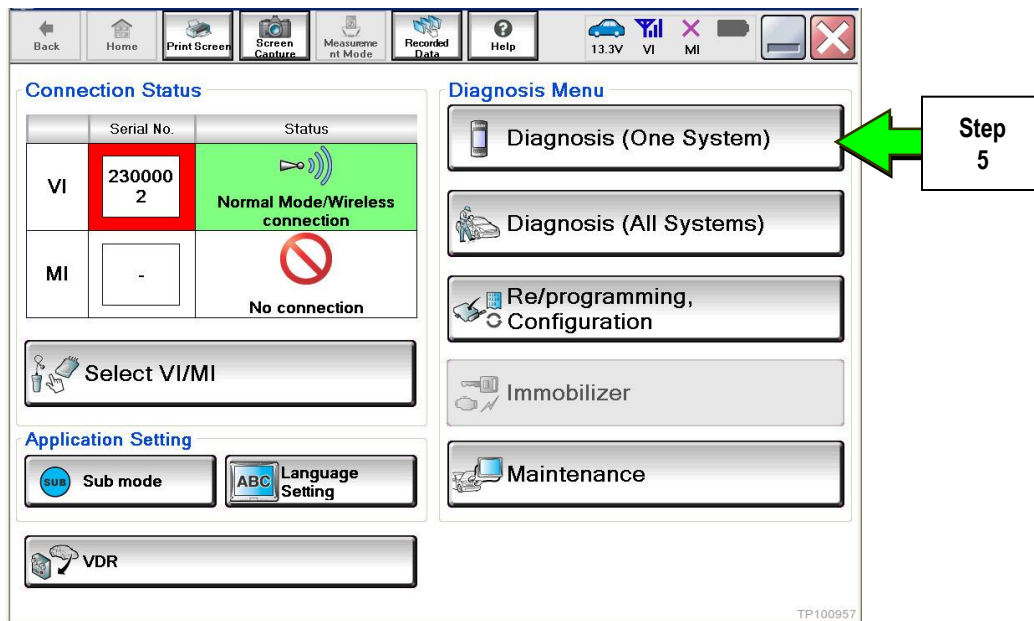
Figure 1

1. Connect the C-III plus VI to the vehicle.
2. Set the parking brake.
3. Turn the Ignition ON, but do not start the vehicle.
4. Launch C-III plus on the CONSULT PC.
5. Select **Diagnosis (One System)**.

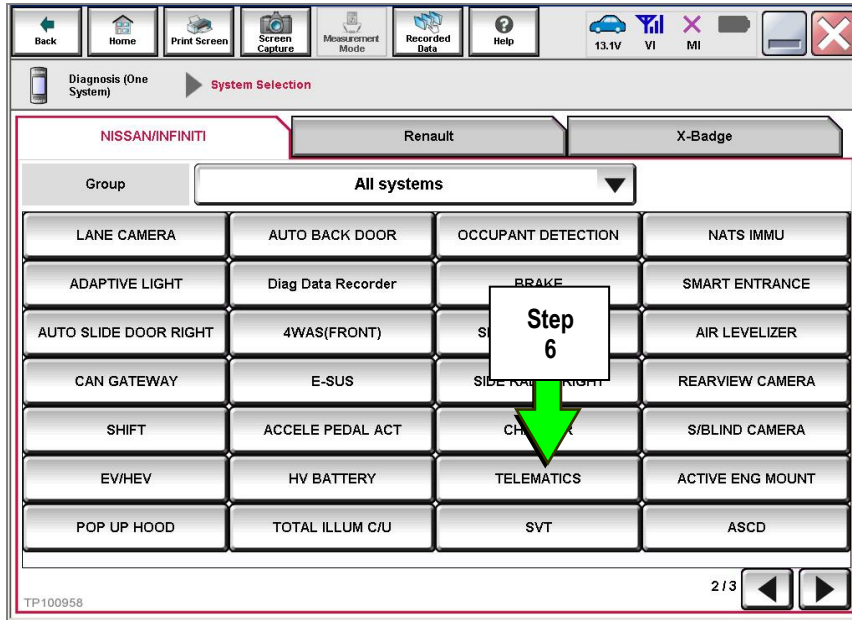
Figure 2

6. Select **TELEMATICS** on page 2 of the “All systems” list.

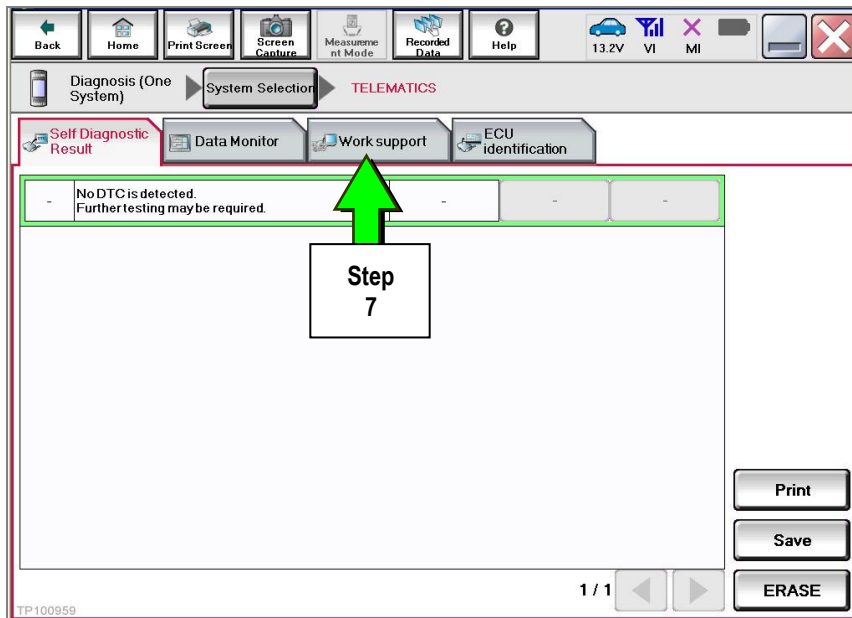
Figure 3

7. Select **Work support**.

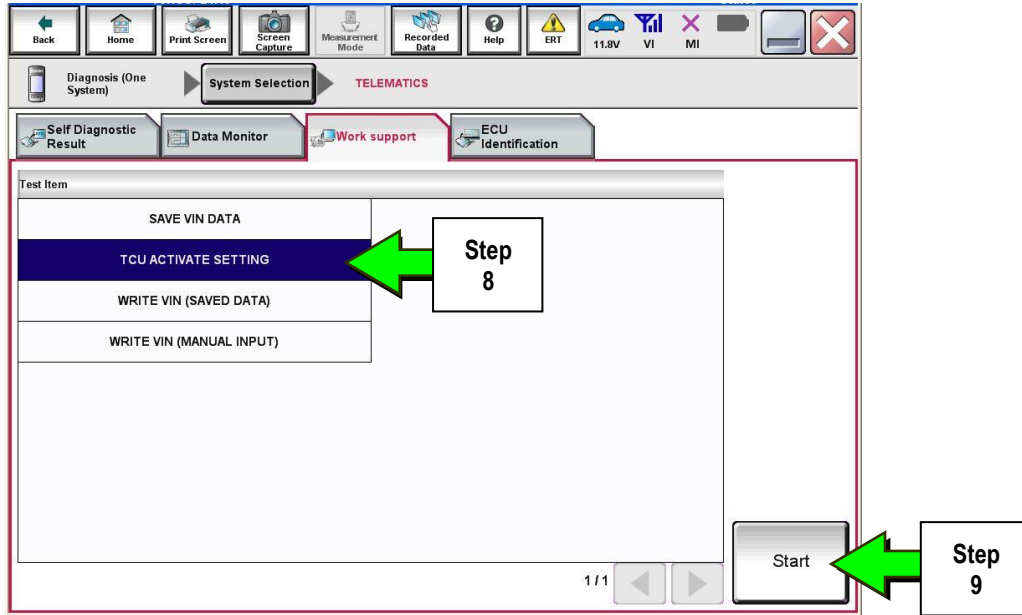
Figure 4

8. Select **TCU ACTIVATE SETTING**.

9. Select **Start**.

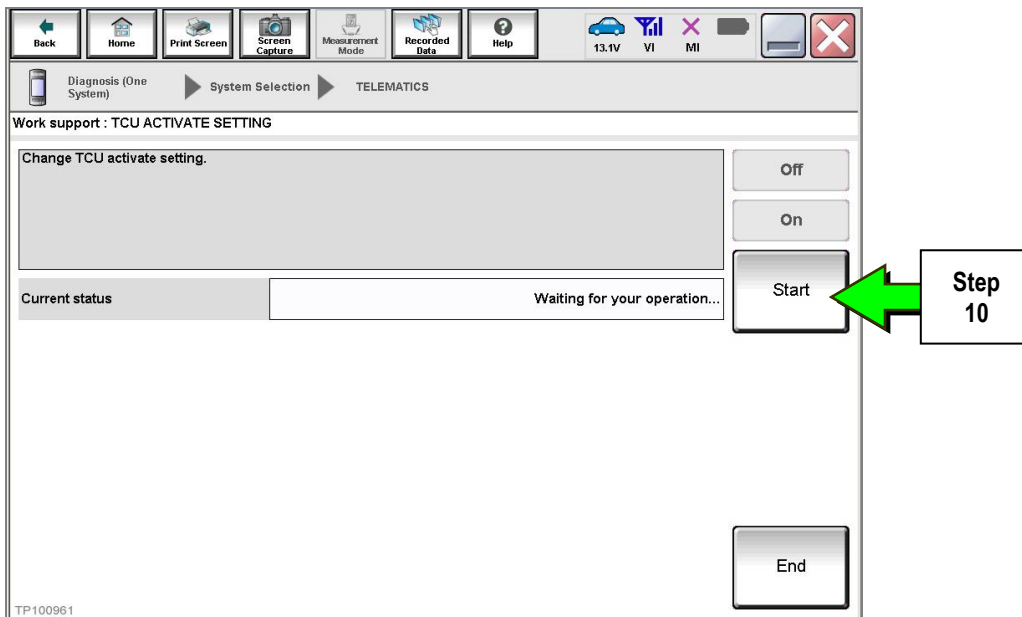
Figure 5

10. Select **Start**.

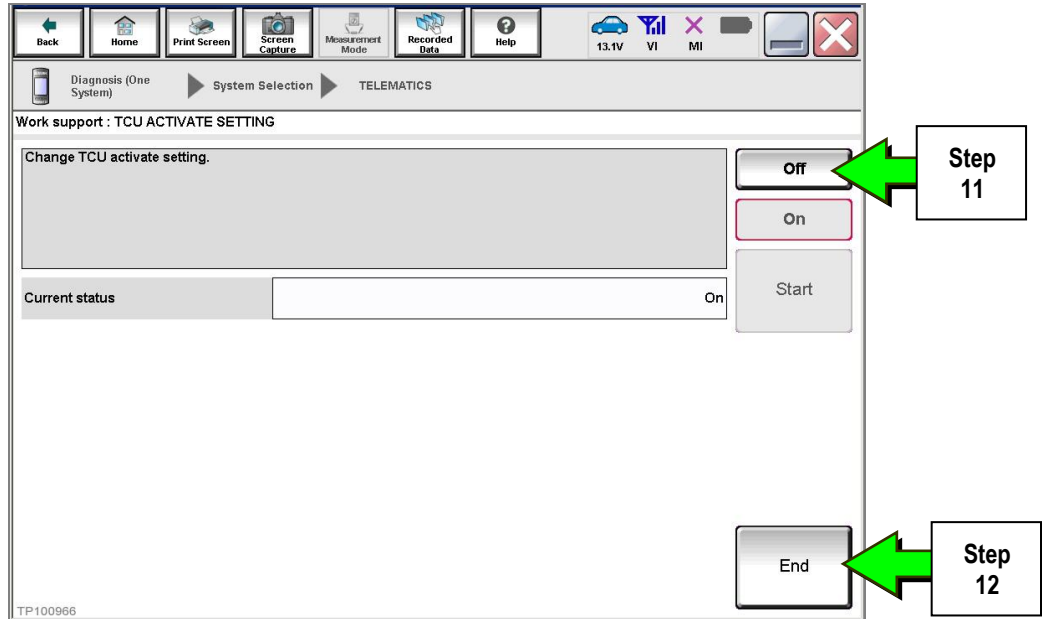
Figure 6

11. Select **Off** to turn OFF the TCU.

12. Select **End**.

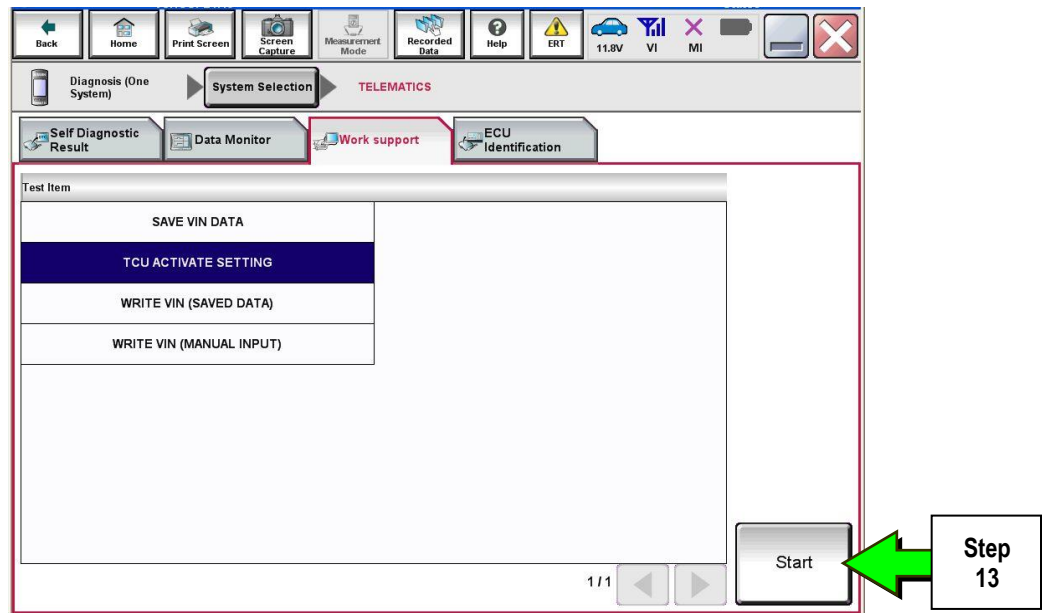
Figure 7

13. Select **Start**.

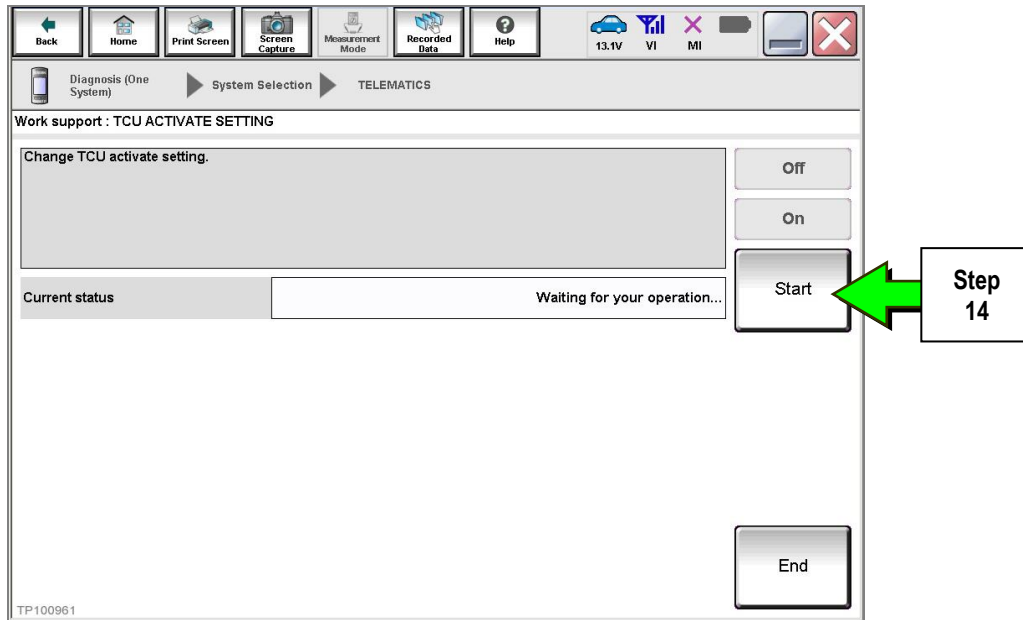
Figure 8

14. Select **Start**.

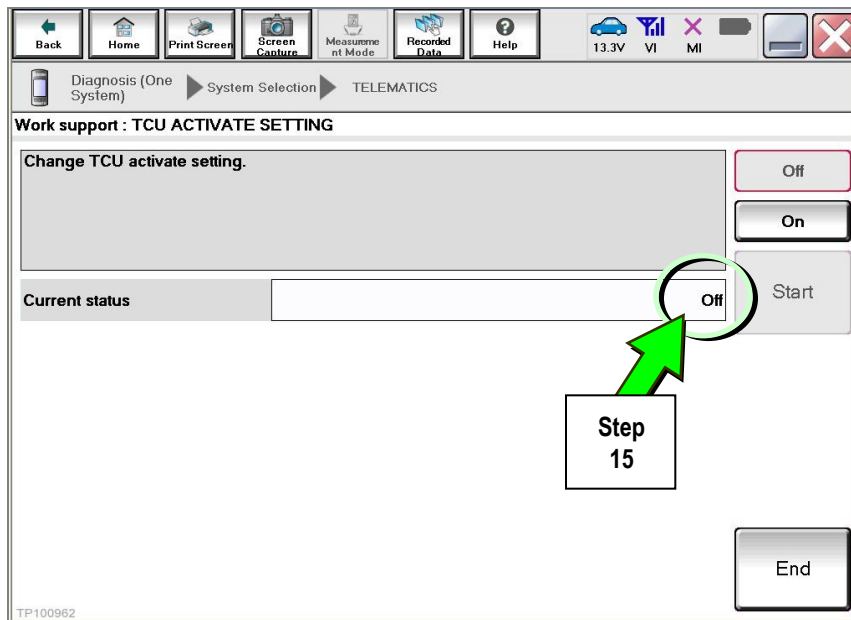
Figure 9

15. Confirm "**Off**" is displayed in the **Current status** field.

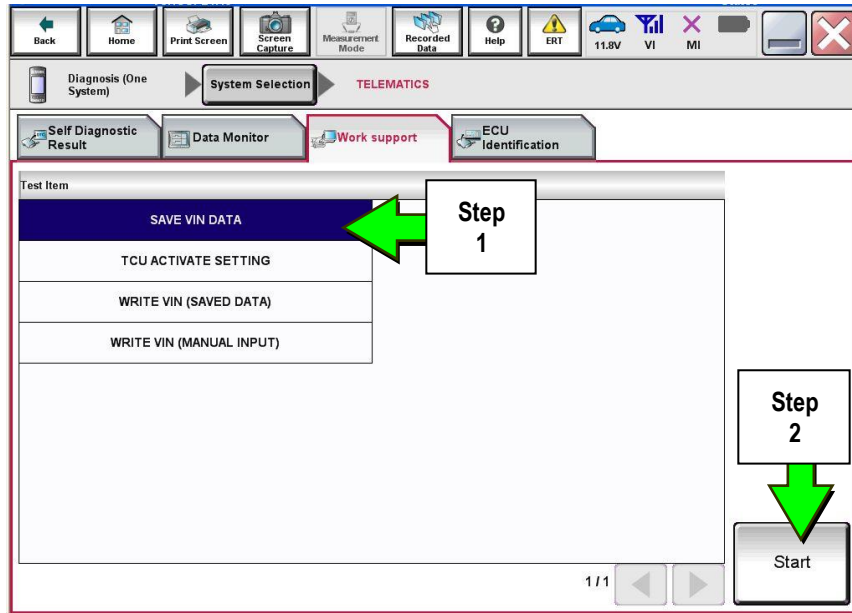
Figure 10

1. Select **SAVE VIN DATA**.
2. Select **Start**.

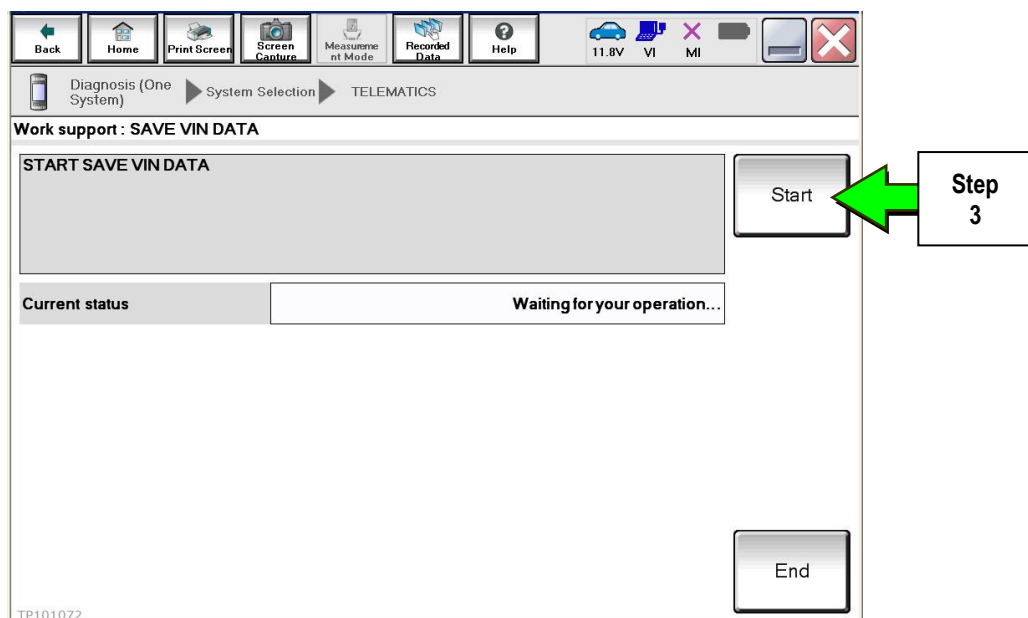
Figure 11

3. Select **Start**.

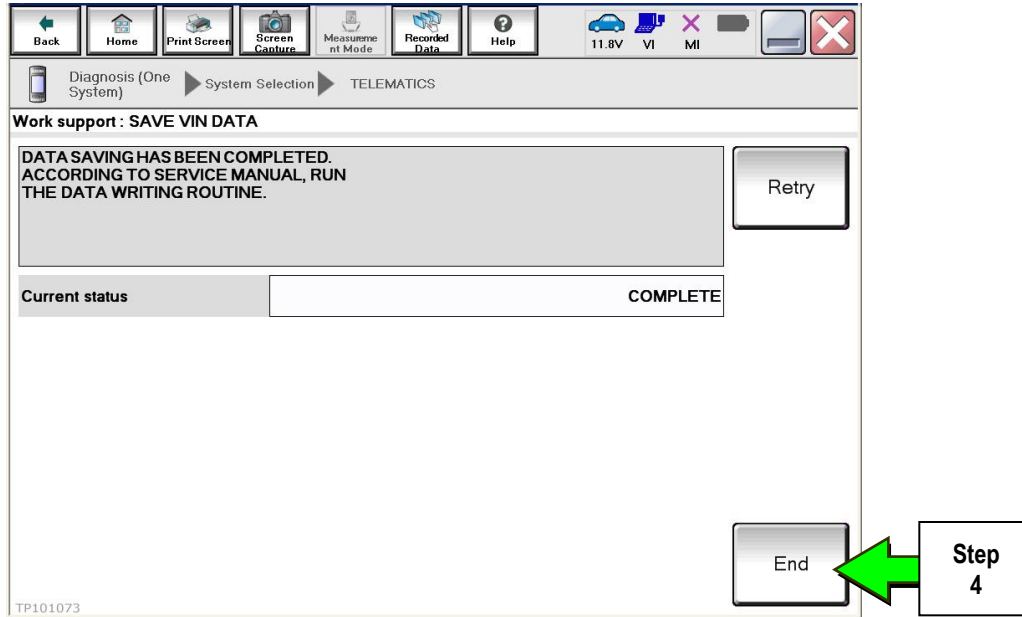
Figure 12

4. Select End.

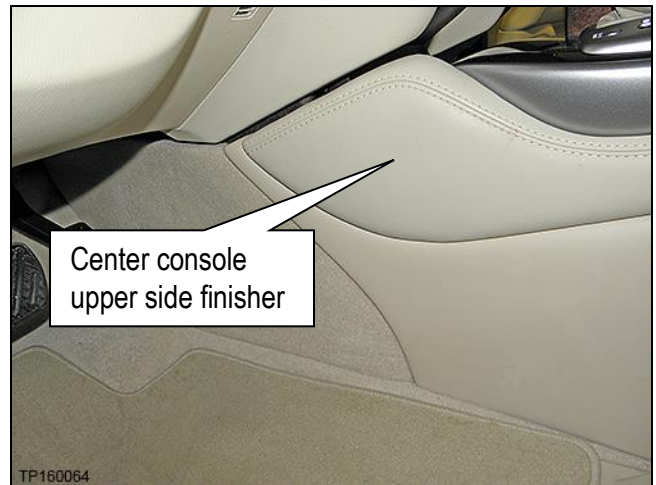
1. Remove both left and right center console upper side finishers.

NOTE: Driver side shown In Figure 13 and 14. Passenger side similar.

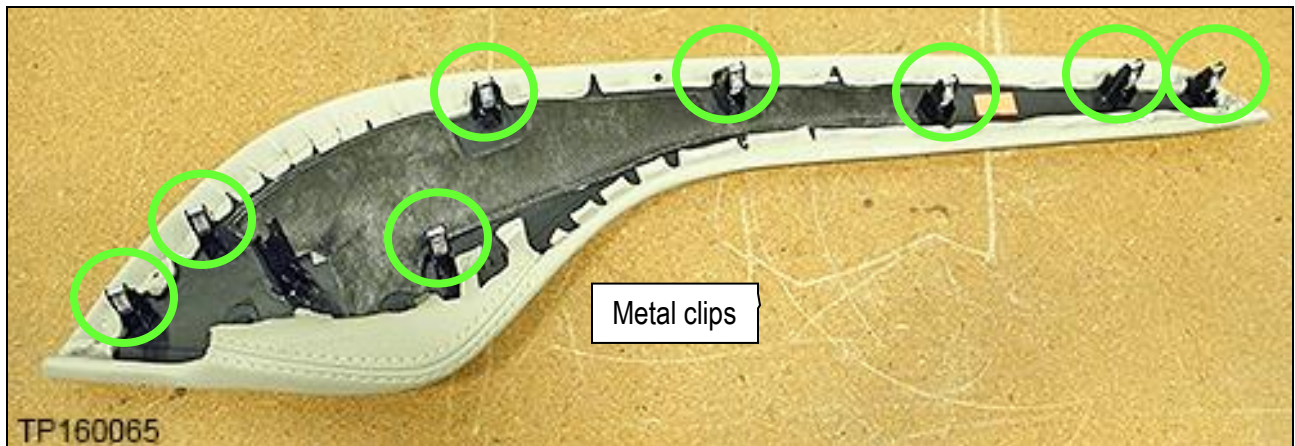
Figure 14

2. Confirm that the metal clips for the left and right upper center console side finisher are in place.
 - If the clips were detached, remove them from the center console and reattach to the upper center console side finishers.

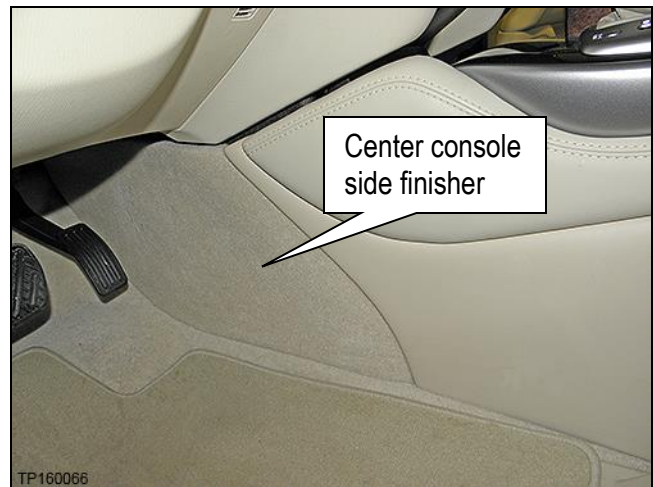
Figure 15

3. Remove both center console side finishers.

NOTE: Driver side shown in Figure 15.

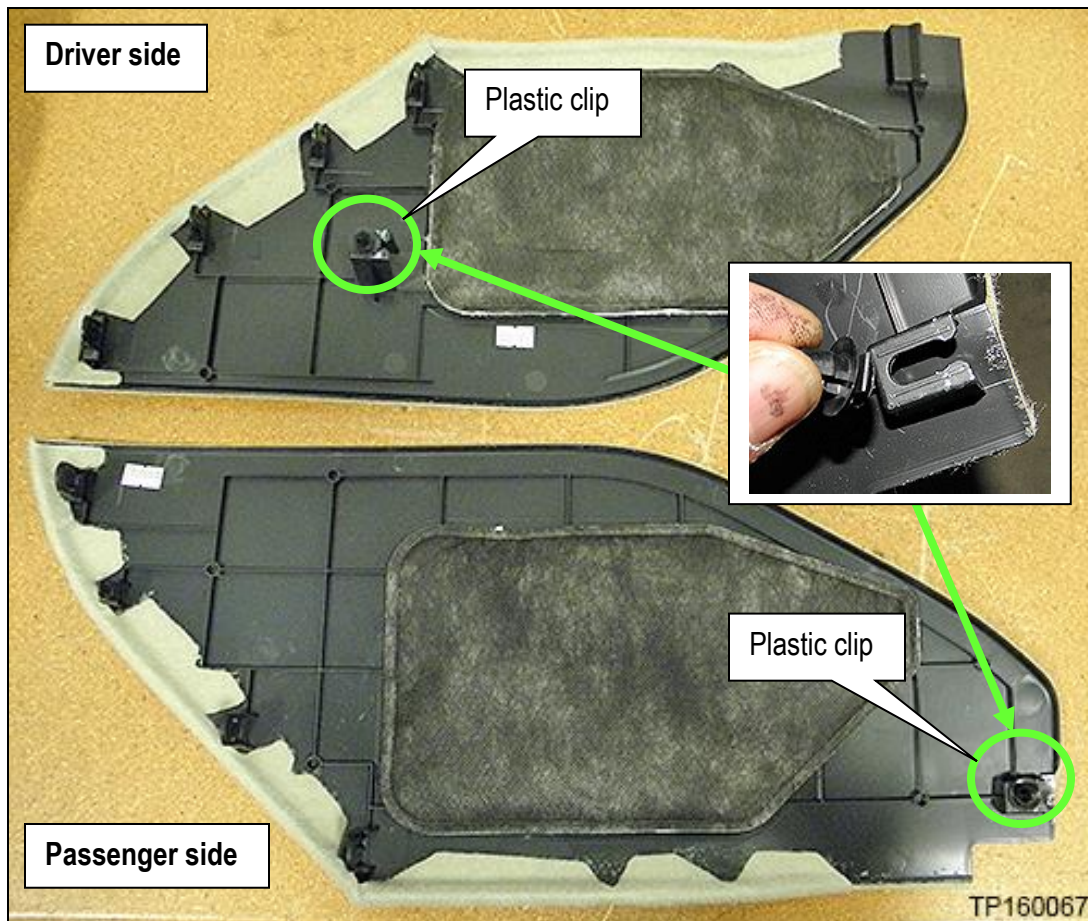
Figure 16

4. Confirm that the plastic clips for the left and right center console side finisher are in place.
 - If the clips were detached, remove them from the center console and reattach to the center console side finishers.

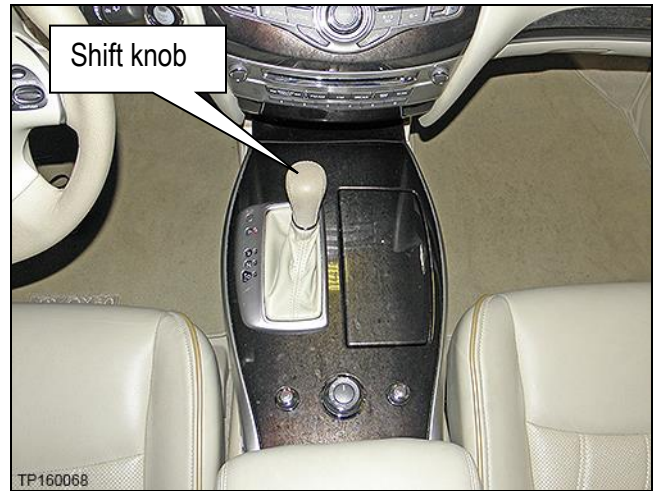
Figure 17

5. Remove the shift knob:

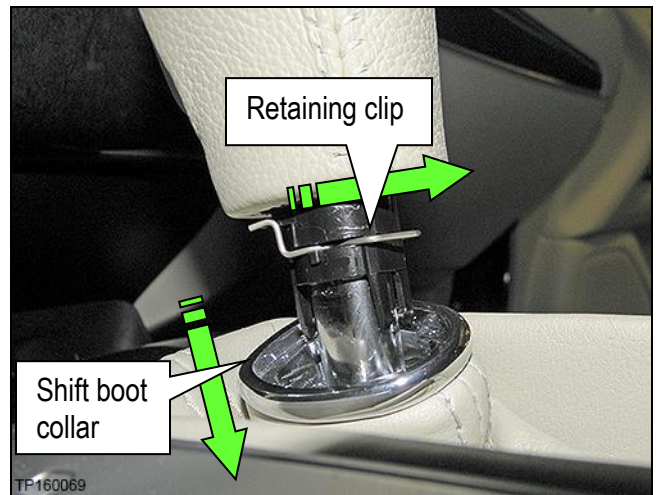
Figure 18

a. Pull shift boot collar down (Figure 18).

b. Remove retaining clip (Figure 18).

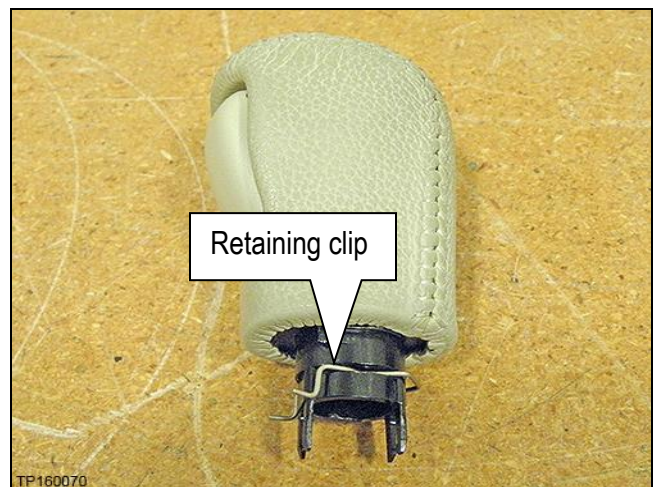
Figure 19

c. Replace retaining clip back onto shift knob (Figure 19).

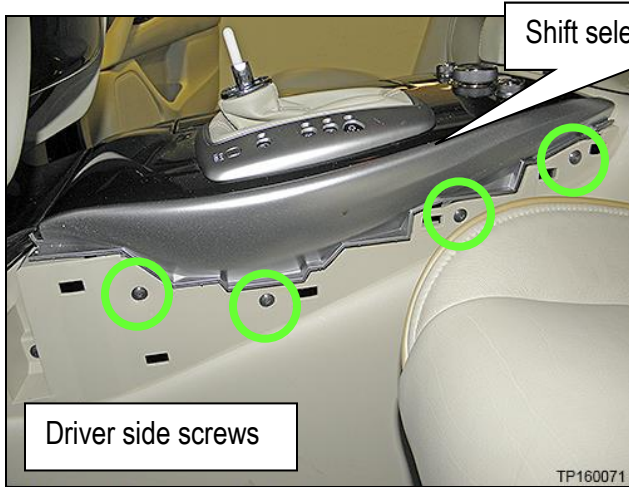
Figure 20

6. Remove the left and right side screws that retain the shift selector finisher.
- Four on driver's side (Figure 20).
 - Five on Passenger side (Figure 21).

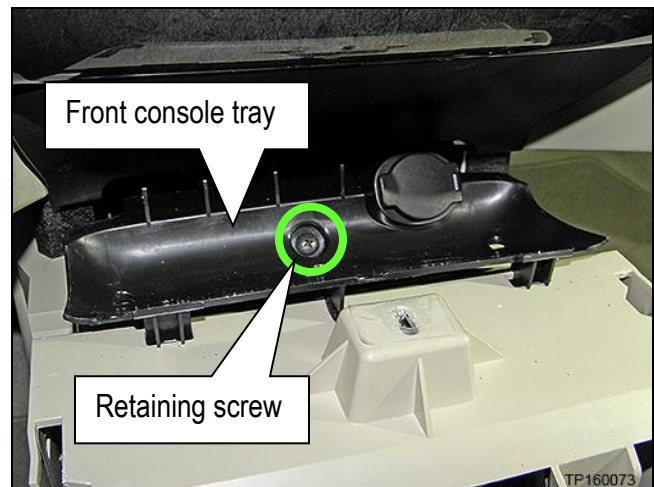
Figure 22

7. Remove one retaining screw and then unclip the front console tray from the center console (Figure 22).

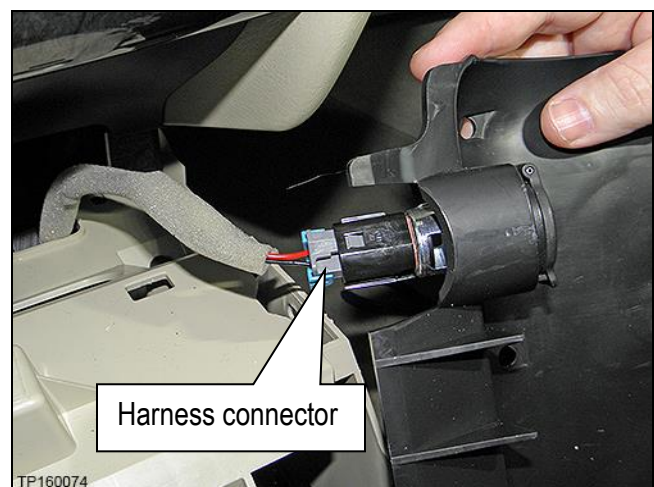
Figure 23

8. Disconnect the harness connector from the 12 volt power receptacle (Figure 23).
- Leave harness attached to the center console.

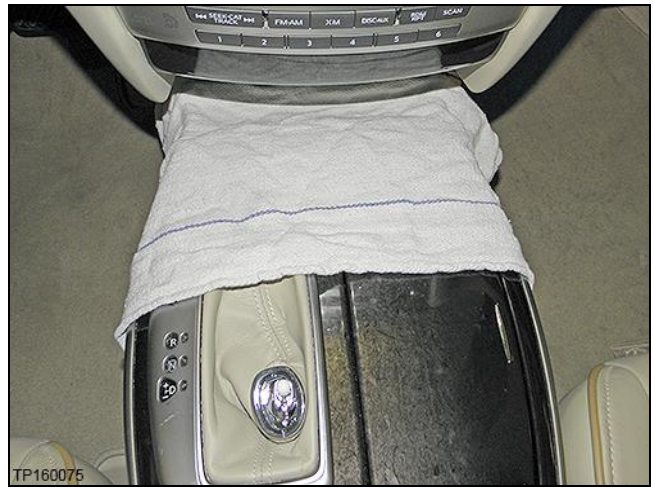
Figure 24

9. Remove the shift selector finisher:
 - a. Place a clean shop towel over the front of the shift selector finisher (Figure 24).

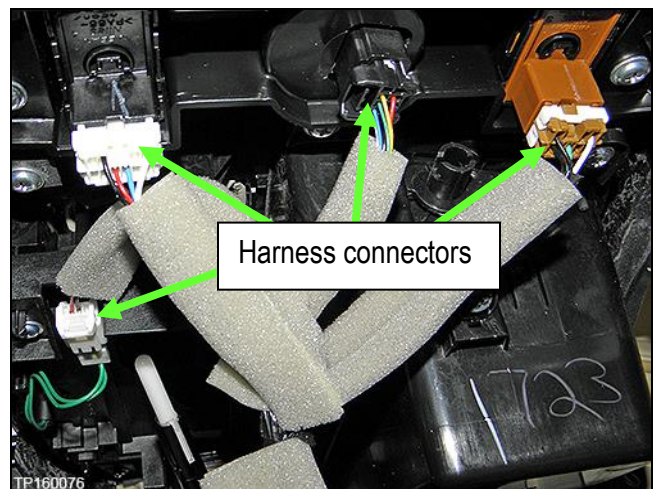
Figure 25

- b. Lift the shift selector finisher at the rear.
 - c. While lifting the shift selector finisher, disconnect the four harness connectors exposed at the rear of the center console (Figure 25).
 - d. Separate the shift selector finisher from the center console.

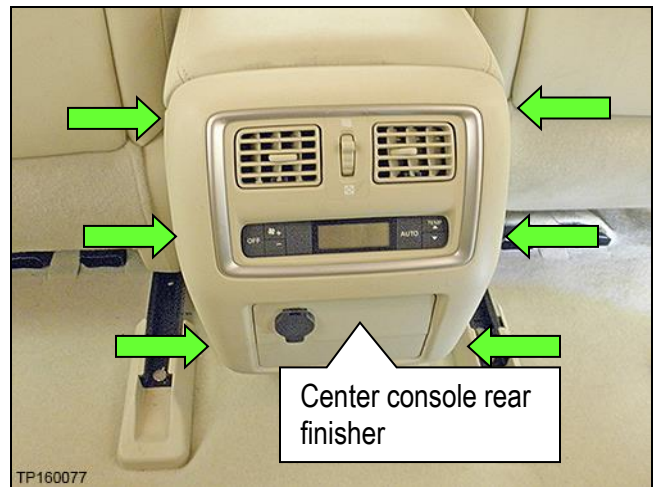
Figure 26

10. Remove the center console rear finisher:

- Six hidden clips (Figure 26).
