I N F I N I T I

2G Telematics Hardware Replacement Client Satisfaction Initiative

Reference: PC451, PC452, PC454

M37, M56, & Q70 Telematics Control Unit Replacement

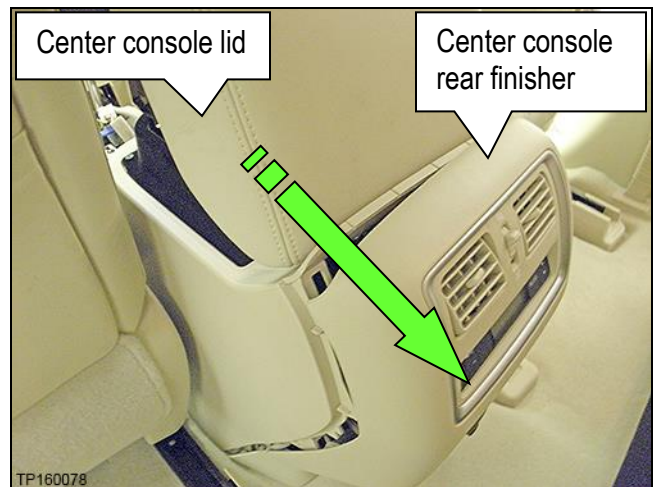
Figure 27

- Lift center console lid.
- Release six clips by gently pulling at the top of the center console rear finisher toward the rear of the vehicle.

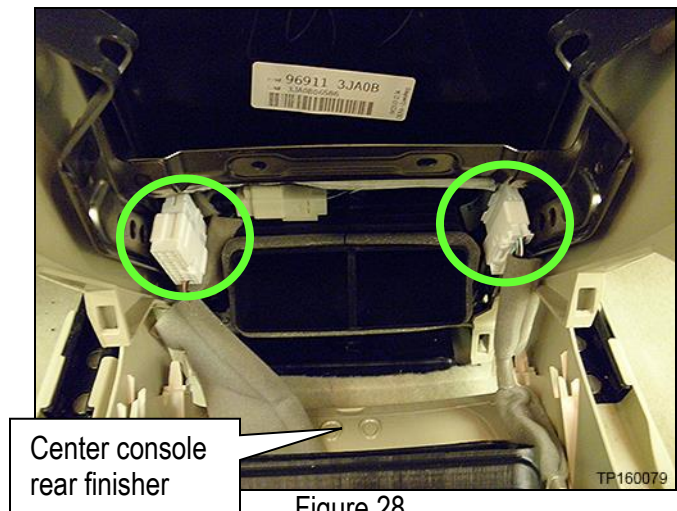
Figure 28

- Lay the center console rear finisher on the vehicle floor.
- Disconnect the two attached harness connectors (Figure 28).

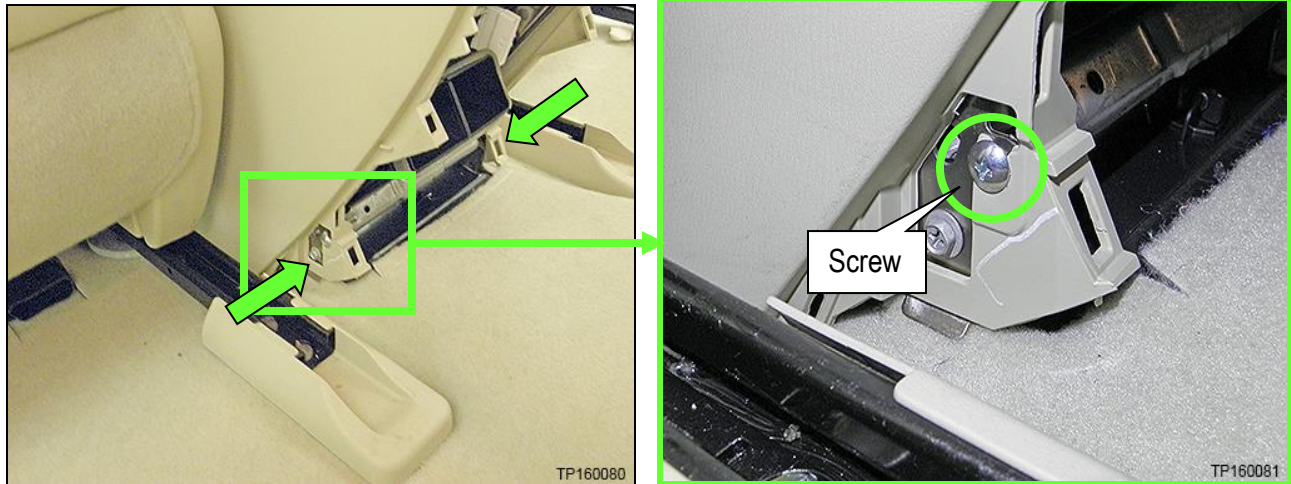
Figure 29

11. Remove the two mounting screws at the bottom rear of the center console (Figure 29).

- Driver's side shown. Passenger side similar.

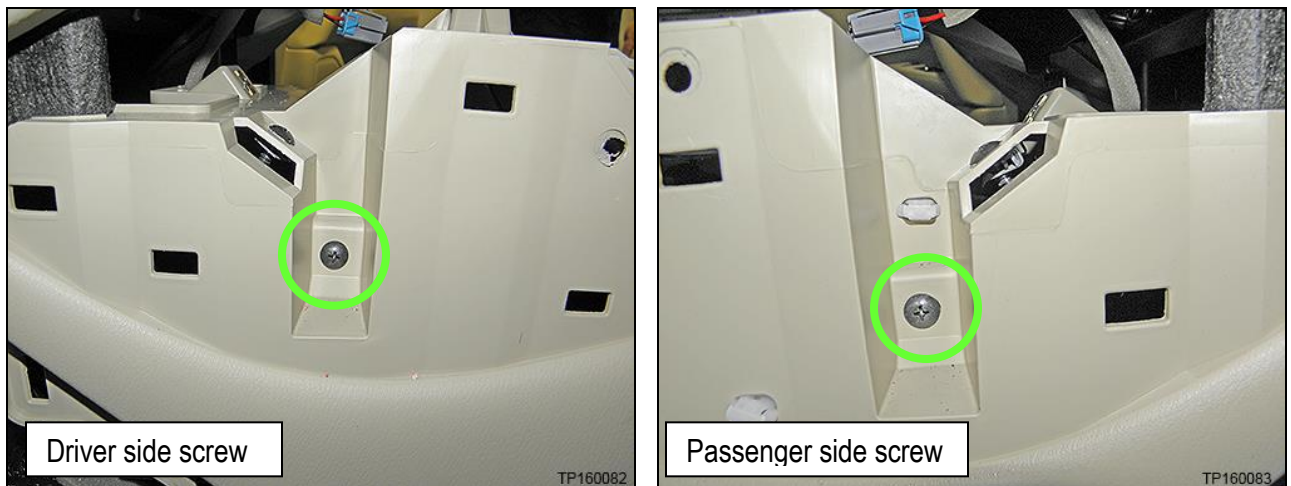
Figure 30

12. Remove one mounting screw from the driver's side and one from the passenger side of the center console (Figure 30)

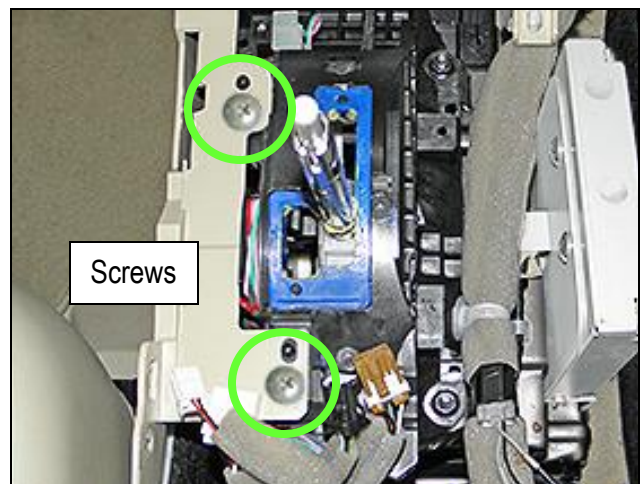
Figure 31

13. Remove the two screws to the left of the shifter.

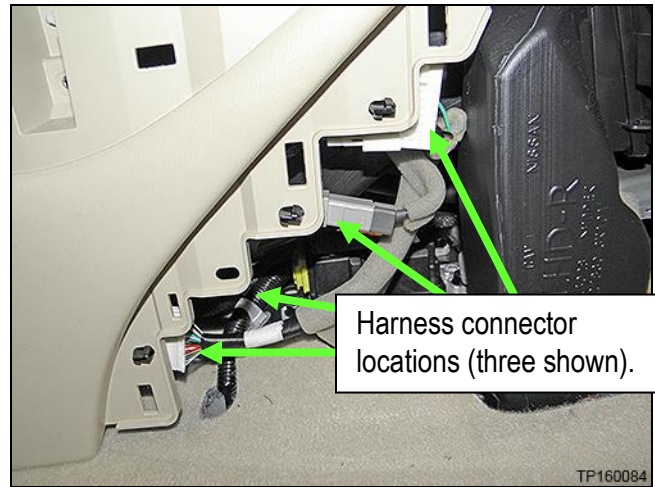
Figure 32

14. Disconnect the harness connectors on the passenger side center console.

- Do not unclip harnesses from center console.

NOTE: There may be three or four connectors depending on the vehicle options.

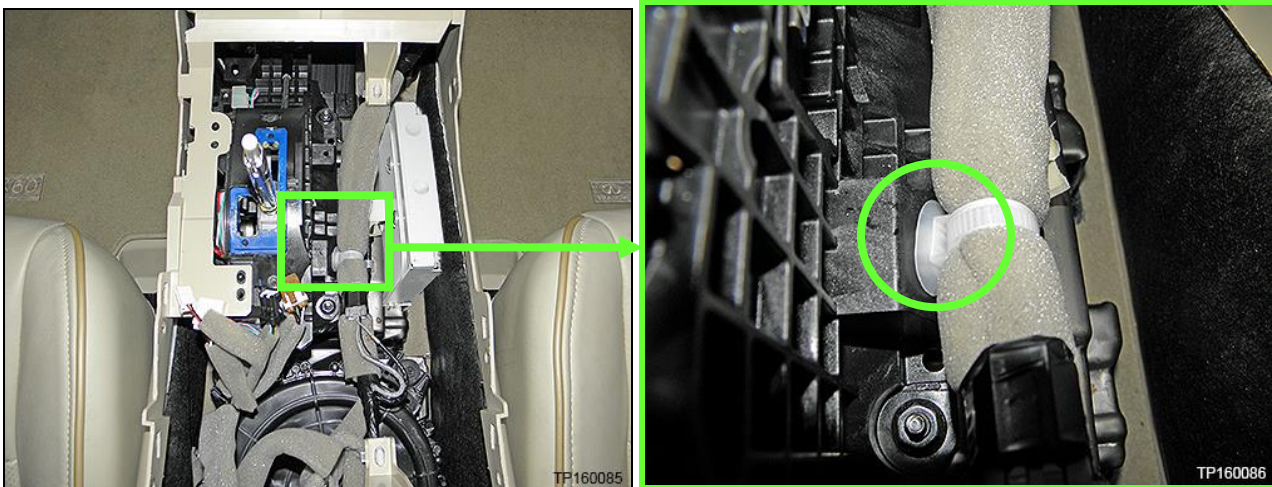
Figure 33

15. Unclip the harness from the shift selector assembly (Figure 33).

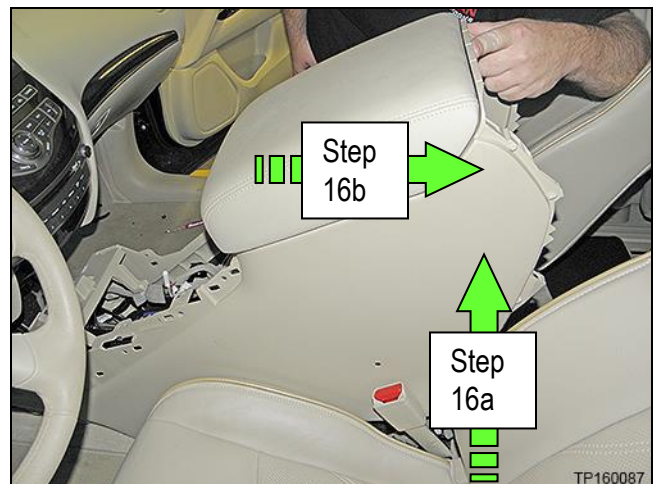
16. Remove the center console (Figure 34).

- a. Gently lift up,
- b. and then rearward.

18. Unclip the two harness clips shown in Figure 34 attached to the center console brace.

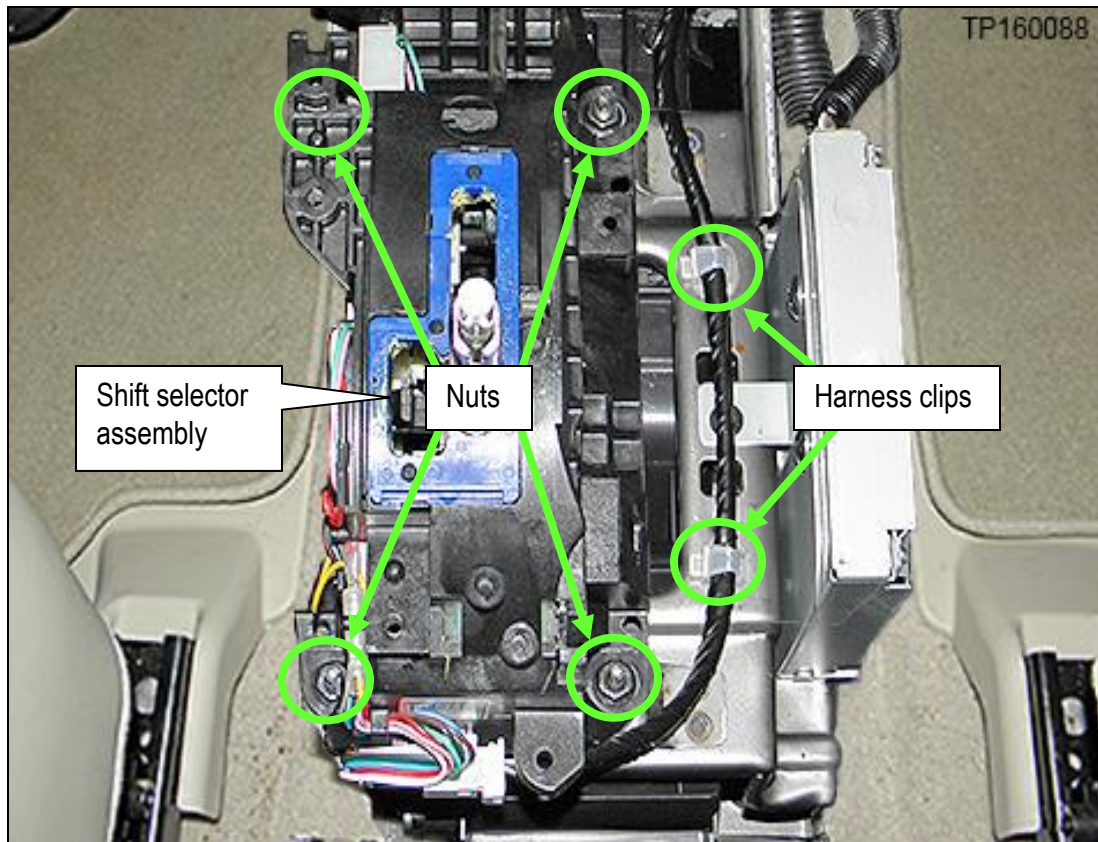
Figure 35

17. Remove the four nuts that attach the shift selector assembly to the center console brace (Figure 35).

NOTE: Top left nut is hidden in Figure 35.

- Reassembly torque to: 7 N•m (0.7 kg-m, **62 in-lb.**)

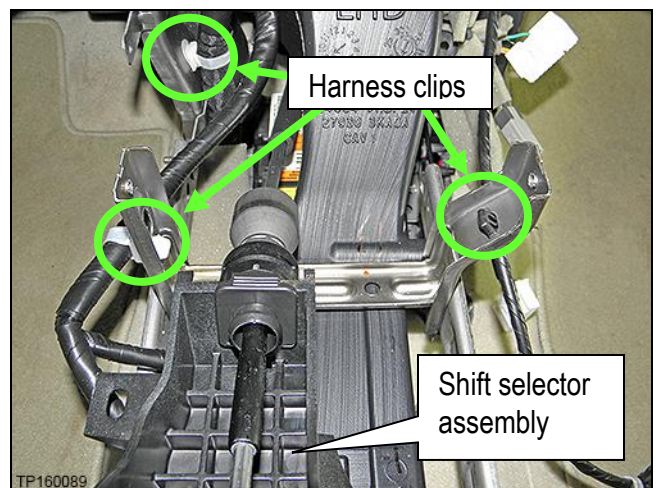
Figure 36

19. Unclip the three harness clips from the center console brace shown in Figure 36.

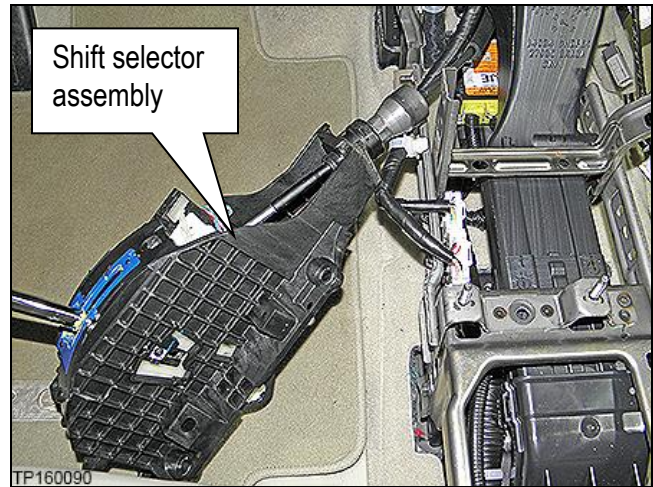
Figure 37

20. Lift the shift selector assembly away from the center console brace and lay it on the driver's side floor (Figure 37).

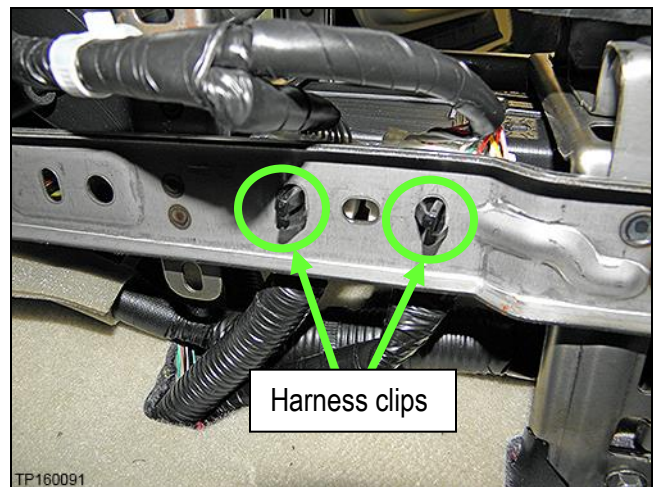
21. Unclip the two harness connectors shown in Figure 38 from the driver's side of the center console brace.

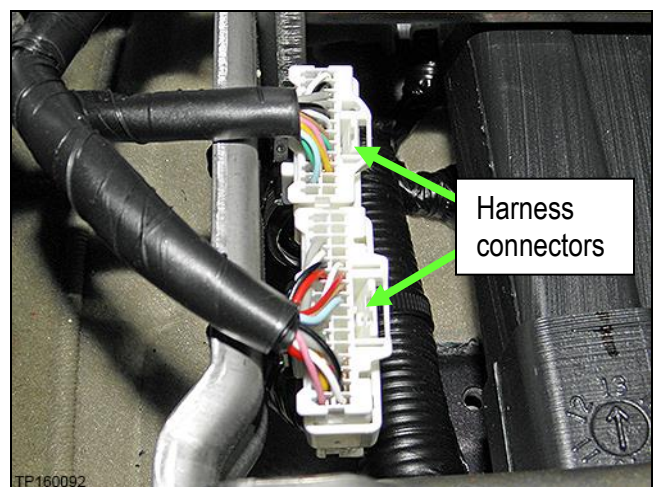
Figure 39

22. Unplug the two harness connectors that were unclipped in step 21 and shown in Figure 39.

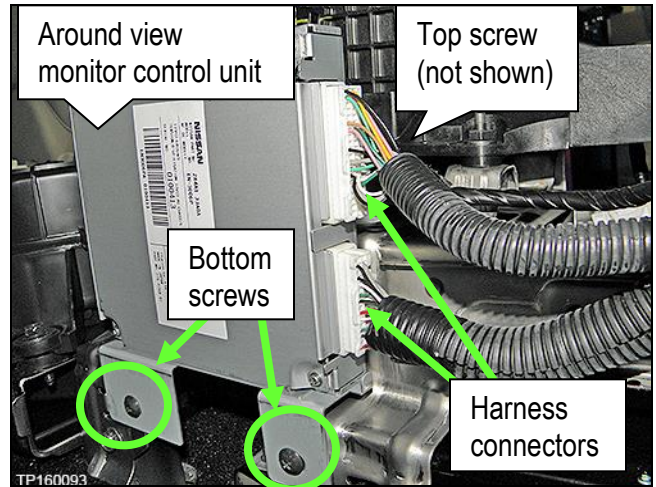
Figure 40

23. Remove the around view monitor control unit from the center console brace (Figure 40).
- Disconnect the harness connectors from the around view monitor control unit.
 - Remove one top screw (not shown) and two bottom screws.

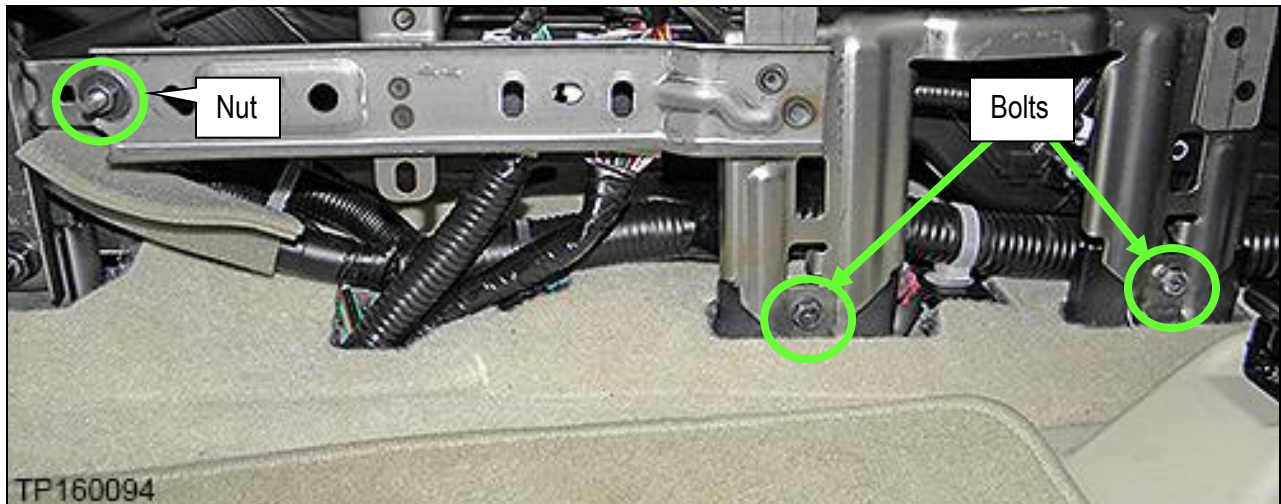
Figure 41

24. Remove the two bolts and one nut on the driver's side of the center console brace.
- Reassembly torque to: 7 N•m (0.7 kg-m, **62 in-lb.**)

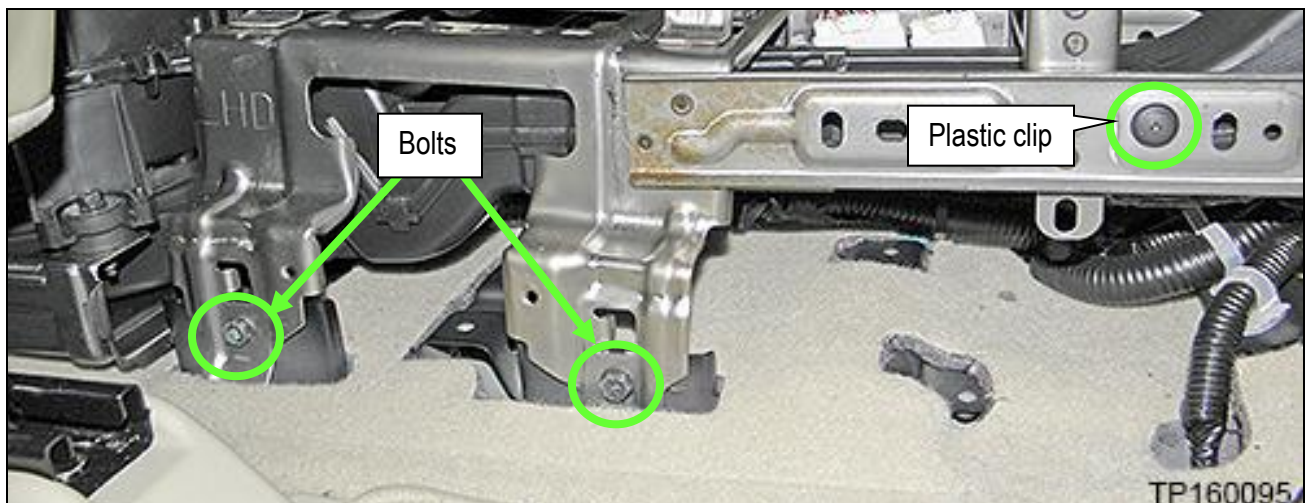
Figure 42

25. Remove the two bolts and one plastic clip on the passenger side of the center console brace.
- Reassembly torque to: 7 N•m (0.7 kg-m, **62 in-lb.**)

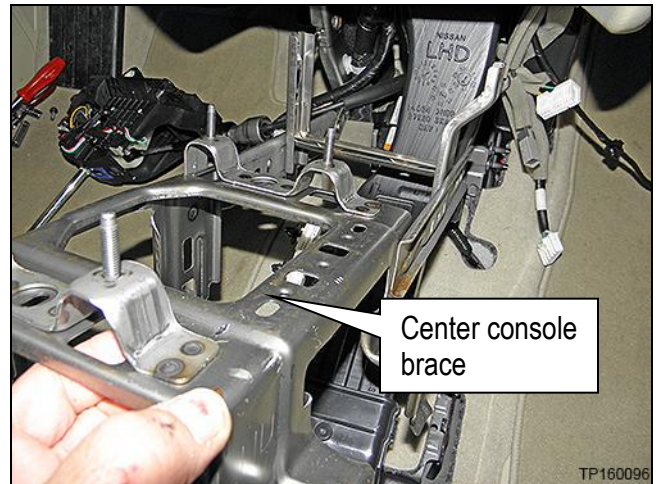
Figure 43

26. Lift the center console brace up at the rear and then remove.

CAUTION: The center console brace may have some sharp edges. Use care when removing it.

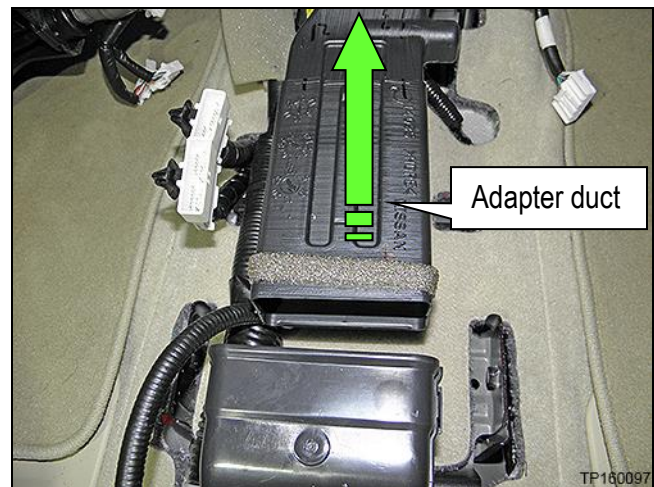
Figure 44

27. Push the adapter duct forward to detach from the rear blower unit assembly and then remove.

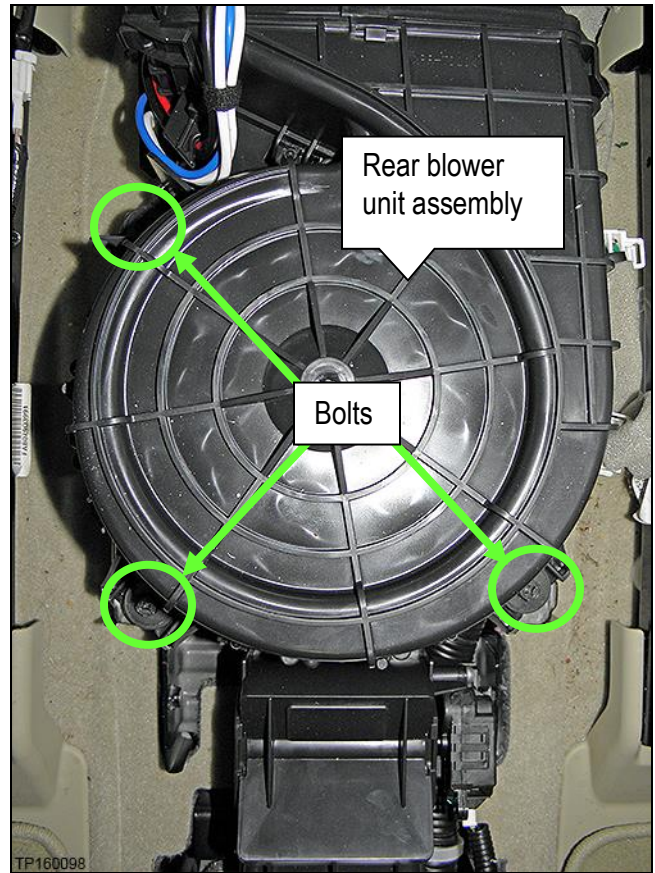
Figure 45

28. Unbolt the 3 bolts that retain the rear blower unit assembly (Figure 45) and then move it to gain access to the “Telematics Control Unit” (TCU).

NOTE: Do not disconnect harnesses to the rear blower unit assembly.

- Reassembly torque to:
7 N•m (0.7 kg-m, 62 in-lb.)

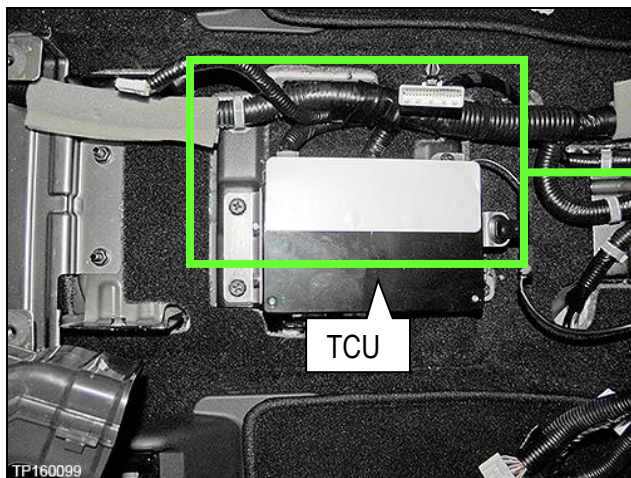
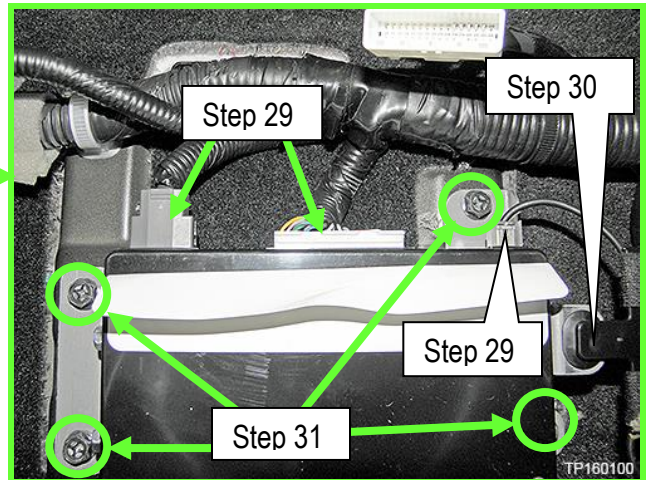
Figure 46

29. Disconnect the three harness connectors from the TCU (Figure 46).

30. Unclip the antenna support clip from the TCU bracket (Figure 46).

31. Unbolt the four bolts that attach the TCU to the vehicle floor (Figure 46)

- One bolt hidden in Figure 46.
- Reassembly torque to: 10.1 N•m (1.0 kg-m, 7 ft-lb.)

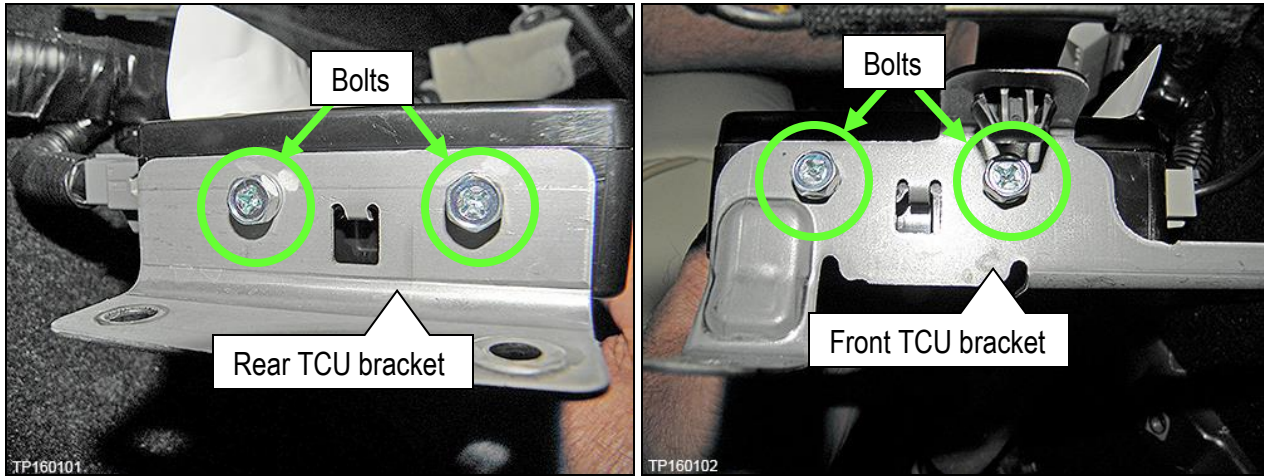
Figure 47

32. Transfer the brackets from the old TCU to the new one.

- a. Remove the two bolts that attach the front and rear TCU brackets; four total (Figure 47).
- b. Transfer the brackets to the new TCU and install bolts.
 - Reassembly torque to: 5.5 N•m (0.56 kg-m, **49 in-lb.**)

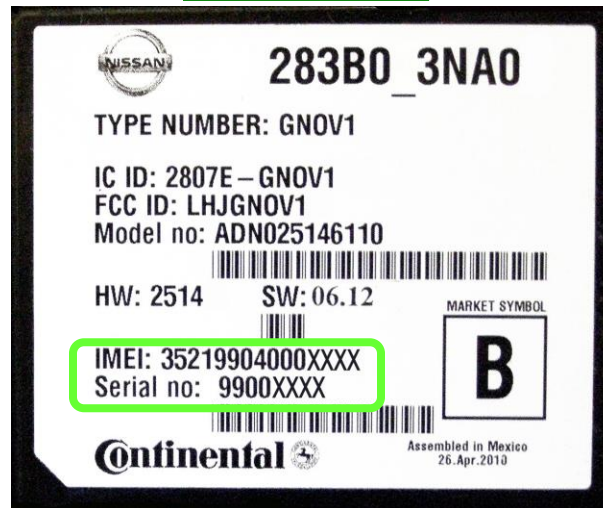
Figure 15

1. Collect and have ready the following information:
 - VIN.
 - International Mobile Equipment Identity Number (IMEI) of the original TCU. This number is located on the TCU.
 - IMEI Number of the replacement TCU. This number is located on the TCU.
 - Serial Number of the replacement TCU. This number is located on the TCU.

LABEL ON TCU

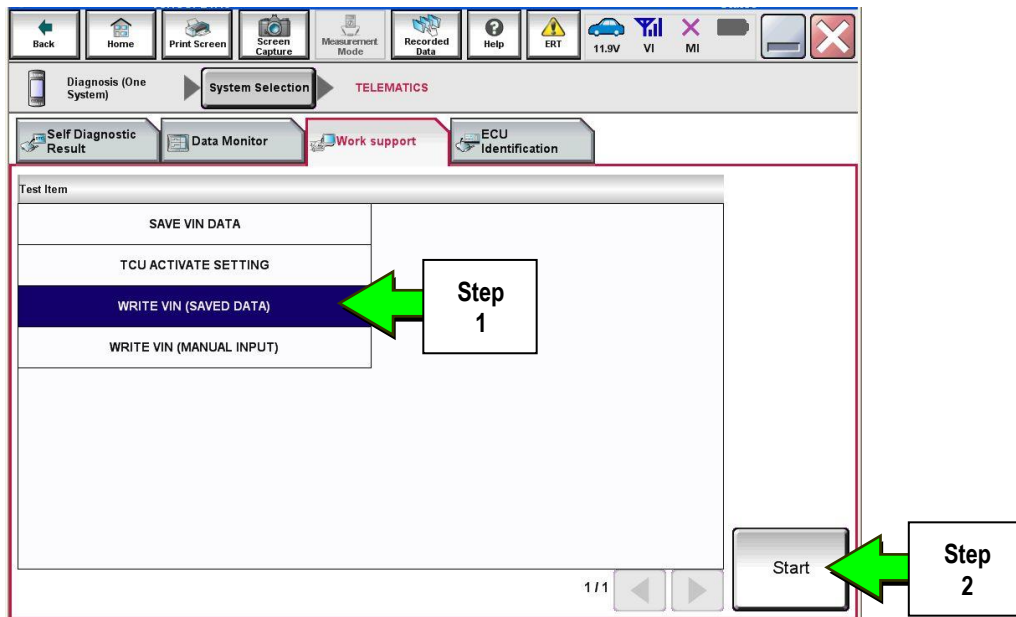
Figure 49

1. Select **WRITE VIN (SAVED DATA)**.
2. Select **Start**.

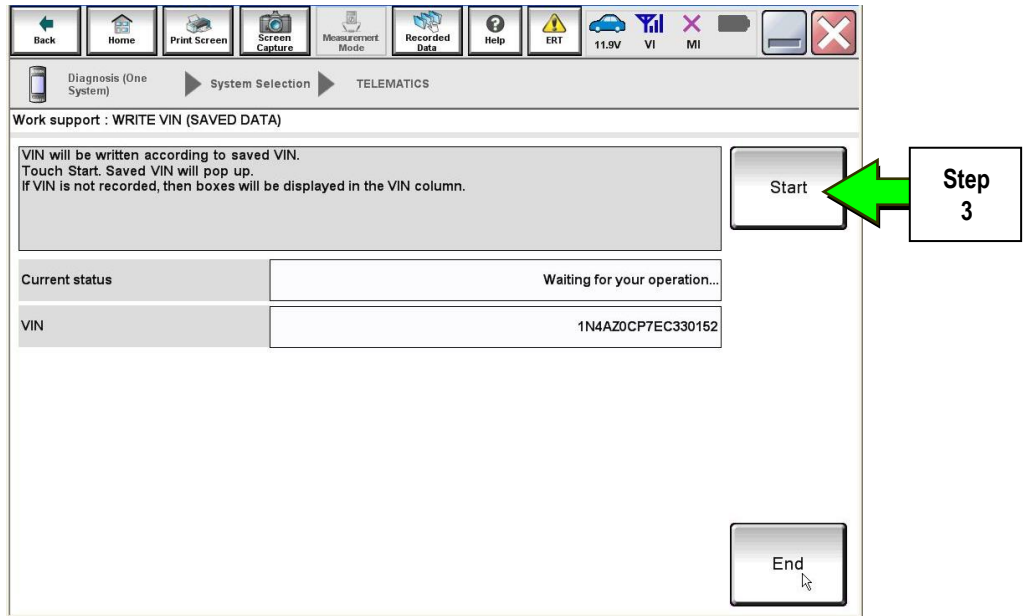
Figure 50

3. Select **Start**.

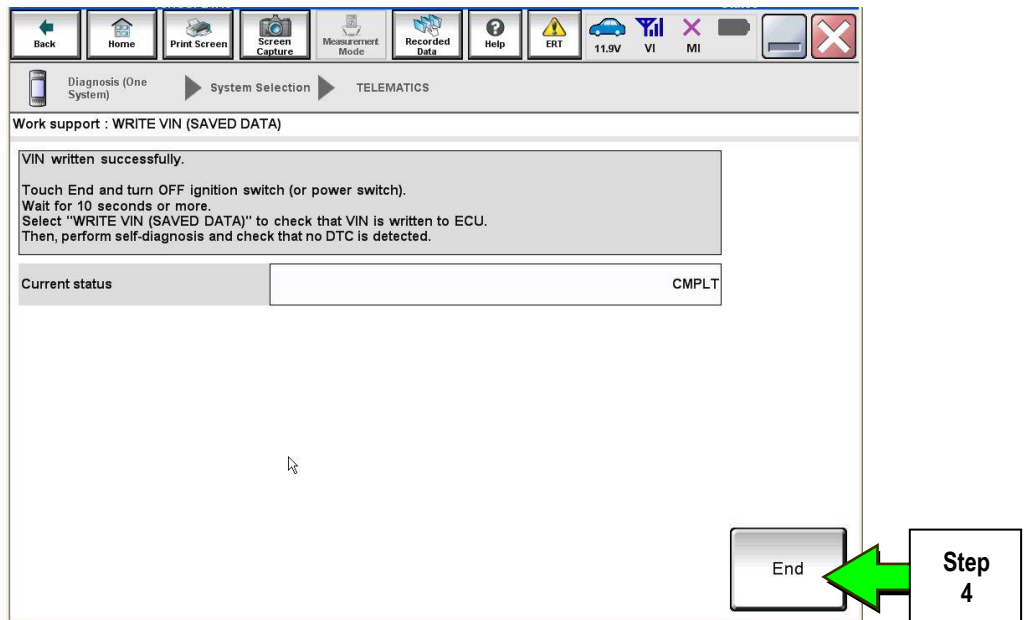
Figure 51

4. Select **End**.

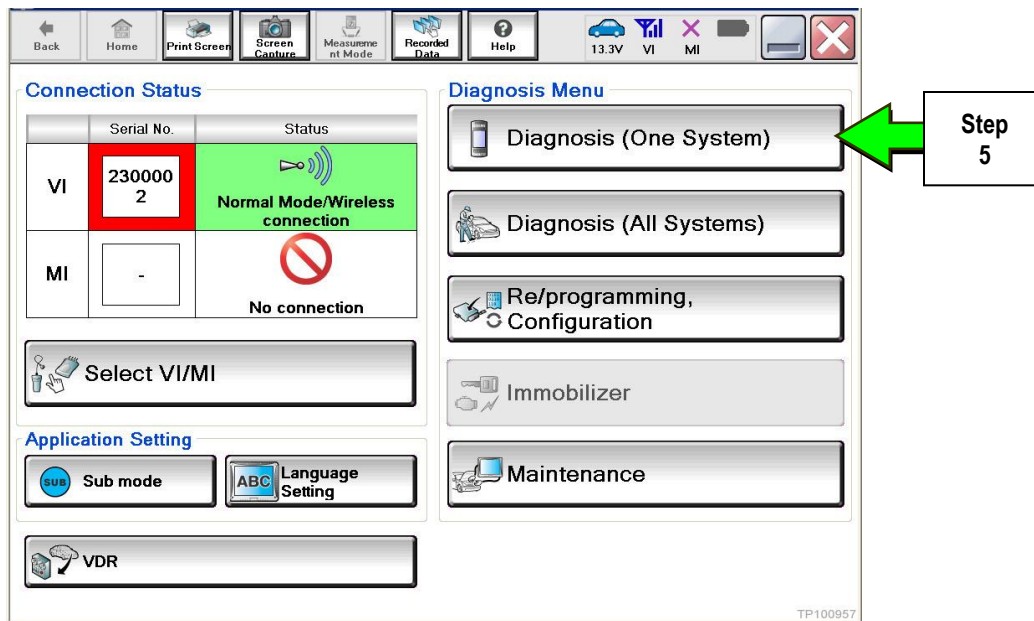
Figure 1

1. Connect the C-III plus VI to the vehicle.
2. Set the parking brake.
3. Turn the Ignition ON, but do not start the vehicle.
4. Launch C-III plus on the CONSULT PC.
5. Select **Diagnosis (One System)**.

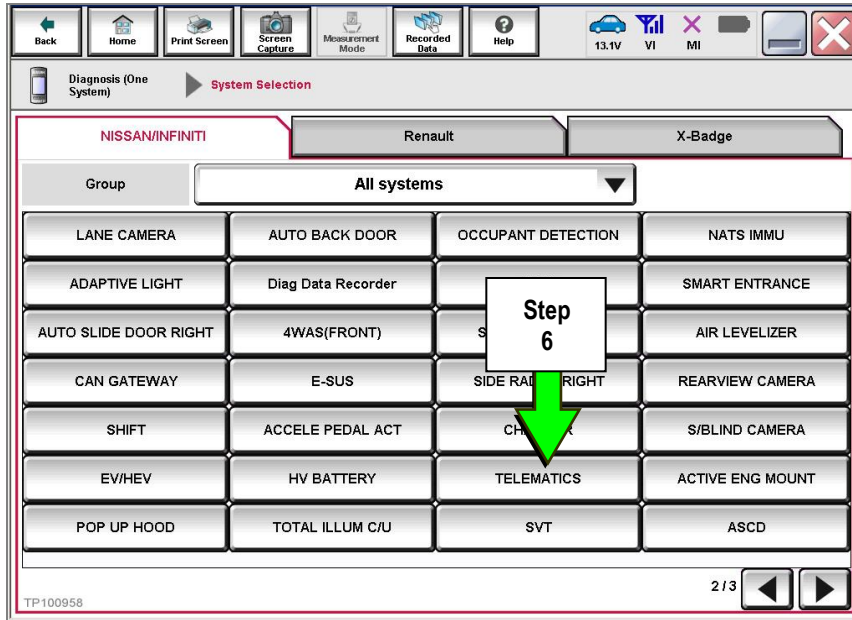
Figure 2

6. Select **TELEMATICS** on page 2 of the “All systems” list.

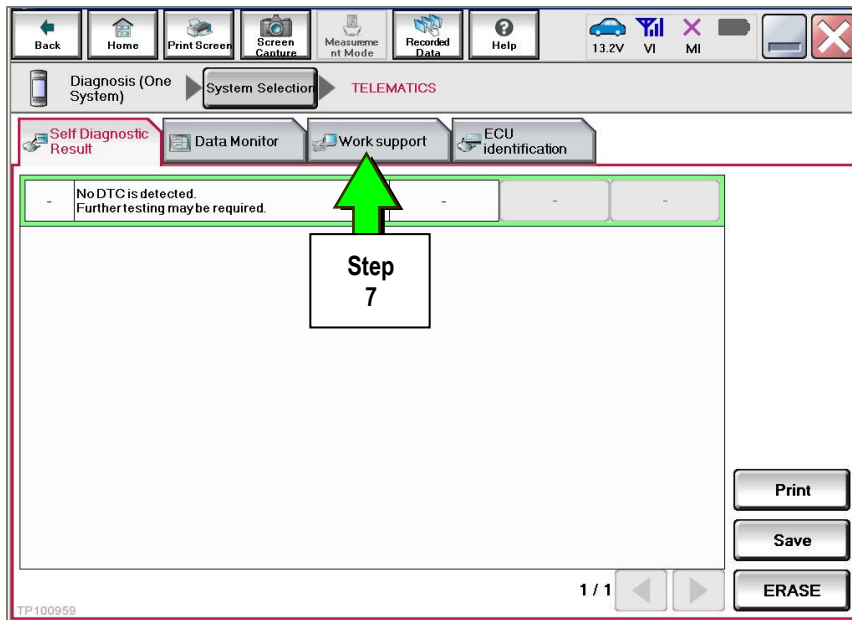
Figure 3

7. Select **Work support**.

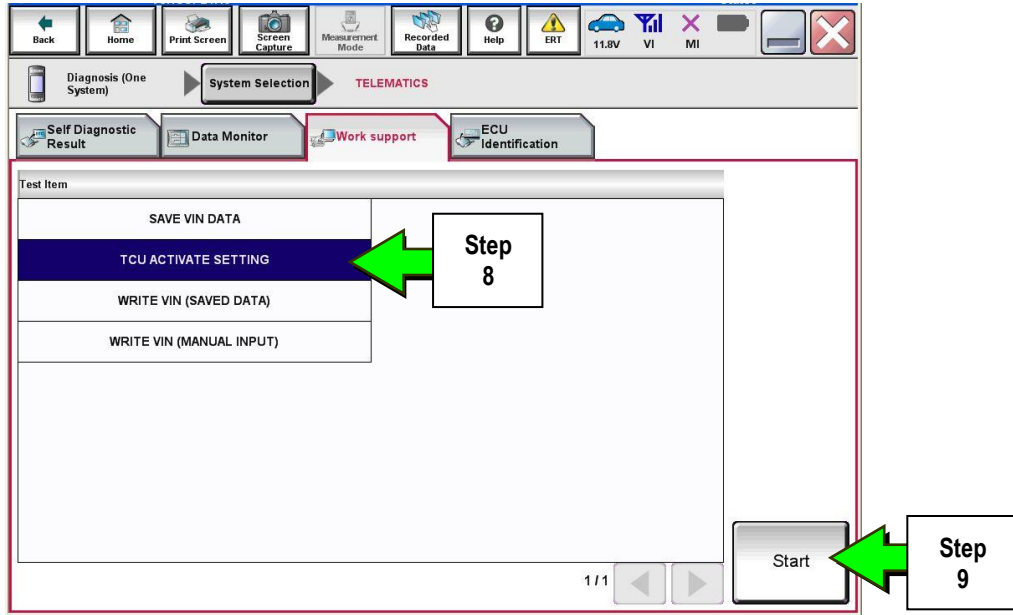
Figure 4

8. Select **TCU ACTIVATE SETTING**.

9. Select **Start**.

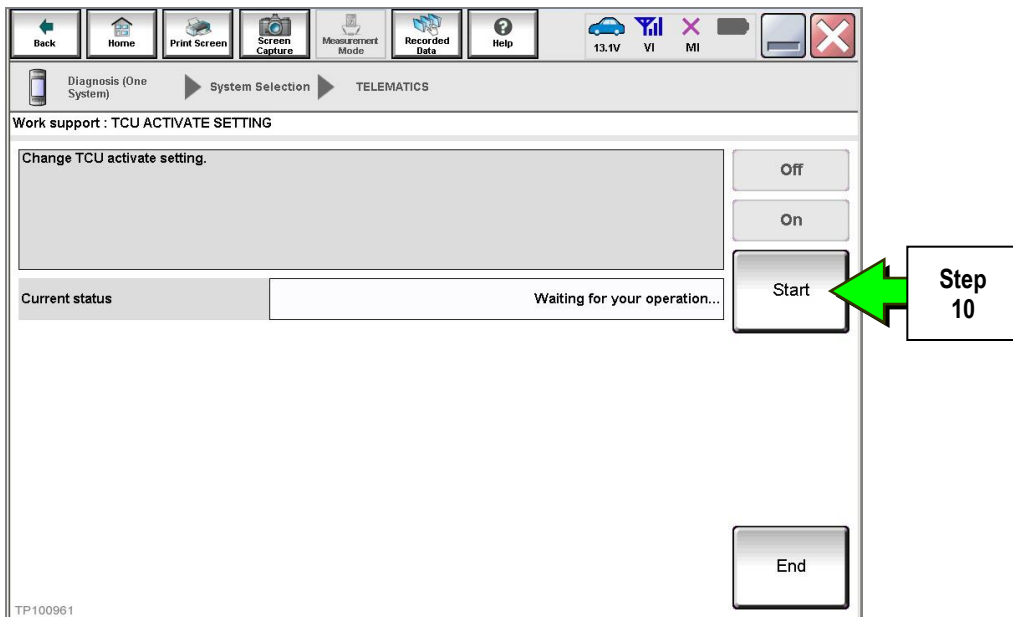
Figure 5

10. Select **Start**.

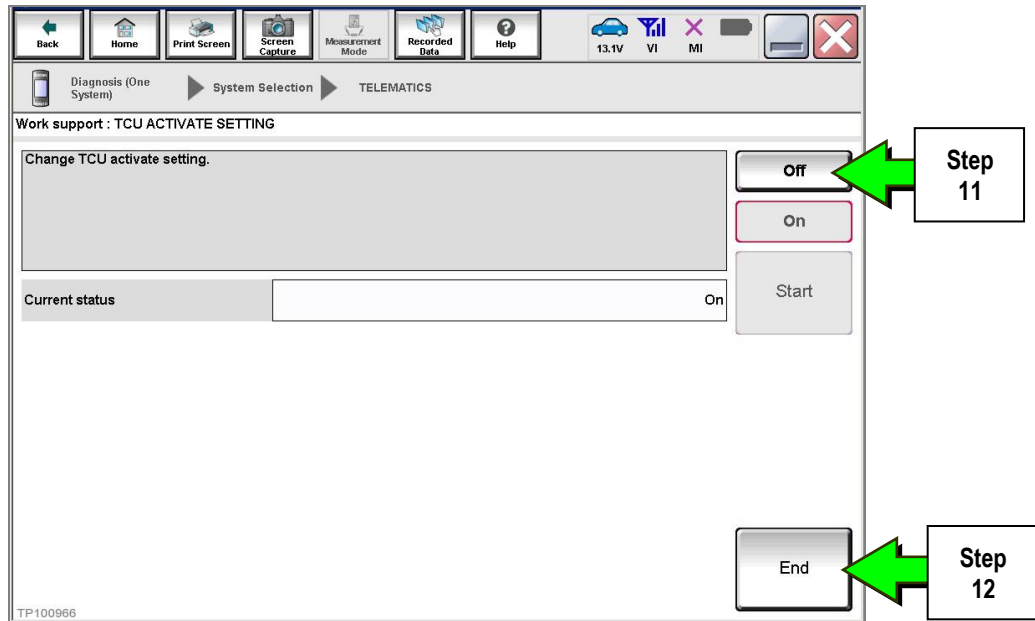
Figure 6

11. Select **Off** to turn OFF the TCU.

12. Select **End**.

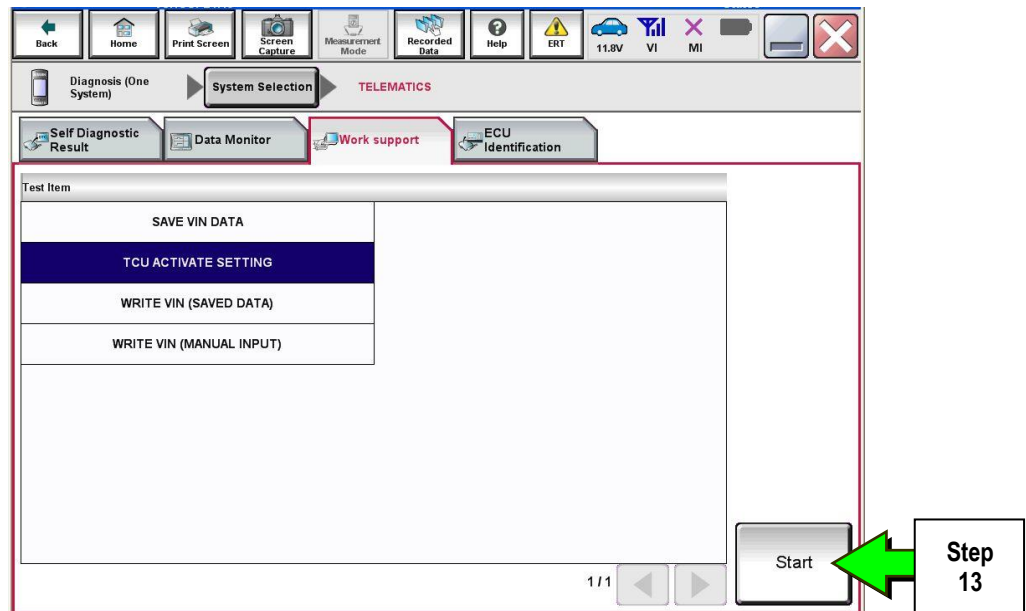
Figure 7

13. Select **Start**.

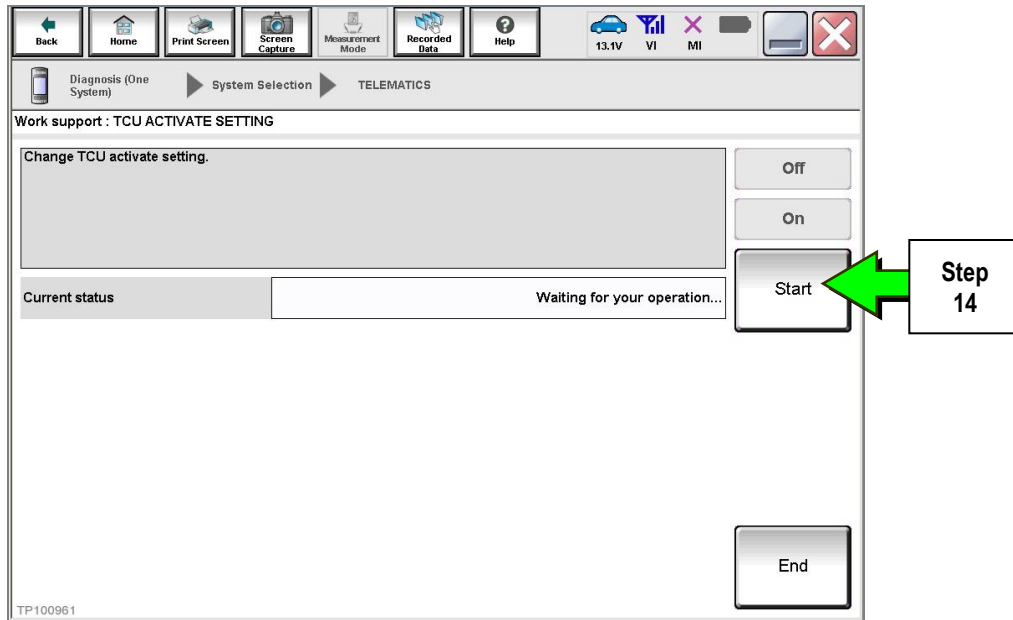
Figure 8

14. Select **Start**.

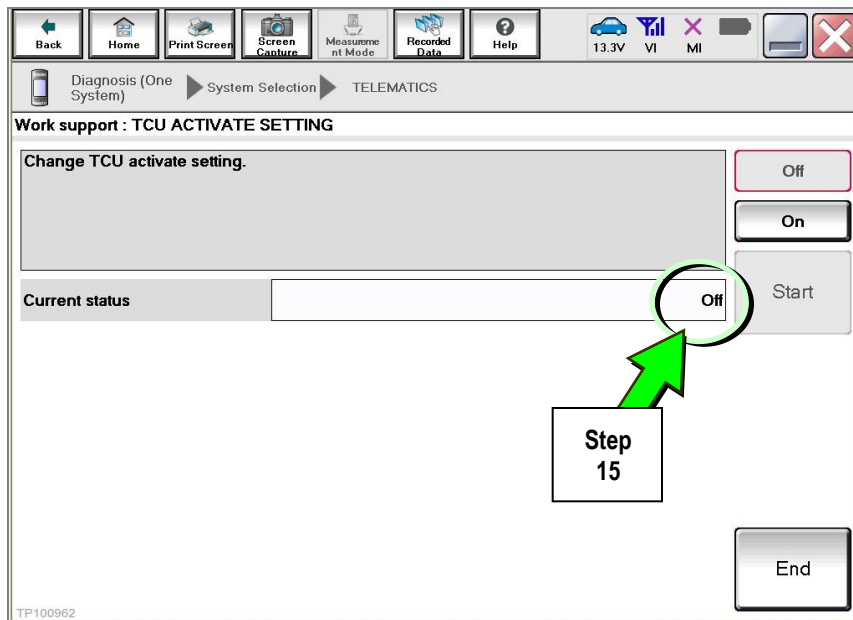
Figure 9

15. Confirm "**Off**" is displayed in the **Current status** field.

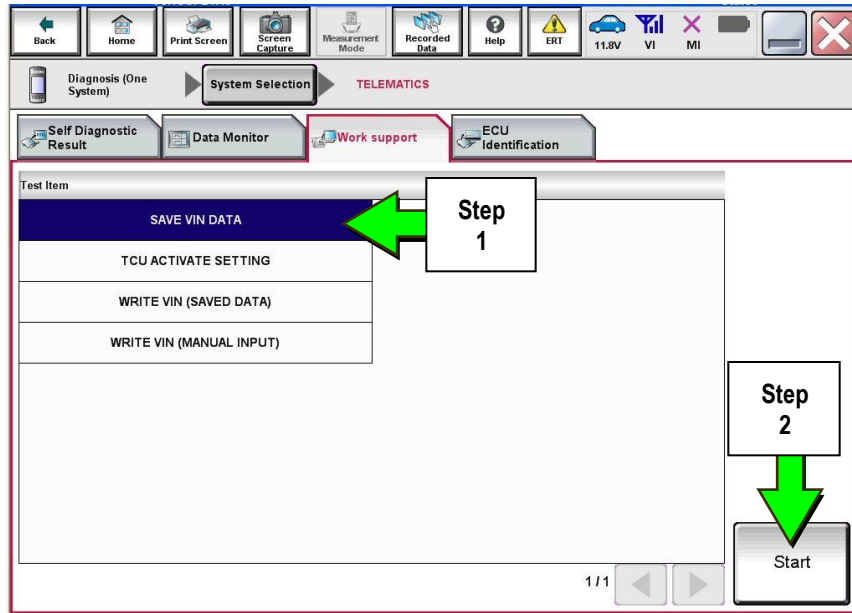
Figure 10

1. Select **SAVE VIN DATA**.
2. Select **Start**.

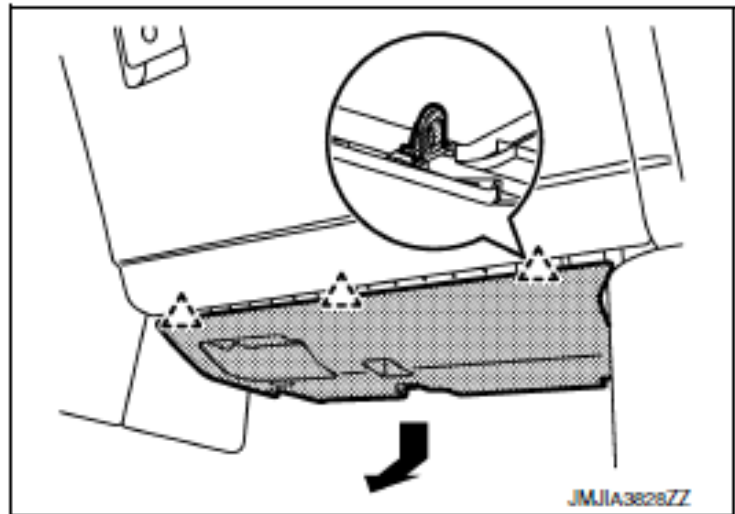
Figure 13

1. Remove instrument lower cover.
 - a. Pull disengaged pawls downward.
 - b. Pull back instrument lower cover.
 - c. Disconnect harness connectors.

△ : Pawl

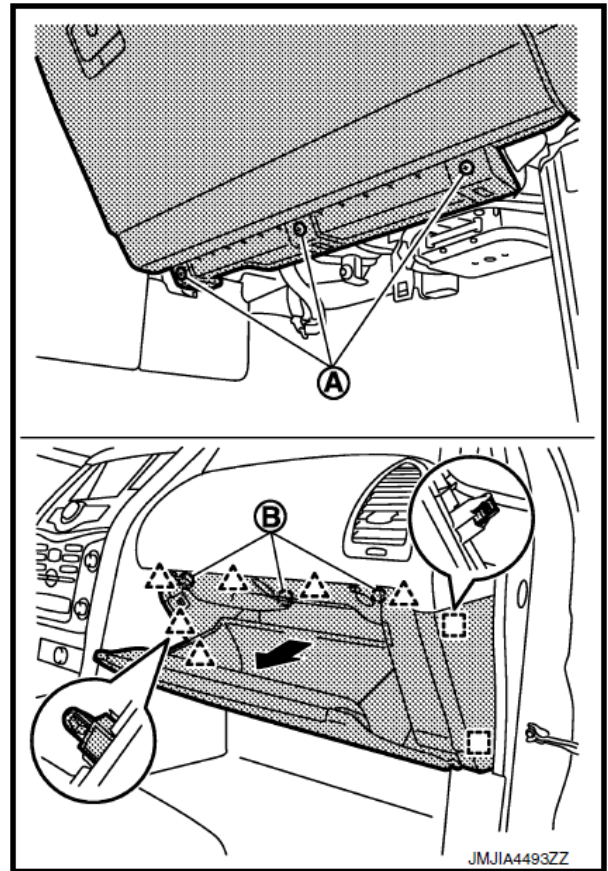
Figure 14

2. Remove glove box assembly.
 - a. Remove glove box assembly fixing screws (A).
 - b. Open glove box lid.
 - c. Remove glove box assembly fixing screws (B).
 - d. Pull back glove box assembly.
 - e. Disconnect harness connector.

: Metal clip

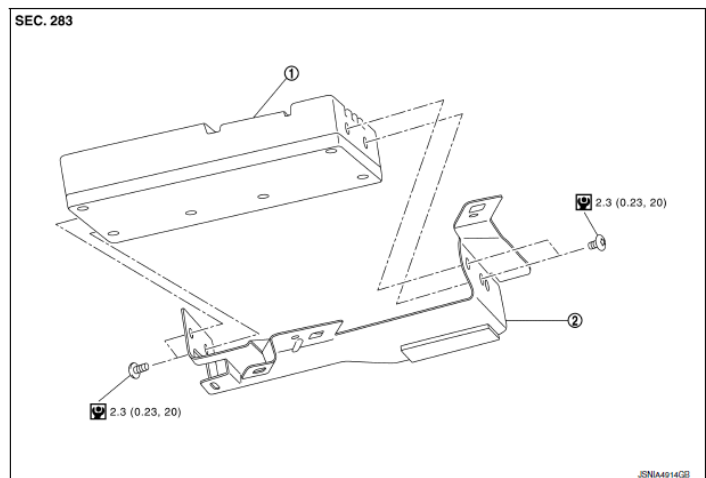
Figure 15

3. Remove the vehicle mounting bolts and disconnect the connector, and then remove them together with the bracket.
4. Remove the bracket mounting screw and remove the bracket from TCU.

1. TCU

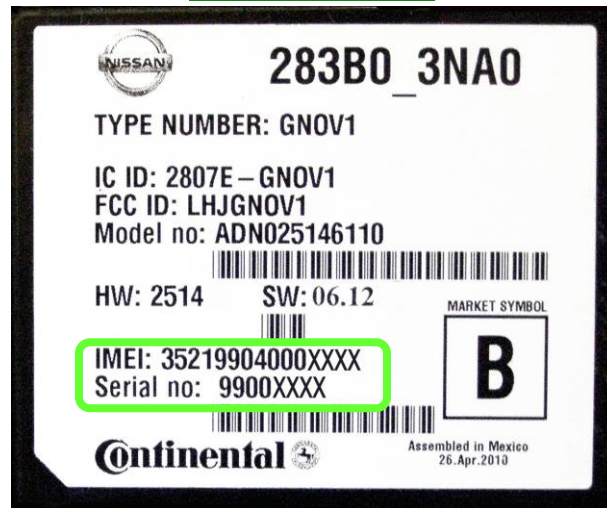
Figure 16

1. Collect and have ready the following information:
 - VIN.
 - International Mobile Equipment Identity Number (IMEI) of the original TCU. This number is located on the TCU.
 - IMEI Number of the replacement TCU. This number is located on the TCU.
 - Serial Number of the replacement TCU. This number is located on the TCU.

LABEL ON TCU

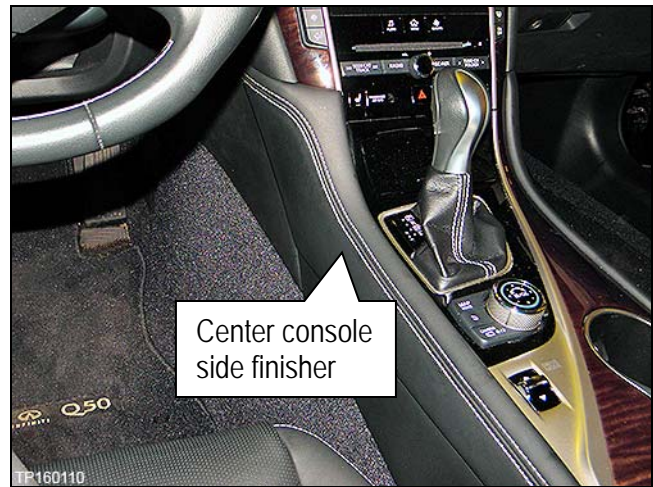
1. Remove both the left and right center console side finishers.

NOTE: Driver side shown In Figure 13 and 14.
Passenger side similar.

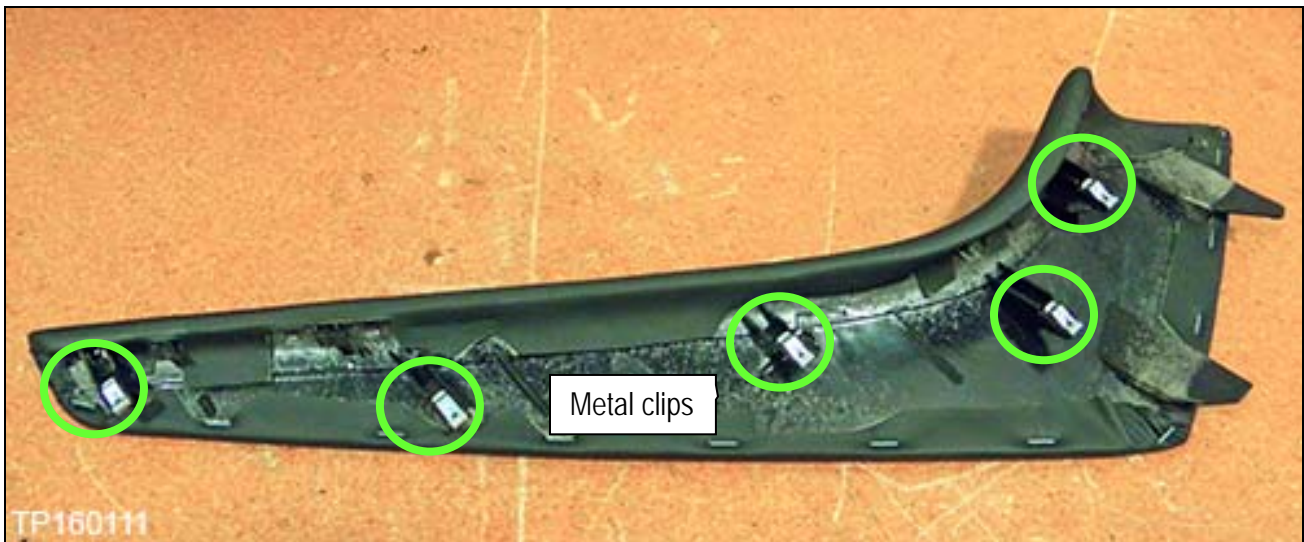
Figure 14

2. Confirm that the metal clips for the left and right center console side finisher are in place.
 - If the clips were detached, remove them from the center console and reattach to the center console side finishers.

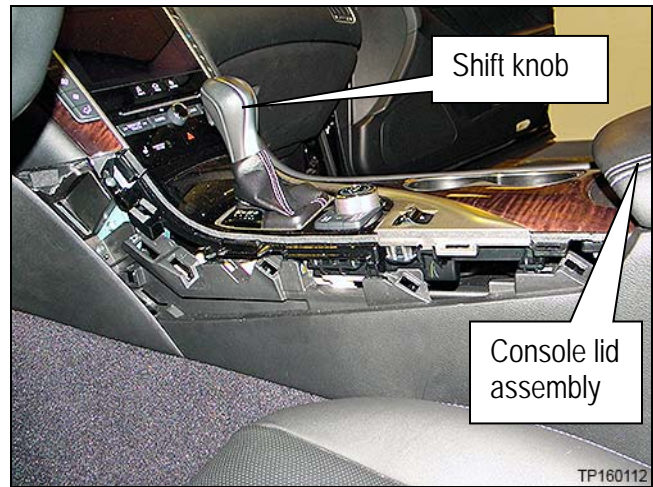
Figure 15

3. With the Parking brake set, place the shift selector into "neutral" (N).

4. Remove the shift knob as follows:

- a. Raise the console lid assembly (partially shown in Figure 15).

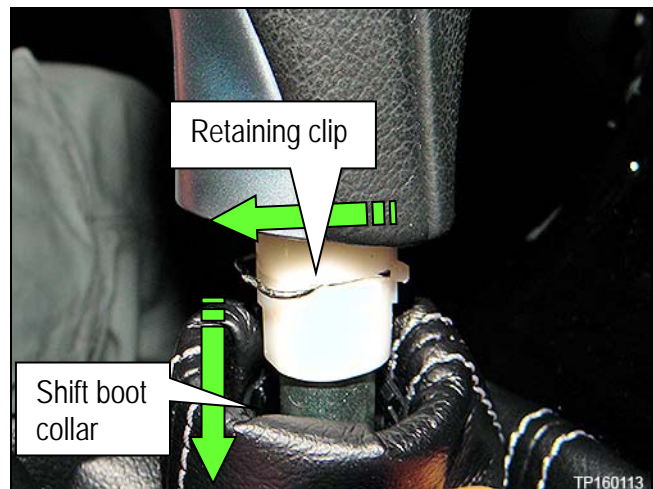
Figure 16

a. Pull the shift boot collar down (Figure 16).

b. Remove the retaining clip (Figure 16).

c. Replace the retaining clip back onto shift knob.

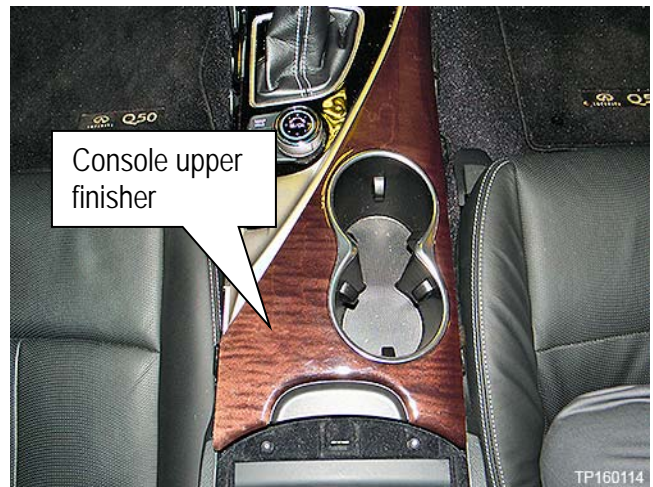
5. Remove the console upper finisher as follows:

NOTE: Figure 17 is shown with the console lid assembly raised.
