I N F I N I T I

2G Telematics Hardware Replacement Client Satisfaction Initiative

Reference: PC451, PC452, PC454

M37, M56, & Q70 Telematics Control Unit Replacement

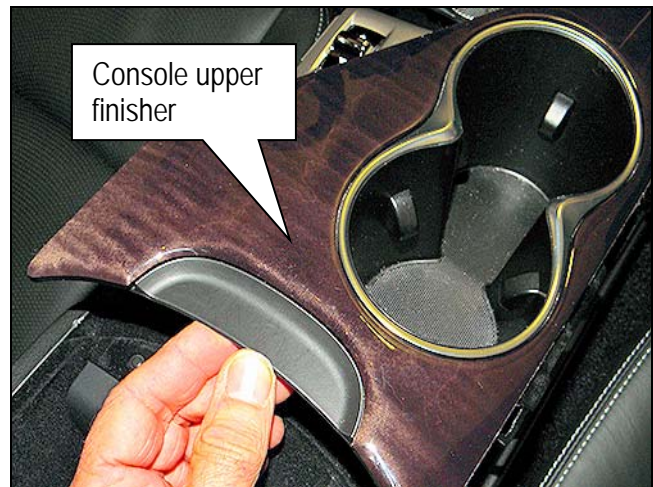
Figure 18

- b. Lift the console upper finisher at the rear to start to unclip it from the center console assembly.
- c. Work forward to detach each clip and remove the console upper finisher.

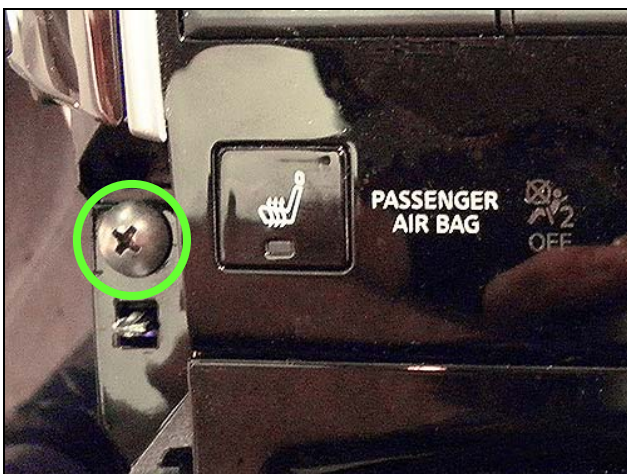
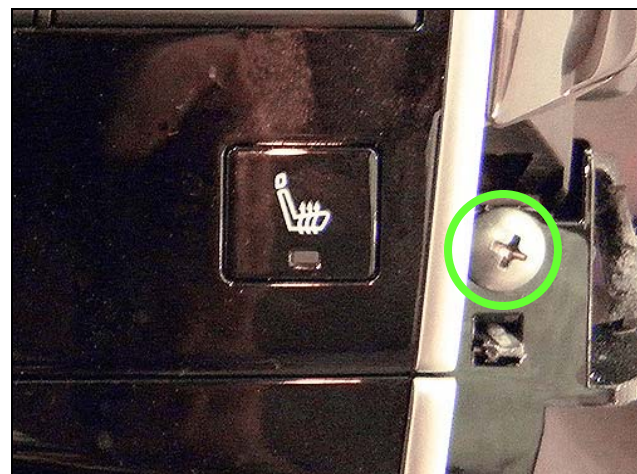
Figure 19

6. Remove the two screws (Figure 19) that retain the console finisher assembly (Figure 20) that are to the left and the right of the seat heater buttons, under the audio controls.

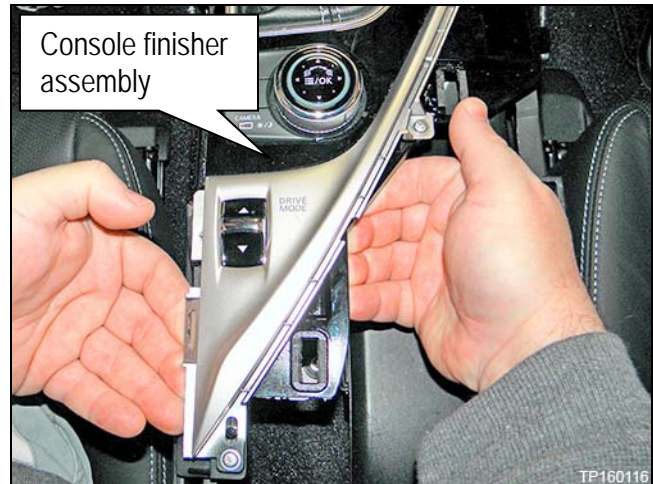
Figure 20

7. Remove the console finisher assembly from center console assembly as follows:

- a. Lift the rear of the console finisher assembly gently with equal pressure, as shown in Figure 20, to detach all clips.
- b. Lift the console finisher assembly off of the shift selector.

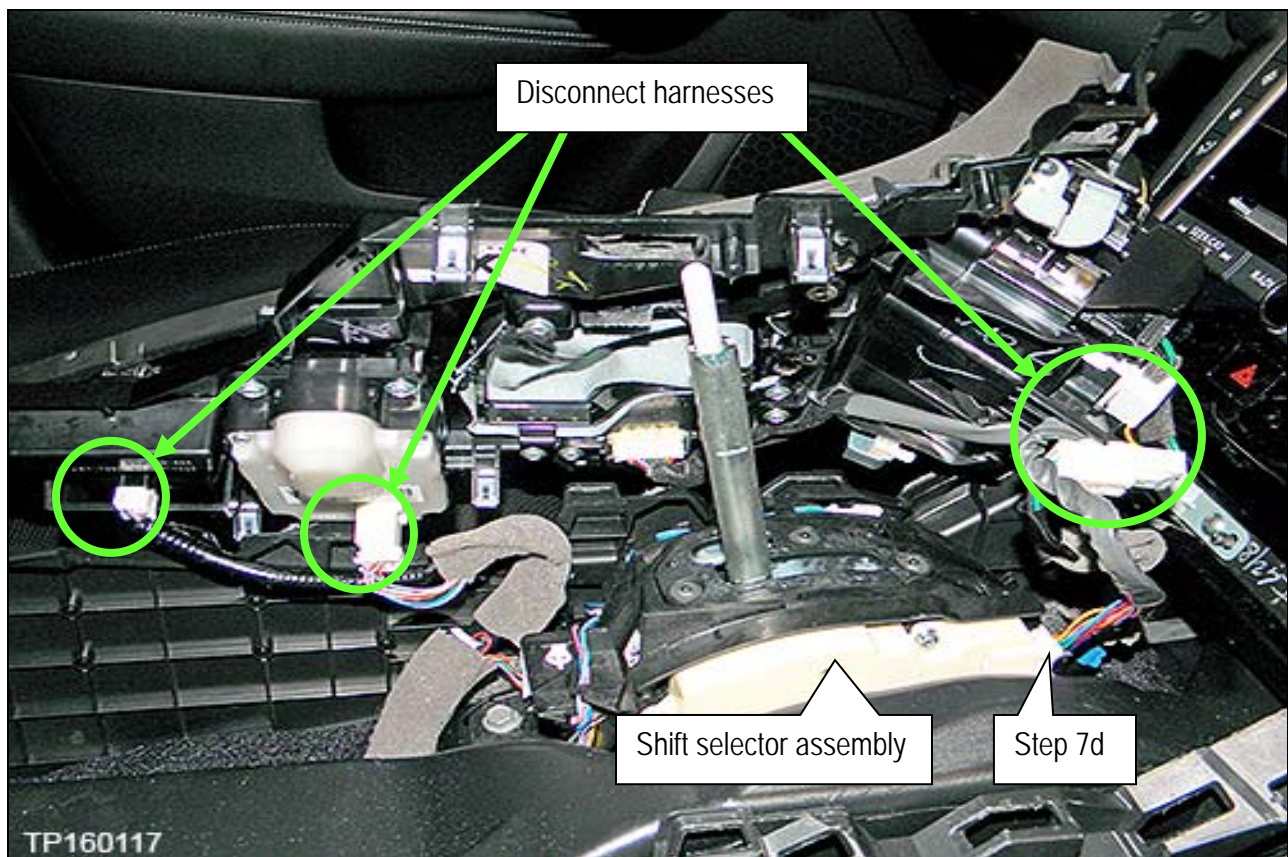
Figure 21

- c. Disconnect all harnesses attached to the console finisher assembly (Figure 21).
- d. Disconnect the harness from the console finisher assembly to shift selector assembly (Figure 21).

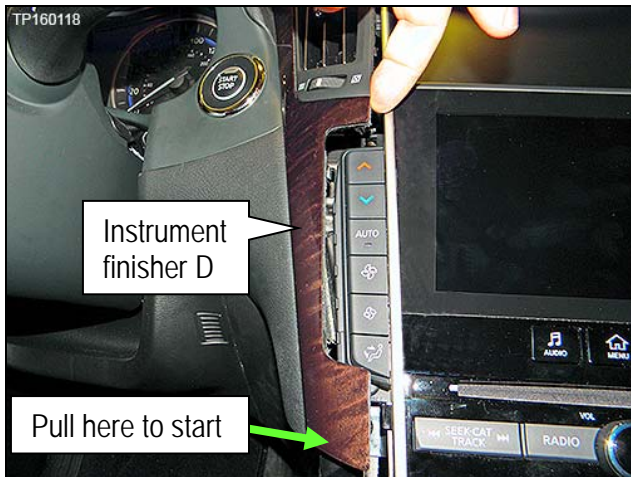
8. Remove the instrument finisher C (Figure 23) and instrument finisher D (Figure 22):
 - a. Gently detach the bottom of each instrument finisher ("Pull here to start" in Figure 22 and 23) by pulling toward the rear of the vehicle.
 - Only pull far enough to unclip from the instrument panel.
 - b. Open a gap between the instrument finisher and the instrument panel so that enough space is present to allow a finger to be inserted into the gap just below the vents (Figure 22).
 - c. Remove both instrument finishers one at a time.

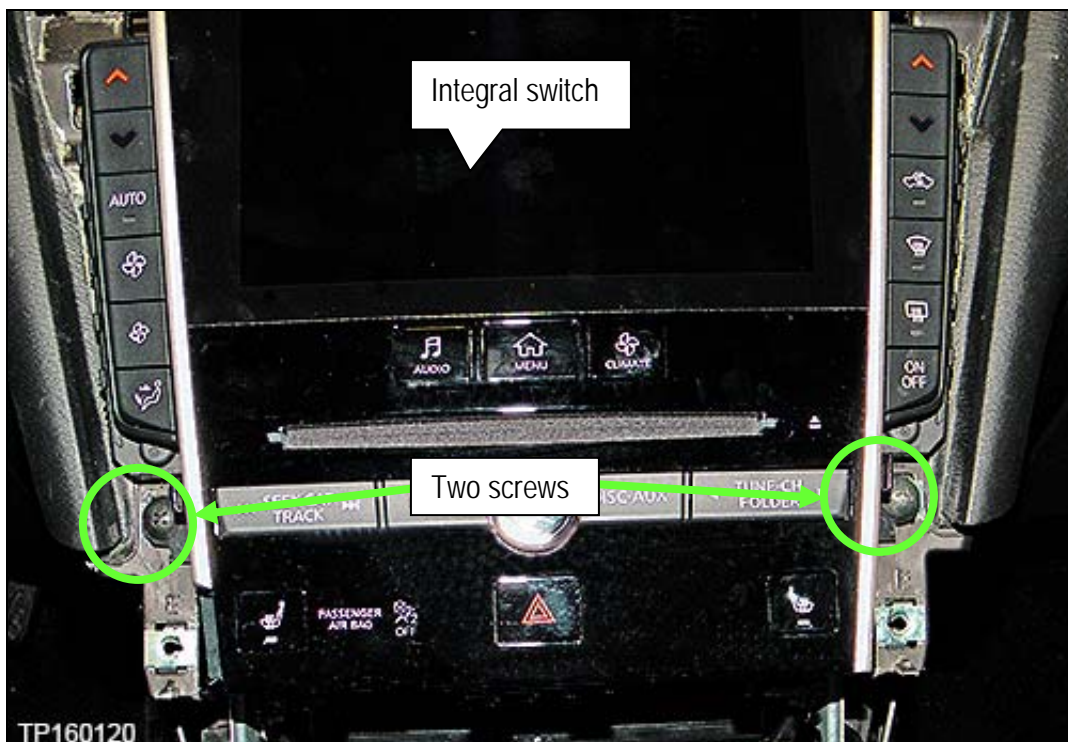
Figure 24

9. Remove the integral switch (Figure 24) as follows:
 - a. Remove the two screws at the bottom of the integral switch (Figure 24).

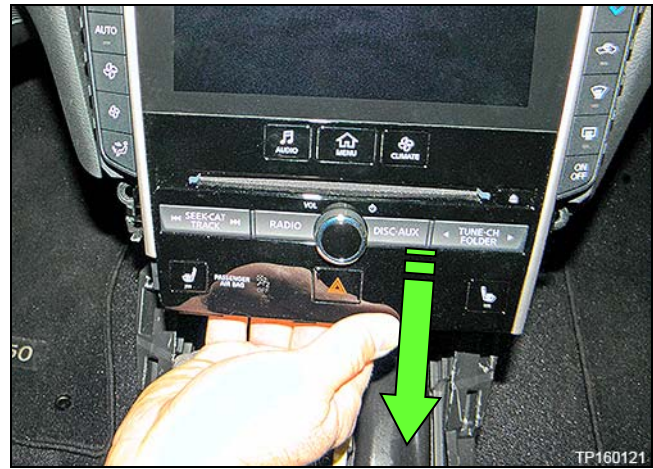
Figure 25

- b. Pull the integral switch away from the instrument panel at the bottom (Figure 25) and then down to detach upper clip (Figure 25).

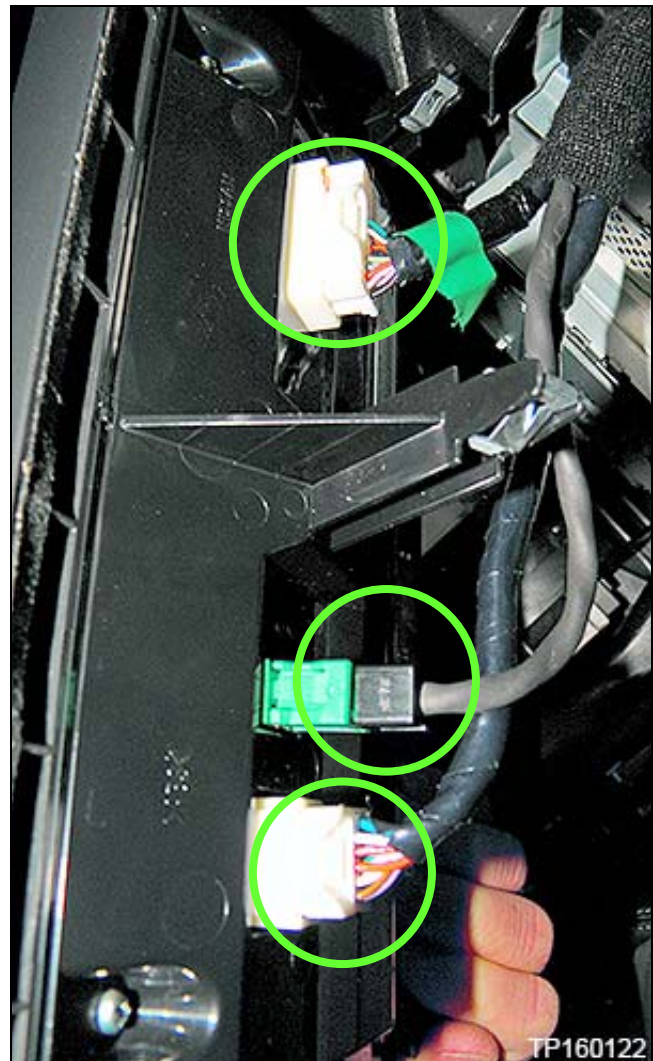
Figure 26

- c. Disconnect the three harness connectors (Figure 26) attached to the integral switch.

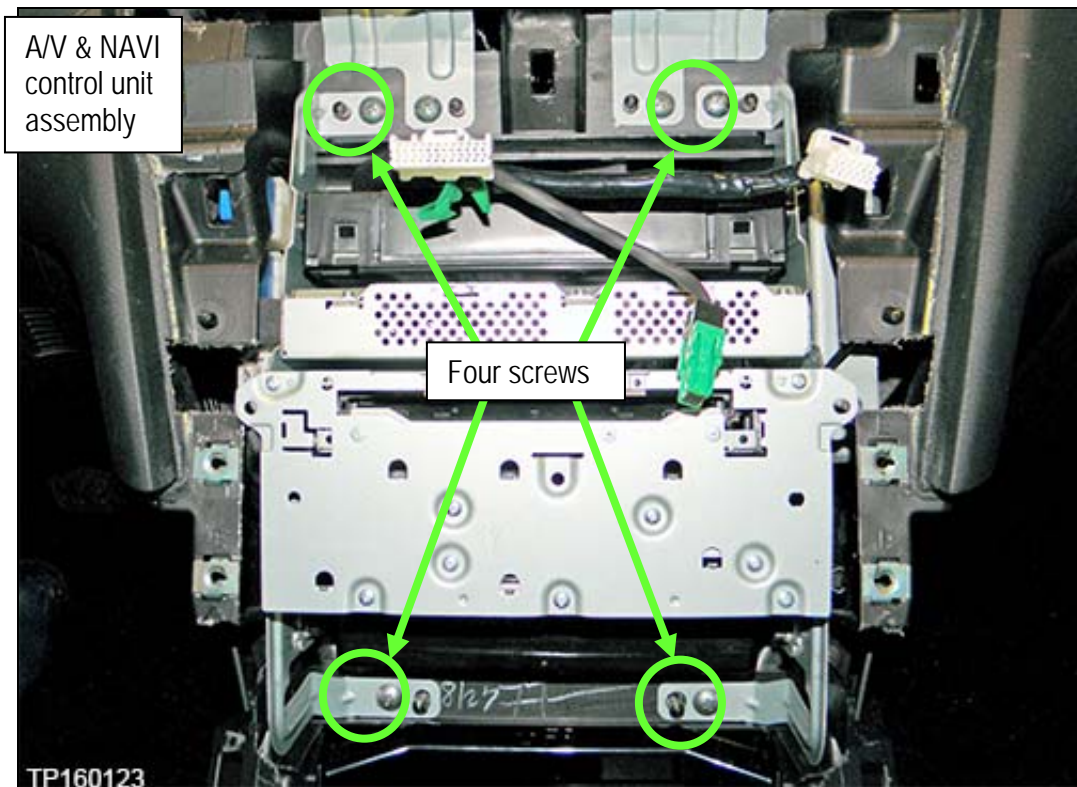
Figure 27

10. Remove the A/V & NAVI control unit assembly (Figure 27):

- a. Remove the four screws that attach the A/V & NAVI control unit assembly to the instrument panel.

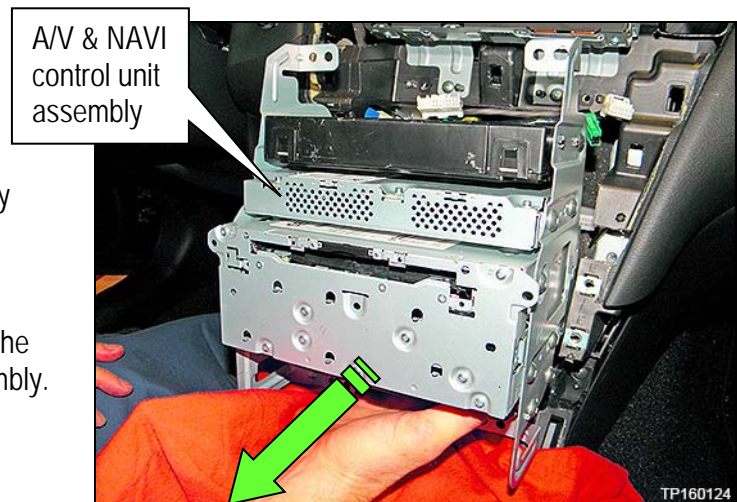
Figure 28

- b. Pull the A/V & NAVI control unit assembly straight back to gain access to attached harness connectors.
- c. Disconnect all harness connectors from the rear of the A/V & NAVI control unit assembly.

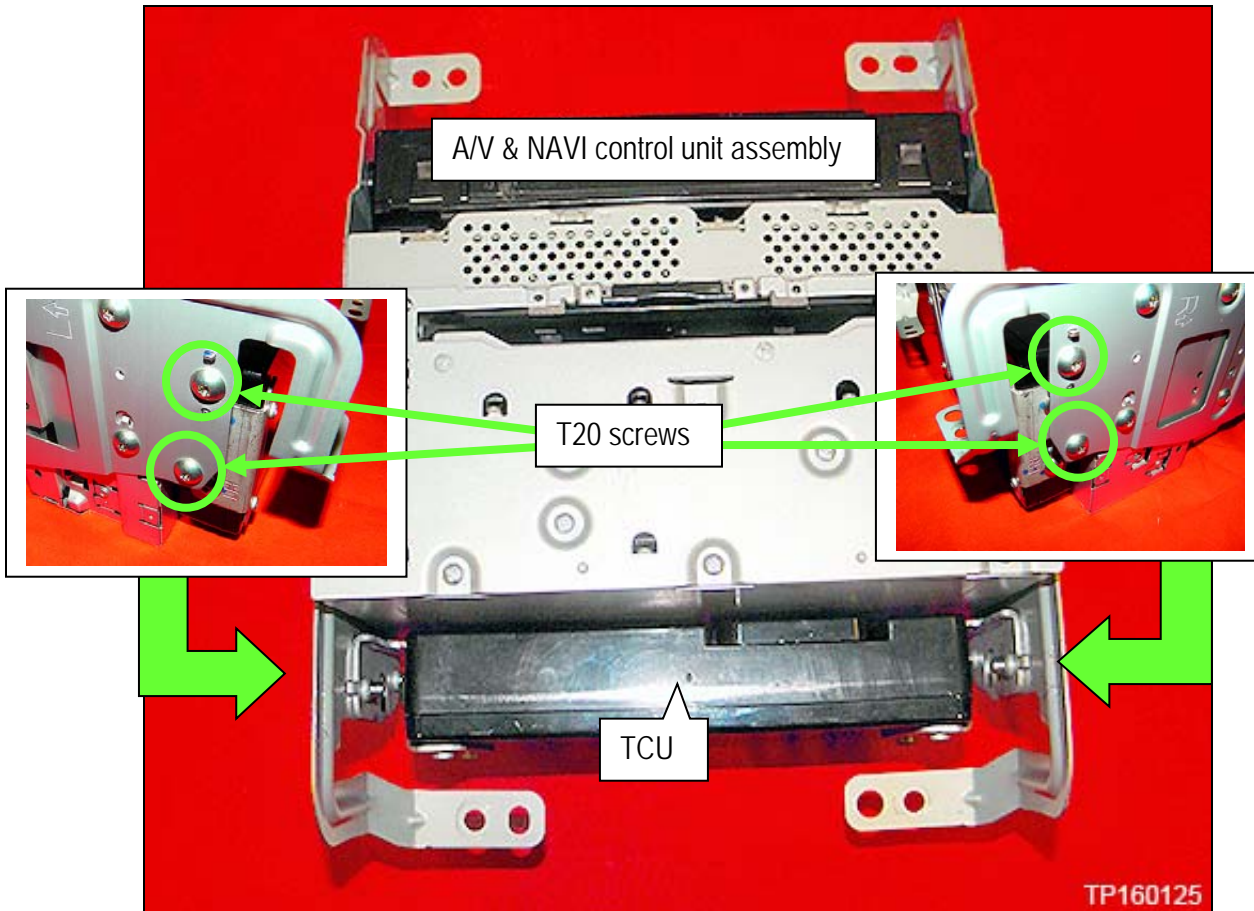
Figure 29

11. Remove four T20 screws and remove the TCU from the A/V & NAVI control unit assembly (Figure 29).

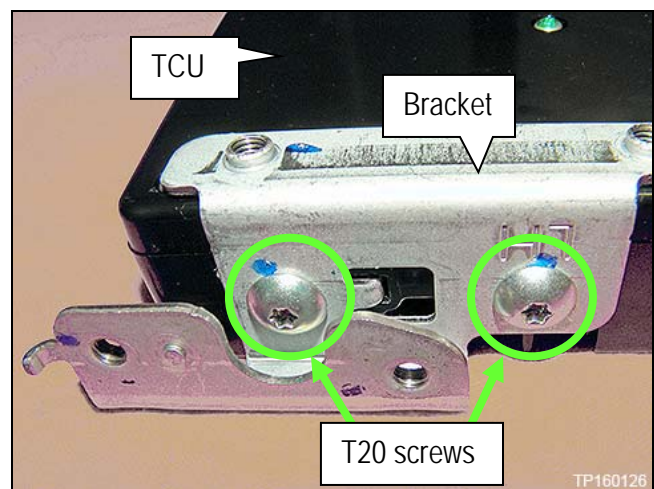
Figure 30

12. Remove the two brackets from the original TCU and transfer to the new TCU (Figure 30).

- Each bracket is attached by two T20 screws.
- The brackets are left and right specific, transfer one side at a time.
- One side shown in Figure 30. The other side is similar.

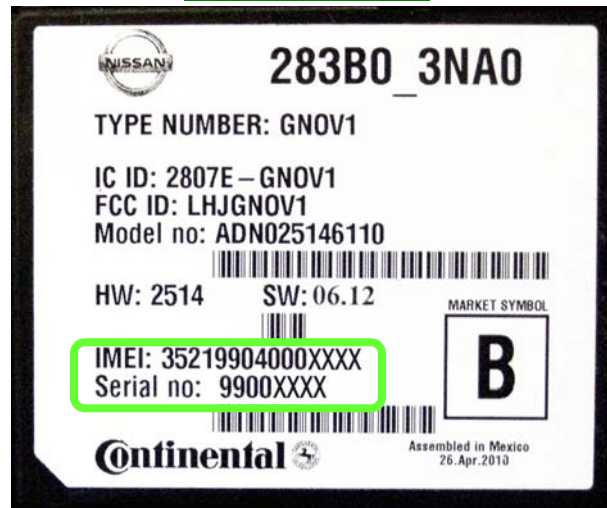
Figure 31

1. Collect and have ready the following information:
 - VIN.
 - International Mobile Equipment Identity Number (IMEI) of the original TCU. This number is located on the TCU.
 - IMEI Number of the replacement TCU. This number is located on the TCU.
 - Serial Number of the replacement TCU. This number is located on the TCU.

LABEL ON TCU

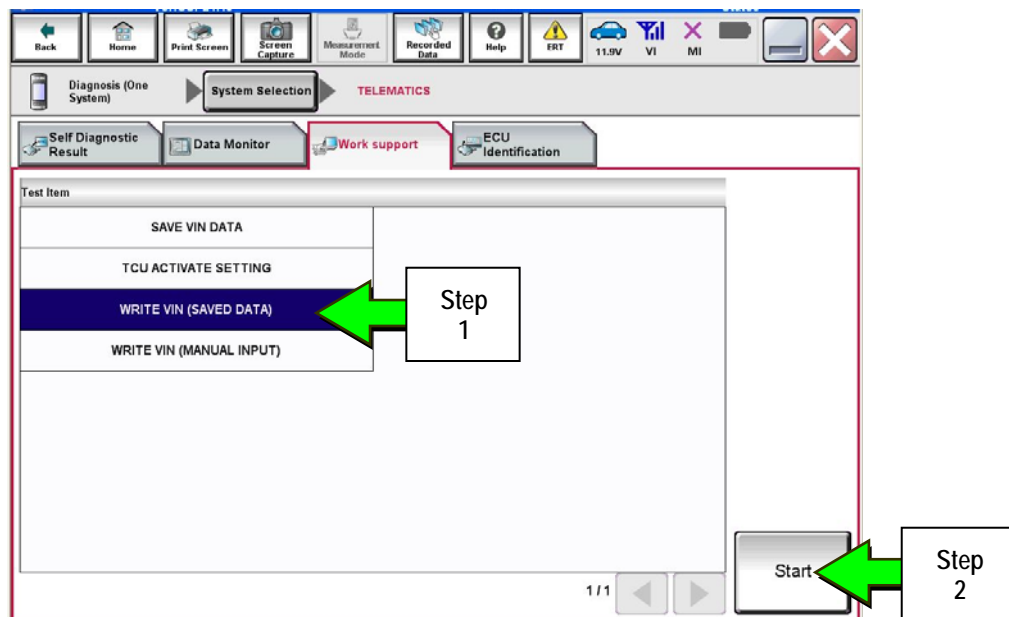
Figure 32

Write VIN Data

1. Select **WRITE VIN (SAVED DATA)**.
2. Select **Start**.

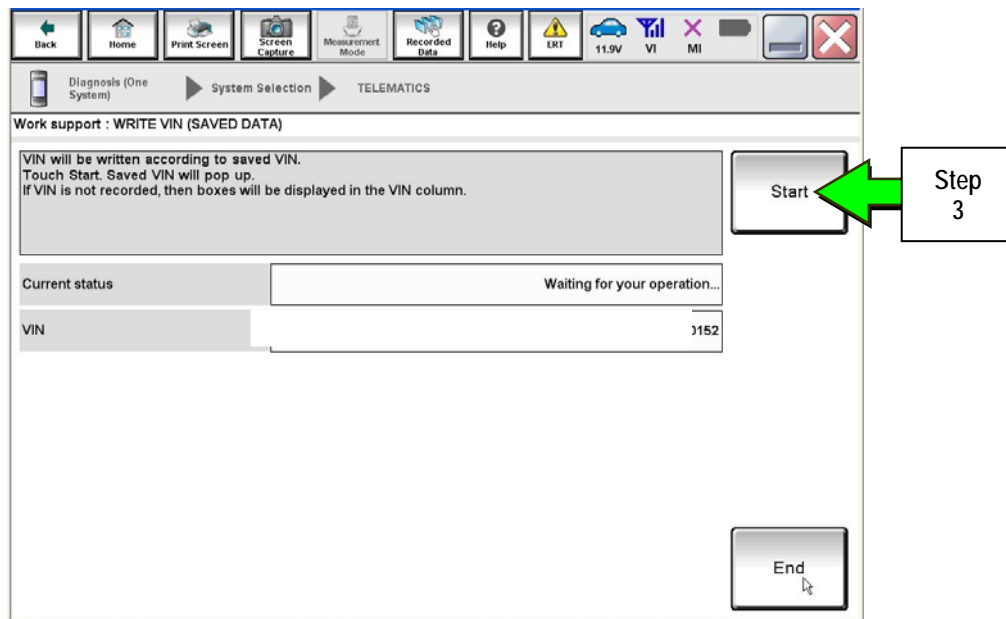
Figure 33

3. Select **Start**.

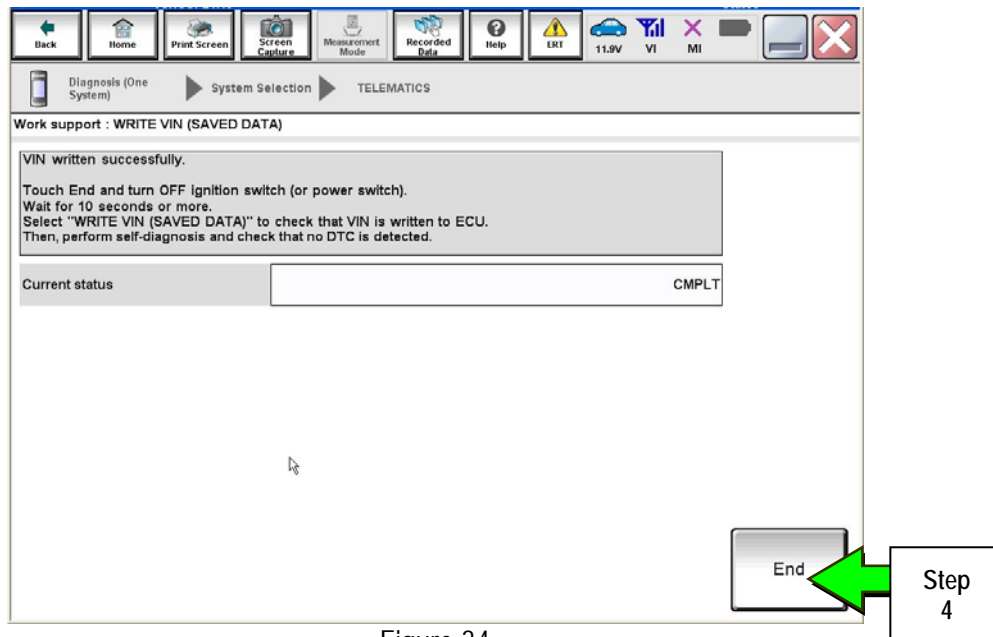
Figure 34

4. Select **End**.
