**WG50 - Re-programming DME Control Unit (Workshop Campaign)**

**Vehicle type:** Panamera S E-Hybrid (970)

**Subject:** DME control unit

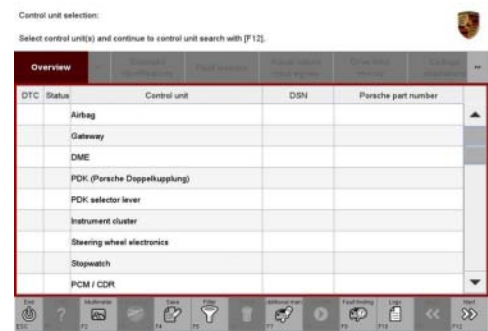
*Control unit selection*

- Once you have erased the fault memories, select the '**Overview**' menu to return to the control unit selection screen ⇒ *Control unit selection*.

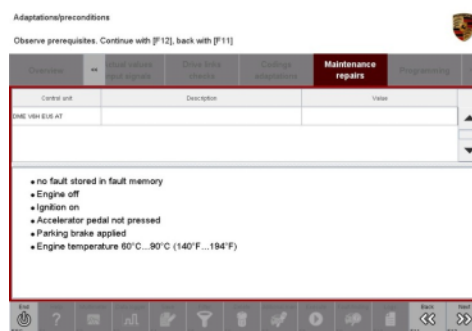
*Adaptation preconditions*

- 4 Comply with the displayed preconditions and press •F12" ('Next') to confirm ⇒ *Adaptation precon-ditions*.
  - 5 Select the '**Throttle valve adaptation**' function so that the corresponding text line turns blue and press •F8" ('Start') to start throttle valve adaptation ⇒ *Throttle valve adaptation*.

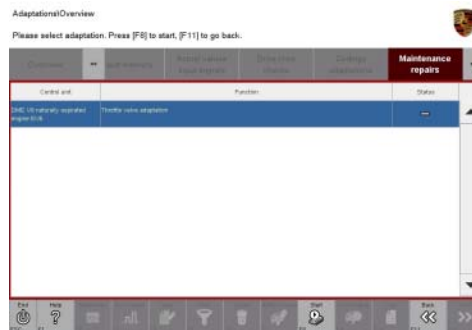
*Throttle valve adaptation*

- 6 Follow the instructions on the PIWIS Tester while throttle valve adaptation is being performed. Once throttle valve adaptation is complete, a tick will appear in the "Value" field on the PIWIS Tester display.

If throttle valve adaptation is **not** completed successfully, the adaptation must be **repeated**.
  - 7 Press •F8" ('Stop') to end throttle valve adaptation.

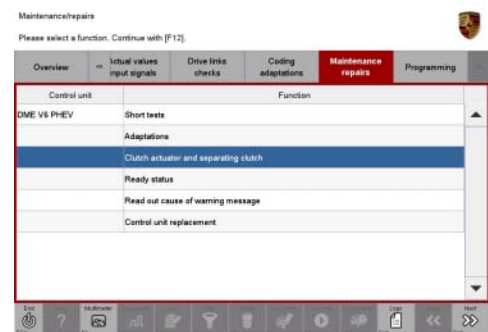
*Clutch actuator and decoupler*

- Procedure:
- 1 Leave the ignition switched off for at least 3 seconds and then switch it on again.  
Then, restore communication between PIWIS Tester II and the vehicle by pressing •F12" ('Next').
  - 2 Select the '**DME**' control unit in the control unit selection screen ('Overview' menu) and press •F12" ('Next') to confirm your selection.
  - 3 Once the DME control unit has been found and is displayed in the overview, select the '**Main-tenance/repairs**' menu.
  - 4 Select the menu item '**Clutch actuator and decoupler**' and press •F12" ('Next') to confirm your selection ⇒ *Clutch actuator and decoupler*.
  - 5 Read and comply with the preconditions for the state of charge of the high-voltage battery and confirm by pressing •F12" ('Next').

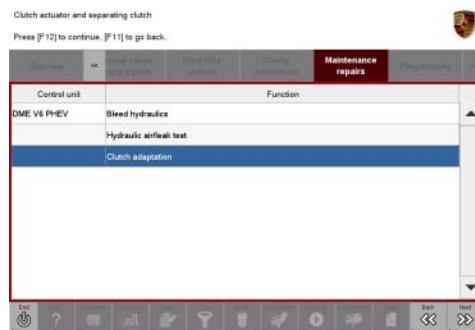
*Adapting the decoupler*

6 Select the '**Clutch adaptation**' function and press •F12" ('Next') to confirm your selection ⇒ *Adapting the decoupler*.

7 Read and follow the instructions for starting the electric motor and performing adaptation. Press the brake pedal and then press •F12" ('Next') to start the adaptation.

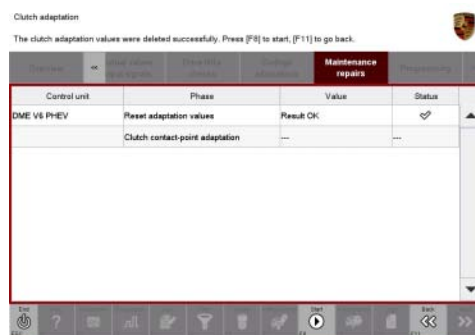
*Resetting adaptation values*

8 During adaptation, the adaptation values will first be deleted ⇒ *Resetting adaptation values*. The clutch contact point and the clutch characteristic will then be adapted ⇒ *Adapting contact point* and ⇒ *Adapting characteristic*. Start each step by pressing •F8" ('Start') and follow the instructions on the PIWIS Tester.

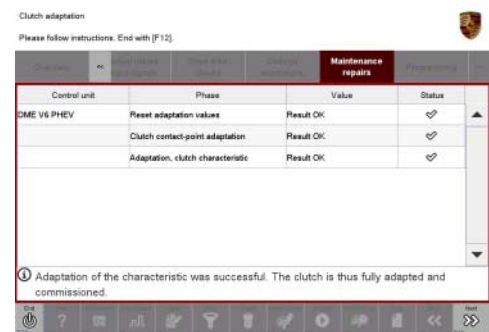
*Adaptation successful*

- 9 Once the decoupler adaptation is complete, a tick will appear in the "Status" field in the PIWIS Tester display ⇒ *Adaptation successful*.  
Press •F12" ('Next') to continue.
