WG47 - Performing Navigation Map Update and Software Update for PCM and Instrument Cluster (Workshop Campaign)

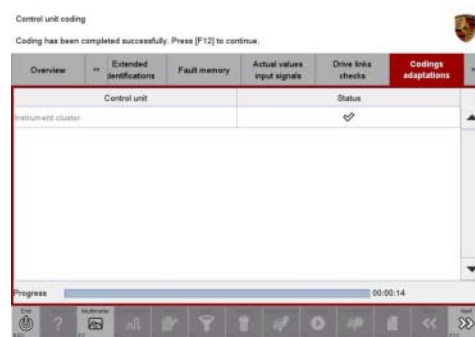
Coding successful

- 3 When coding is complete, the message "Coding has been completed successfully" is displayed and a tick appears in the 'Status' box ⇒ *Coding successful*.
