WG47 - Performing Navigation Map Update and Software Update for PCM and Instrument Cluster (Workshop Campaign)

Model Year: 2017

Model line: 718 (982)
911 (991)

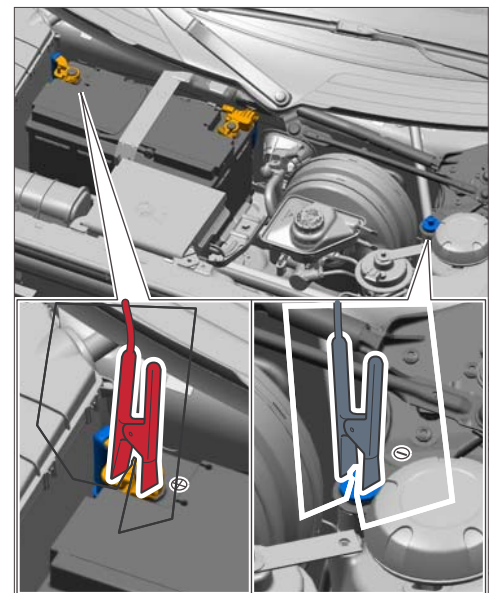
External power connection

- Procedure:
- 1 Connect battery charger.
First connect the positive cable of the charger to the positive terminal of the battery and then connect the negative cable of the charger to the ground point for jump-lead starting ⇒ *External power connection*.
 - 2 Switch on the ignition using the **original driver's key**. For vehicles with "Porsche Entry & Drive", replace the control panel in the ignition lock with the original driver's key, if necessary.

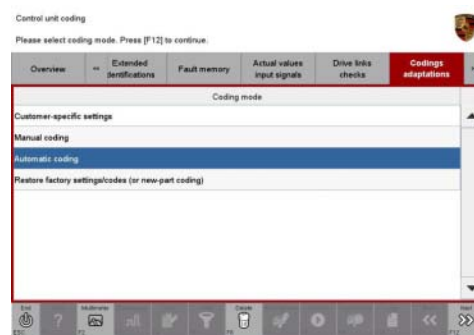
Automatic coding

- Procedure:
- 1 Call up the '**Codings/programming**' menu in the '**PCM**' control unit.
 - 2 Select the '**Automatic coding**' function and press •F12“ (“Next”) to start coding ⇒ *Automatic coding*.

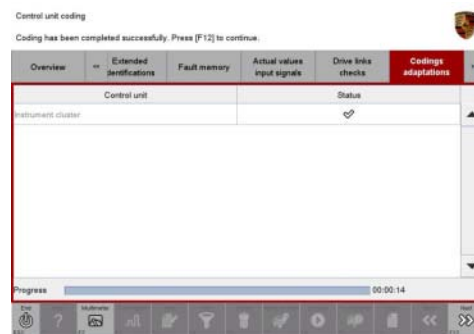
Coding successful

- 3 When coding is complete, the message “Coding has been completed successfully” is displayed and a tick appears in the 'Status' box ⇒ *Coding successful*.
If coding is not completed successfully (error message “Coding was not completed successfully”), coding must be **repeated**.

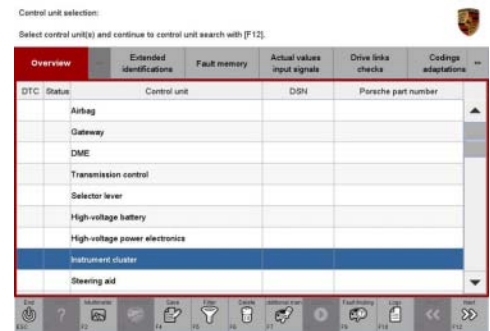
Control unit selection – Instrument cluster

- Procedure:
- 1 Select **'Instrument cluster'** in the control unit selection screen (**'Overview'** menu) and press **•F12** ("Next") to confirm your selection ⇒ *Control unit selection – Instrument cluster.*
 - 2 Once the instrument cluster has been found and is displayed in the overview, select the **'Codings/adaptations'** menu.
 - 3 Select **'Restore factory settings/codes'** and press **•F12** ("Next") to start the process ⇒ *Resetting instrument cluster to factory settings.*
 - 4 Once the settings have been reset successfully, press **•F12** ("Next") to continue.
 - 5 Select the **'Overview'** menu and press **•F11** ("Back") to return to the control unit selection screen.

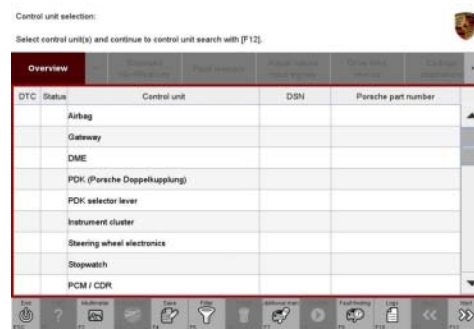
Control unit selection

- Procedure:
- 1 Read out and erase all fault memories.
 - 1.1 In the control unit selection screen ('Overview' menu), press •F7" to call up the 'Additional menu' (⇒ Control unit selection).
 - 1.2 Select the function "Read all fault memories and erase if required" and press •F12" ("Next") to confirm your selection ⇒ Erasing fault memories.

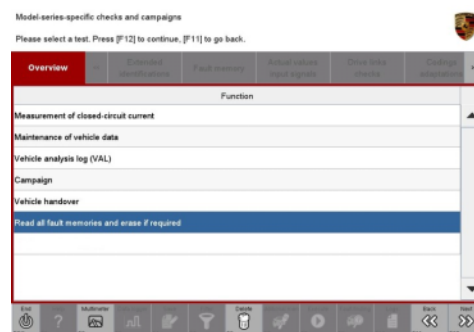
Erasing fault memories

- 1.4 Press •F8" to delete fault memory entries.
- 1.5 Press •F12" ("Yes") in response to the question as to whether you really want to delete all fault memory entries.
