**WG44 - Re-programming PDK Control Unit (Workshop Campaign)**

**Model Year:** 2017

**Vehicle Type:** 718 Cayman (982)/718 Boxster (982)

**Subject:** PDK control unit

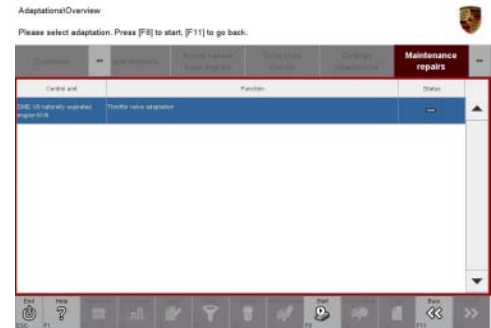
- 5 Select the ⇒ **'Throttle valve adaptation'** function so that the corresponding text line turns blue and press •F8" ('Start') to start throttle valve adaptation ⇒ *Throttle valve adaptation*.
- 6 Follow the instructions on the PIWIS Tester while throttle valve adaptation is being performed.

*Throttle valve adaptation*

*Throttle valve adaptation successful*

Once throttle valve adaptation is complete, a tick will appear in the "Value" field on the PIWIS Tester display.

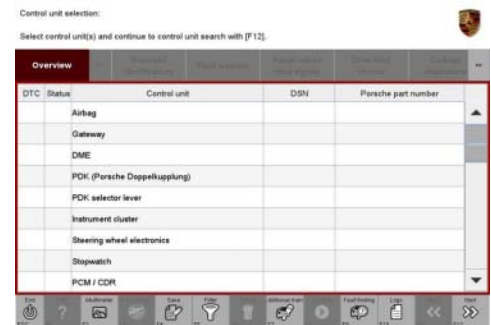
*Control unit selection*
