87 16 22 October 24, 2015 **2019947** Supersedes T.B. V871516 dated November 20, 2015 to include new model years.

Air Conditioning, Cleaning of the Refrigerant Circuit (U.S. Only)

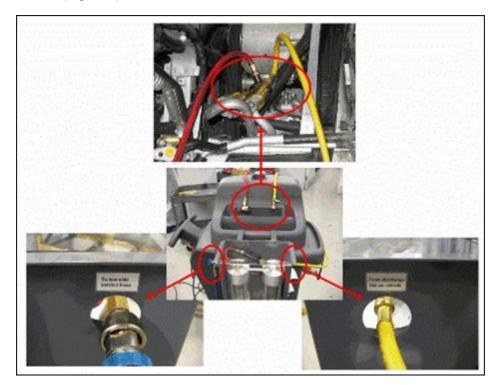
• This connection strategy allows for a system flush *in the opposite* direction of the normal refrigerant flow (Figure 4).

Figure 4. Connection strategy: Vehicle to service station to flushing device.

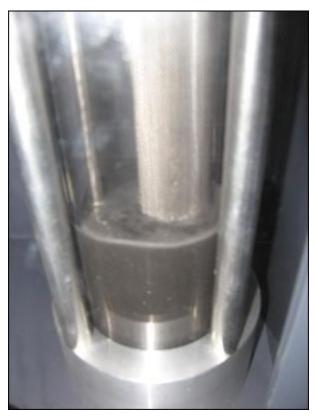
Figure 5. The first cycle.

The flush program will begin with an evacuation of the system and a rate of rise test. This is necessary to test the integrity of the connections before the flush cycles begin. If the rate of rise test passes, the program will proceed into the flush cycles. (Figures 5 – 7). These cycles will occur automatically in succession.

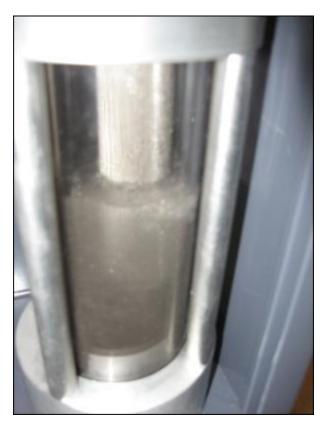
Figure 6. The second cycle.

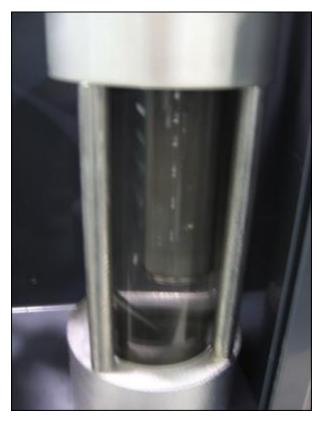
Figure 7. The third cycle.

- The debris is then rinsed from the circuit and contained within the filtration in the flusher. After the flush program, the system will be evacuated.
- 5. After the system is evacuated, remove any adapters that were installed from the VAS 6338/1.
- 6. Replace Expansion Valve (if equipped), Receiver-drier and Restrictor (if equipped).
- 7. Connect the station in the usual manner through the service fittings and perform the normal evacuation and refrigerant recharge operations.
- 8. Print a log of the job and attach to the repair order.
