# Entune Audio Head Unit Software Update (Panasonic)

**Service Category** Audio/Visual/Telematics

**Section** Navigation/Multi Info Display

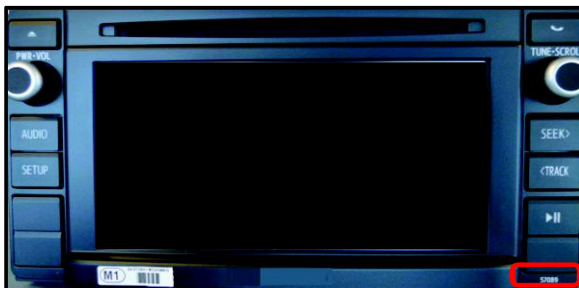
Figure 1. Avalon, Avalon HV, Highlander, Highlander HV, Prius, Prius V, Sienna, Sequoia, Tacoma & Tundra.

1. Confirm the audio system type by checking the Panel ID printed on the bottom-right or bottom-center of the machine.

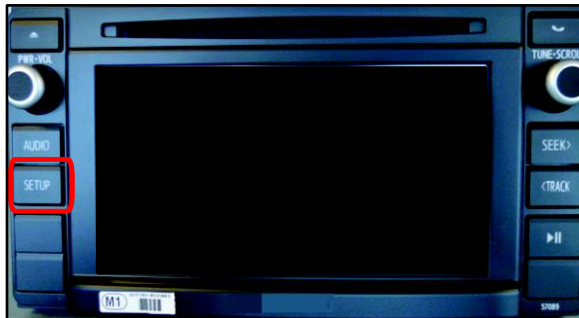
Figure 3. Tacoma, Prius, Prius V

A. For Entune™ Audio: Press the SETUP button on the panel.

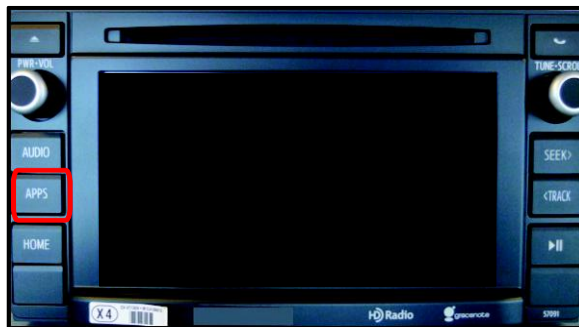
Figure 5. 4Runner, Avalon, Avalon HV, Highlander, Highlander HV, Prius, Prius V, Sienna, Sequoia, Tacoma & Tundra

B. For Entune™ Audio Plus/Entune™ Premium Audio: Press the APPS button on the panel.

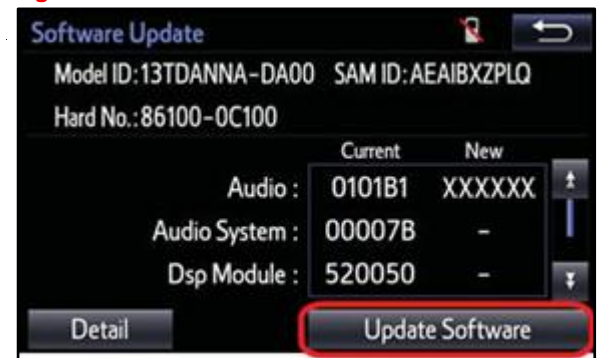
Figure 13.

8. Verify that the new software is up-to-date on the *Software Update* screen.

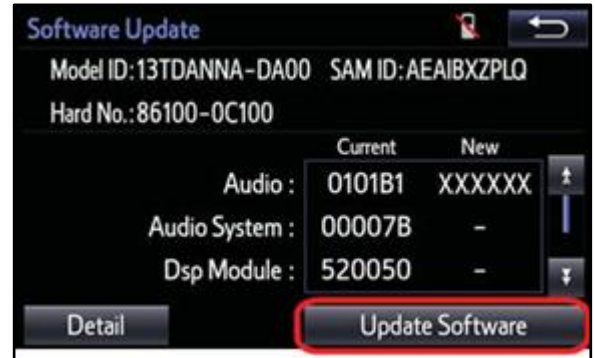
Figure 14.

9. Select Update Software on the Software Update screen.

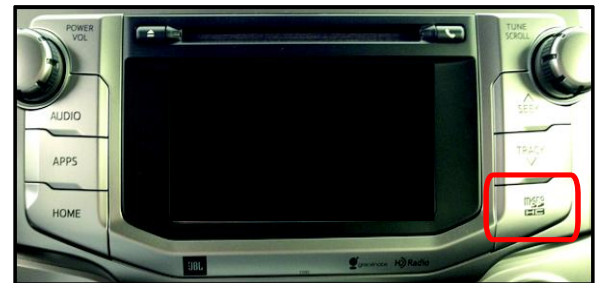
**Figure 17.**

If update fails and the error message “New software is not compatible with the system.” displays, cycle the ignition OFF, remove the Map Micro SD Card from the head unit, and repeat steps 3 – 11.

**1** Map Micro SD Card

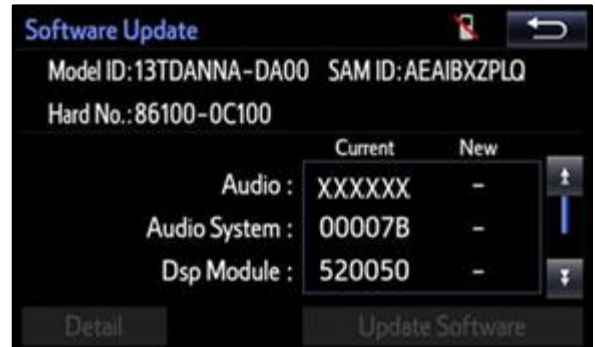
Figure 19.

1. Perform steps 3 – 6 of the Software Update procedure to re-enter the Software Update screen.
2. Verify that the software information is updated on the Software Update screen.
