NUMBER: 08-057-16

GROUP: Electrical

SUBJECT:
RA3 RA4 Radio Enhancements

OVERVIEW:
This bulletin involves inspecting and, if required, updating the radio software.

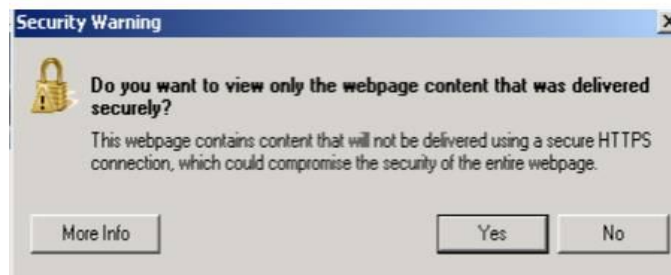
Fig. 1 Pop-up Security Message

1. Has the USB flash drive been created?
 - a. Yes >>> Proceed to [Step #4](#).
 - b. No >>> Proceed to [Step #2](#).
2. Go to DealerCONNECT> Service> UCONNECT Information & Utilities> Uconnect Dealer software downloads to download the files.
3. If a security message appears “Do you want to view only the webpage content that was delivered securely?” see ([Fig. 1](#)). Press **No** to continue.
