**NUMBER:** 08-023-16

**GROUP:** Electrical

RB5 RB6 Radio Software Enhancements (X66 Warranty Extension)

2014 - 2015 (PF) Dodge Dart

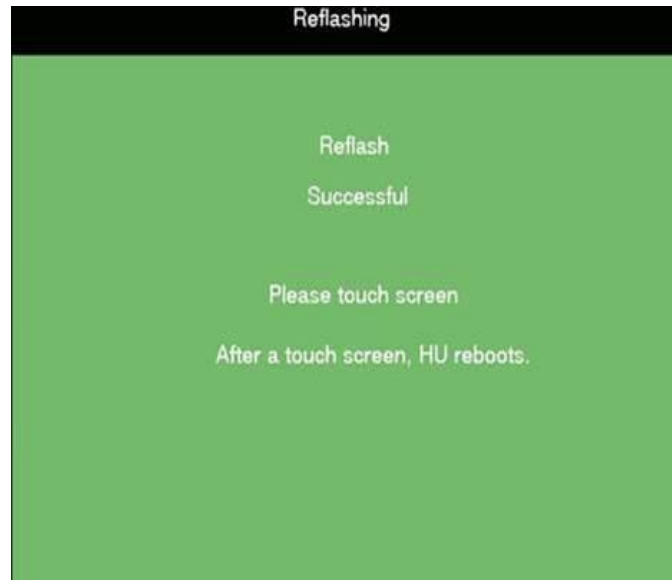
***Fig. 2 Touch Screen Instruction***

11. When the update is completed, the screen will read “Reflash Successful”. Remove the USB flash drive and press the screen anywhere to initiate the radio to reboot. See (Fig. 2).

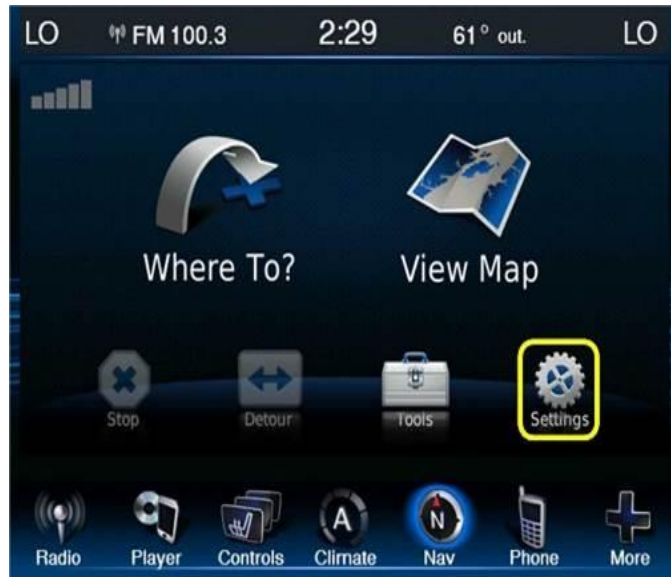
**Fig. 4 Settings Screen Icon**

- 16. Press the Settings Icon. See (Fig. 4).

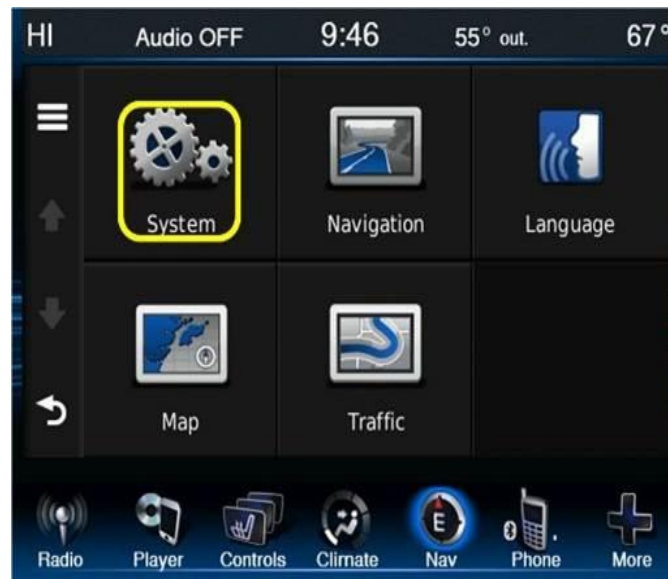
**Fig. 5 System Screen Icon**

17. Select the System Screen icon and then the About icon to display the Garmin System Information. See (Fig. 5) and (Fig. 6).

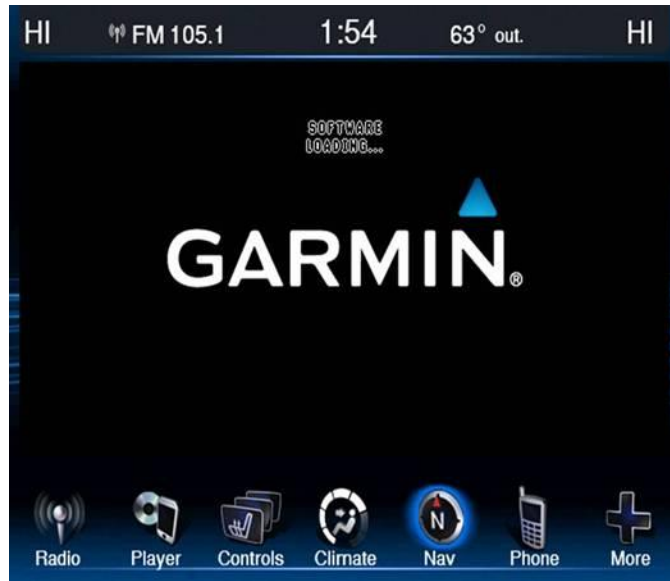
**Fig. 7 Garmin Software Loading**

21. Once the update has started the radio will change to the software loading screen. See (Fig. 7).

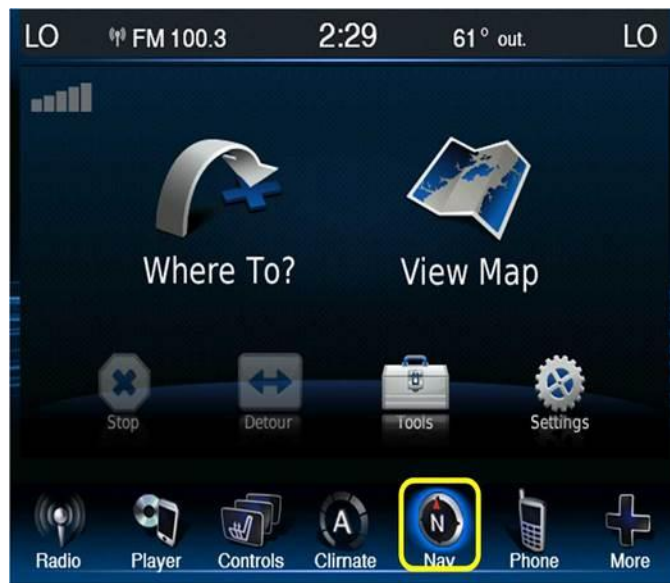
**Fig. 8 Update Complete**

22. Once the software update has completed down loading, the screen will automatically change to the Garmin main screen. See (Fig. 8).
