SI B11 11 16
Warranties

N20 ENGINE OIL FEED LINE TO THE TURBOCHARGER: LIMITED WARRANTY EXTENSION TO 10 YEARS/120,000 MILES

MODEL

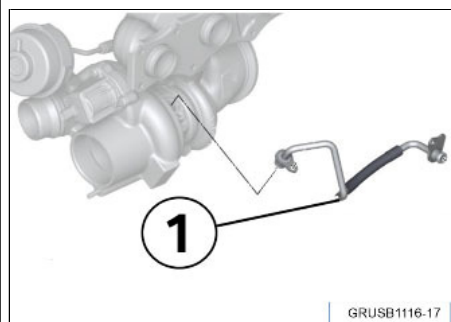
If “affected vehicle” is experiencing the “situation” noted above, replace the “engine oil feed line” to the turbocharger using part number 11 42 8 648 368* or 11 42 8 678 840.

The check valve eliminates engine oil pressure equalization and the consequential engine oil leakage past the turbocharger’s “exhaust side” turbine seal.
