SI B11 17 16
Engine

VOLUNTARY EMISSIONS RECALL CAMPAIGN 16E-A05 - N26 ENGINE: REPLACE TURBOCHARGER OIL SUPPLY LINE

F30 (3 Series Sedan)

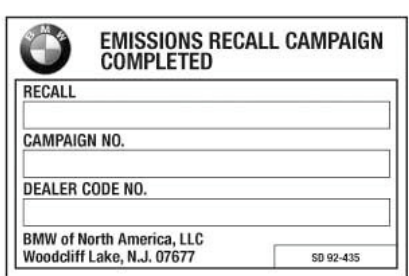
LABEL INSTRUCTIONS

<p>EMISSIONS RECALL CAMPAIGN COMPLETED</p> <p>RECALL _____</p> <p>CAMPAIGN NO. _____</p> <p>DEALER CODE NO. _____</p> <p>BMW of North America, LLC Woodcliff Lake, N.J. 07677</p> <p>SD 92-435</p> <p>GRUSB1212-01</p>	<p>After the vehicle has been checked and corrected, obtain a label (SD 92-435) and with the indelible marker provided, legibly print the Recall name, Recall number, and dealer code (5 digits) on the "Emissions Recall Campaign Completed Label" (see illustration). Note: Additional labels can be ordered online at BMW TIS.</p>
-----------------------------------------------------------------------------------------------------------------------------------------------------------------------------------------------------------------------------------------------------------------------------------------------------------------------	----------------------------------------------------------------------------------------------------------------------------------------------------------------------------------------------------------------------------------------------------------------------------------------------------------------------------------------------

First check if a Recall Completion Label, SD 92-435 for this campaign is already attached to the underside of the hood on the right (passenger) rear close to the windshield.
