# Techstream ECU Flash Reprogramming Procedure

**Service Category** Engine/Hybrid System

**Section** Engine Control

## Introduction

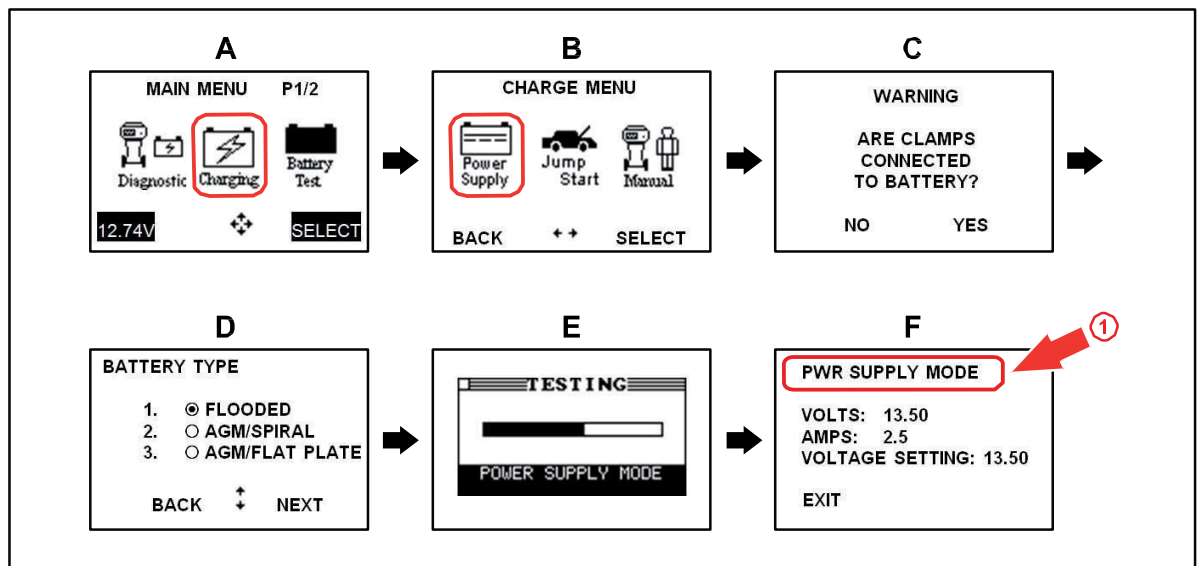
Figure 7.

- A. Connect the GR8 Battery Diagnostic Station to the vehicle and turn it ON.
- B. Select Power Supply Mode by following the screen flow below.

- ECU damage may occur if the correct battery charger and mode setting are NOT used.
- Power Supply Mode is used to maintain battery voltage at 13.5 volts while flash reprogramming the vehicle.
- For details on how to use the GR8 Battery Diagnostic Station, refer to the [GR8 Instruction Manual](#) located on TIS, *Diagnostics – Tools & Equipment – Battery Diagnostics*.

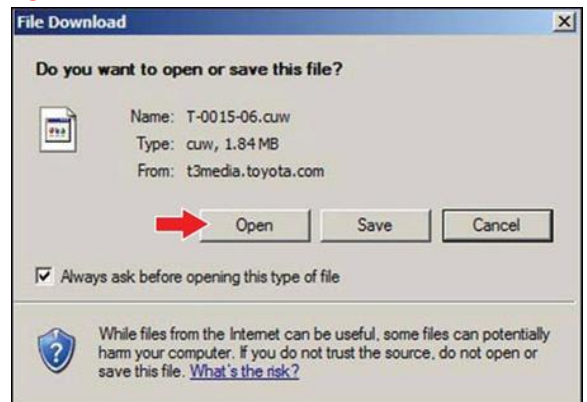
**Figure 9.**

- B. Click Open to load calibration file information.

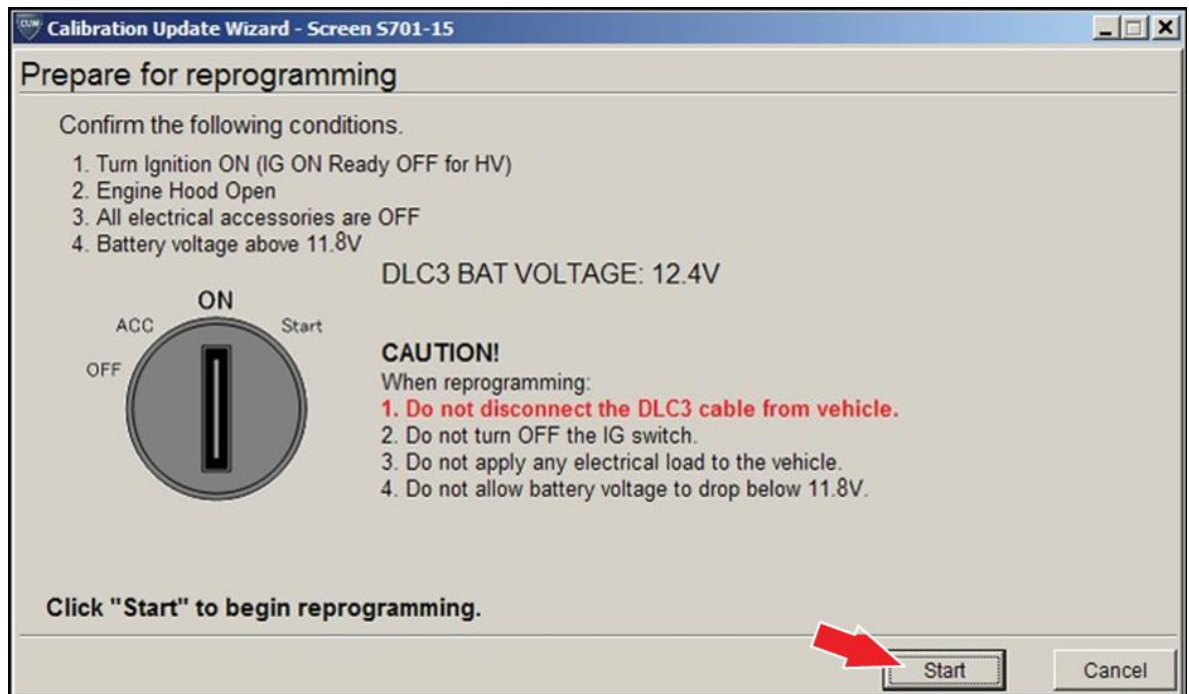
Figure 14.

Verify the vehicle is connected to a battery charger before continuing — If battery voltage falls below 11.8 volts, ECU damage may occur.

Then click *Next*.

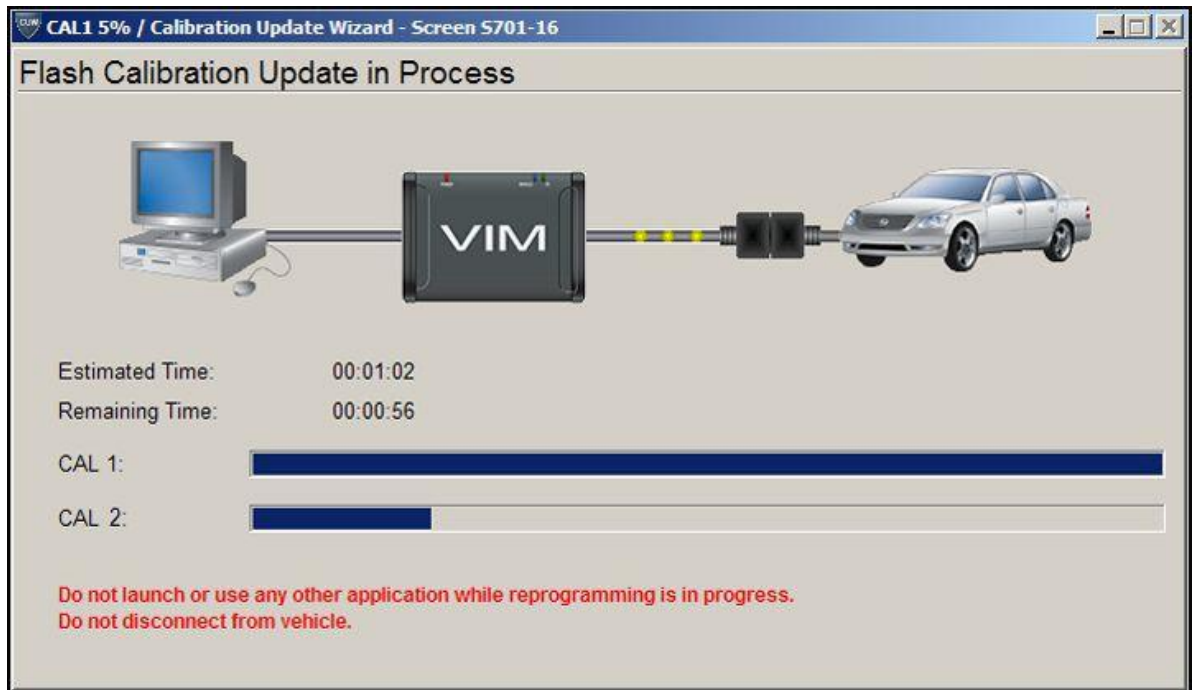
**Figure 18.**

- K. Do NOT disturb the vehicle during flash reprogramming.

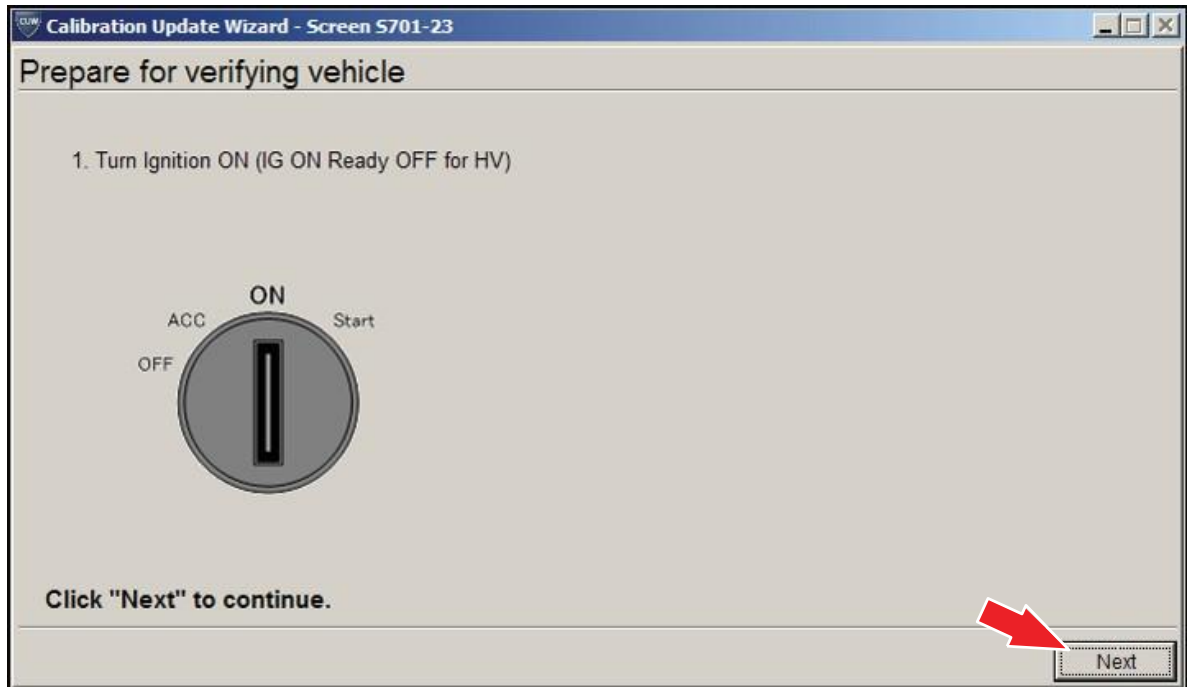
**Figure 20.**

- M. Turn ignition to the ON position. Then click *Next*.

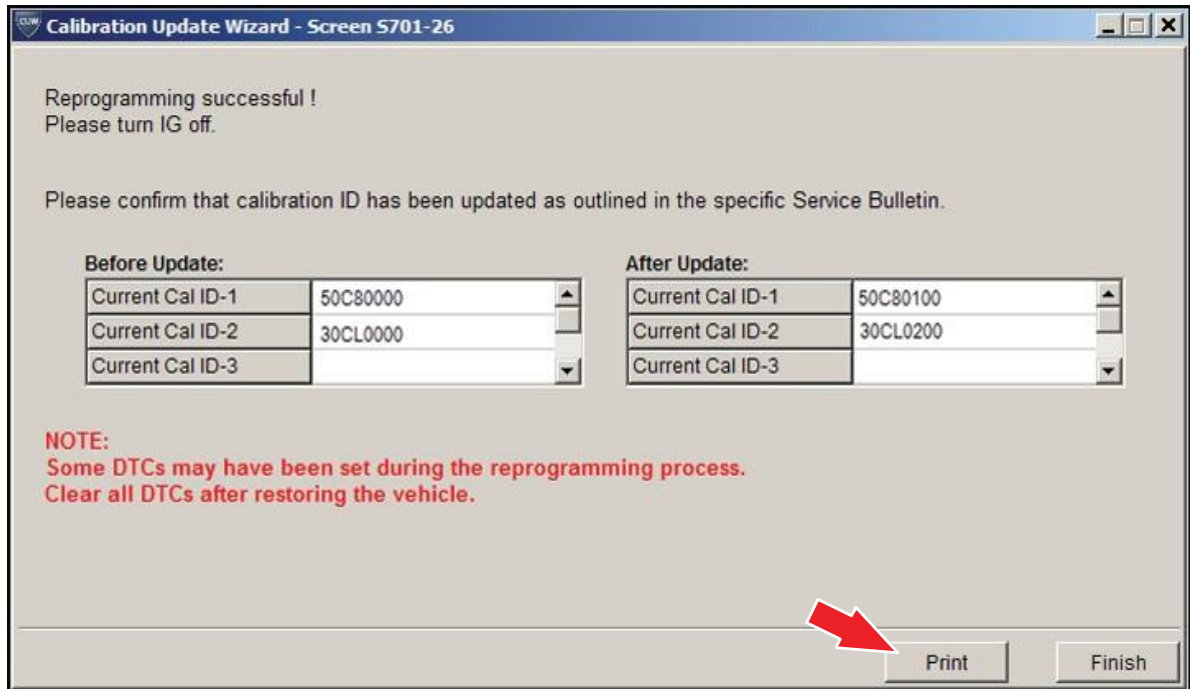
**Figure 21.**

- N. Confirm all calibrations were updated as specified in the Service Bulletin. Then click *Finish*.
