Voluntary Emissions Recall Campaign 13E-A03: Program Control Units (OBD)

E89 (Z4)

With the N20 engine and option 2TB (Sport Automatic Transmission) produced from July 2011 to August 2012

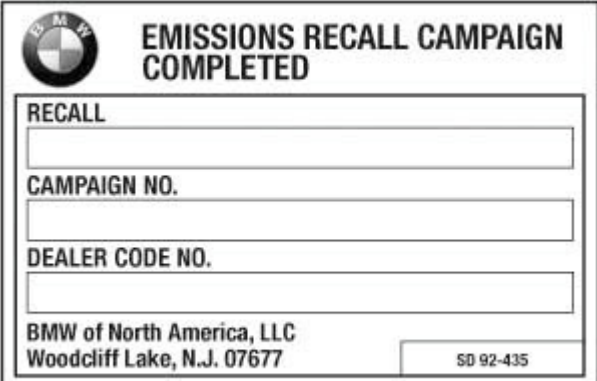
LABEL INSTRUCTIONS

First check if a Recall Completion Label, SD 92-435 for this campaign is already attached to the underside of the hood on the right (passenger) rear close to the windshield.

<p>EMISSIONS RECALL CAMPAIGN COMPLETED</p> <p>RECALL <input type="text"/></p> <p>CAMPAIGN NO. <input type="text"/></p> <p>DEALER CODE NO. <input type="text"/></p> <p>BMW of North America, LLC Woodcliff Lake, N.J. 07677</p> <p style="text-align: right;">SD 92-435</p> <p style="text-align: right;">GRUSB1212-01</p>	<p>After the vehicle has been checked and corrected, obtain a label (SD 92-435) and with an indelible marker, legibly print the Recall name, Recall number, and dealer code (5 digits) on the Recall Completion Label (see illustration). Note: Additional labels can be ordered online at BMW TIS.</p>
--	--
