## Technical product information

| <b>Topic</b> | Mulsanne Premium Amplifier |

The Premium Amplifier is not shutting down when the vehicle ignition is deactivated, this is due to a missing or ignored message between the Amplifier Power Board and the Amplifier Main Controller. Software Version 0120 has been introduced to correct this issue.

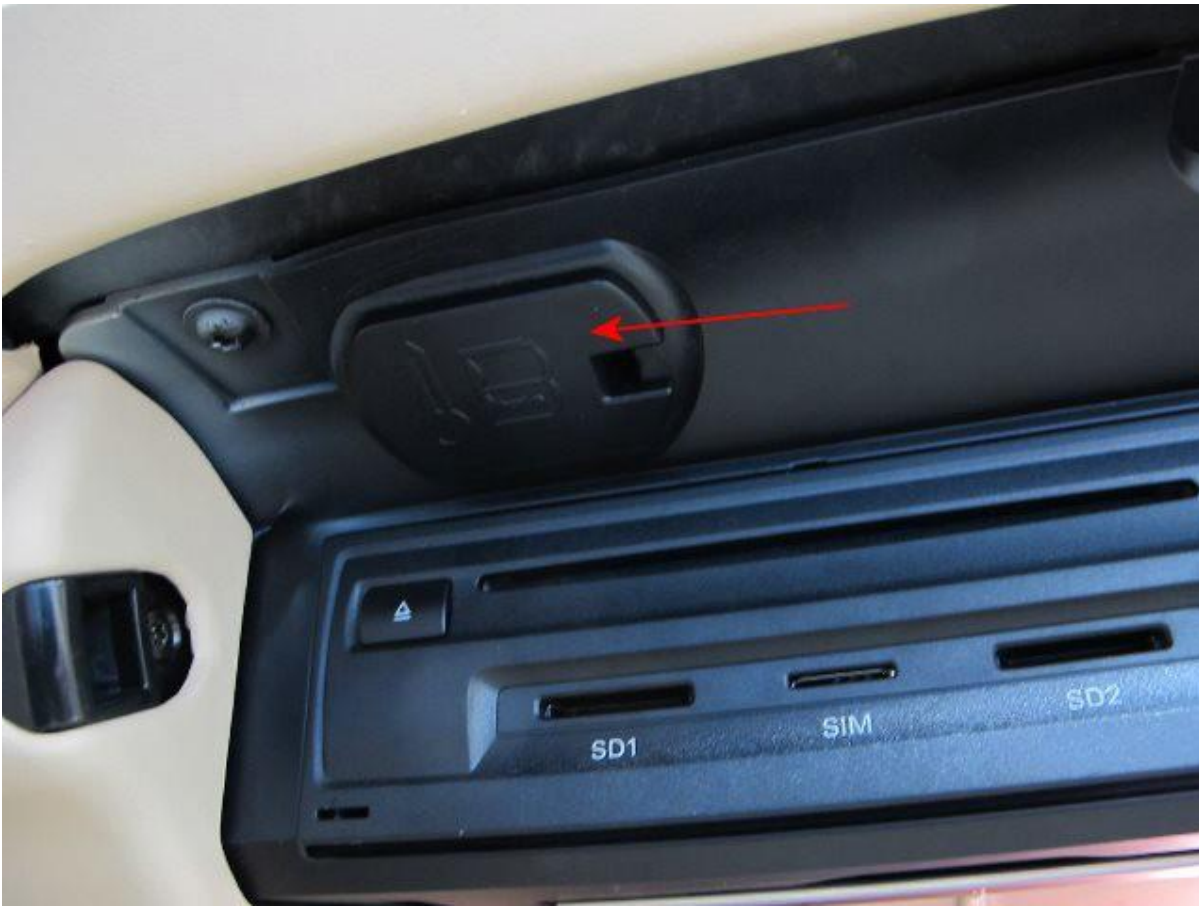
Figure 1.

Locate the key reader situated within the glove compartment and remove the cover – figure 1.

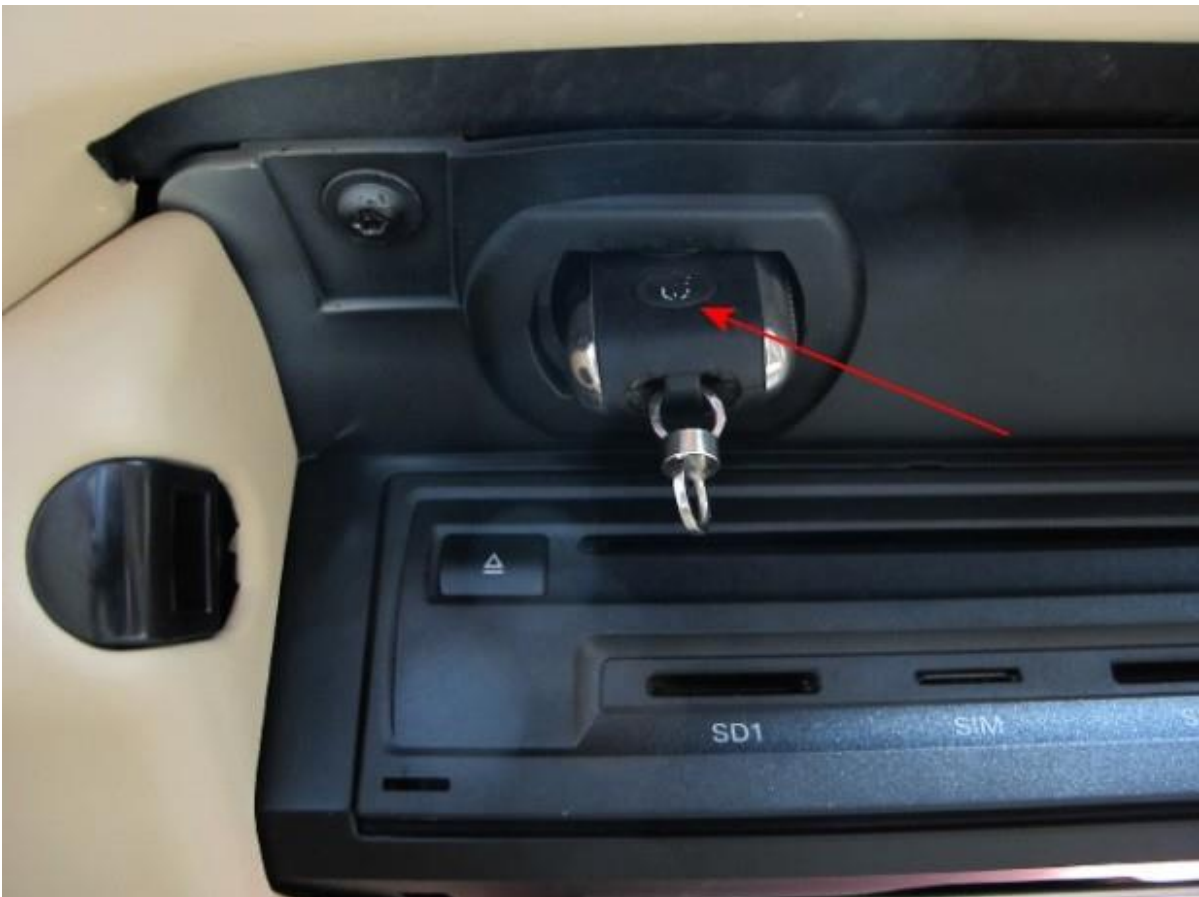
Figure 2.

Insert a single key into the key reader with the blade folded away until it “clicks” into place, make sure the key is securely located within the key reader – figure 2.

**It is important that any additional keys or key rings are removed from the ignition key, the extra weight of a second key or key ring may cause the key to withdraw from the reader during the software update process.**

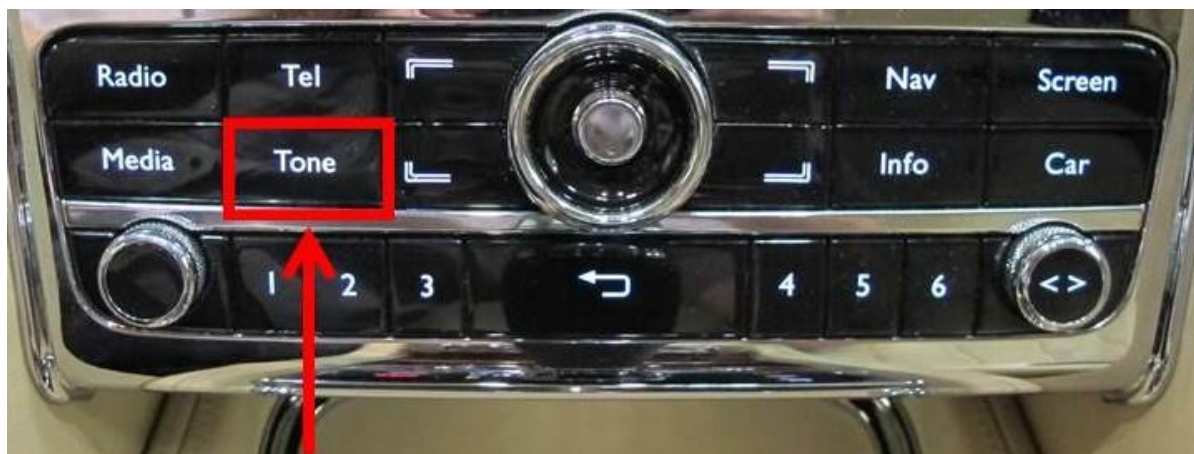
Figure 3.

Press and hold the "Tone" key on the Infotainment Control Panel – figure 3 – Immediately press and hold the "Back" key – figure 4 – hold both keys for around three seconds until the "Engineering" menu is displayed on the Infotainment Display Screen – figure 5.

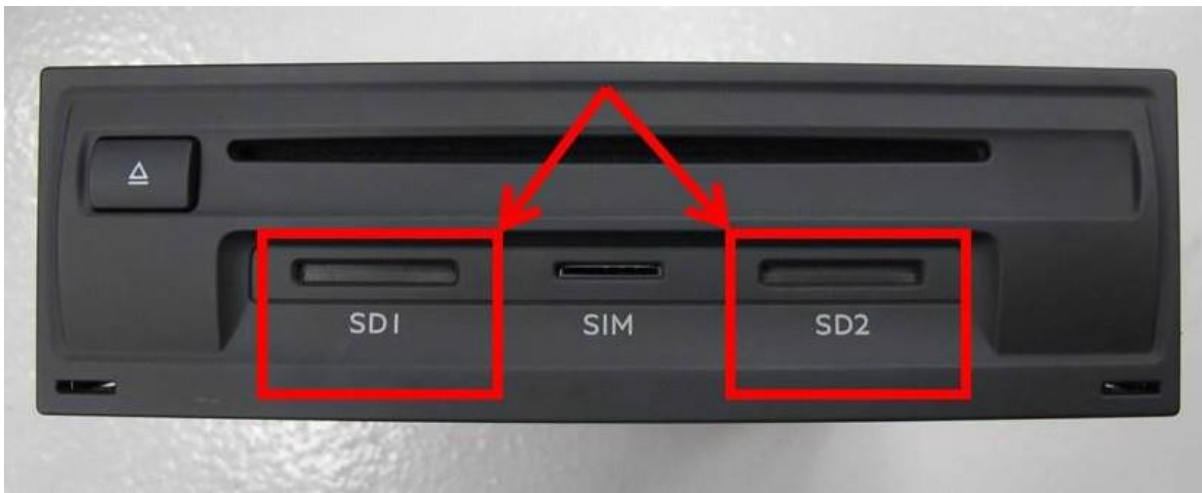
Figure 6.

Insert the update SD card - **WT10380 "SD card SW UPDATE AMP0120"** – into the media unit located within the vehicle glove compartment – figure 6.

Media card reader SD1 or SD2 may be used for the update.

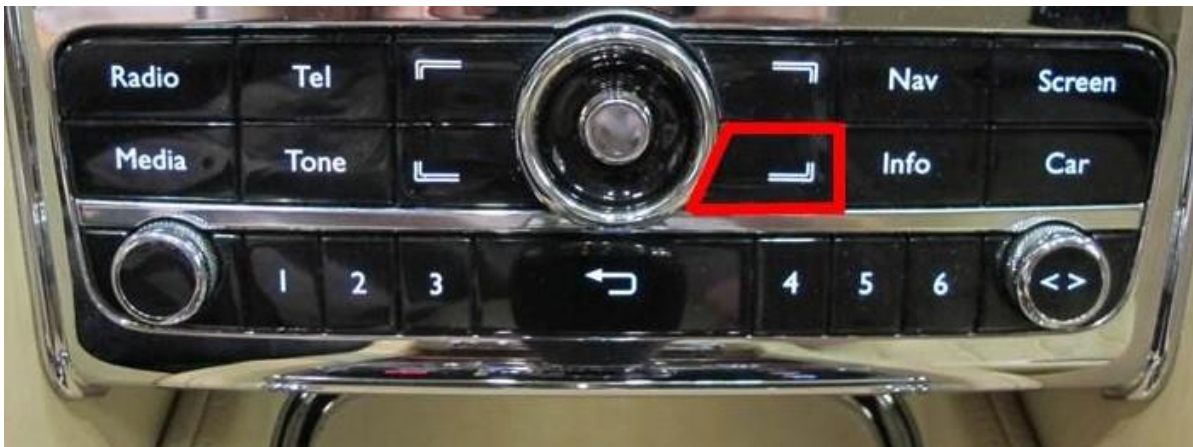
Figure 7.

Press the lower right menu key on the Infotainment Control Panel to start the update – figure 7.

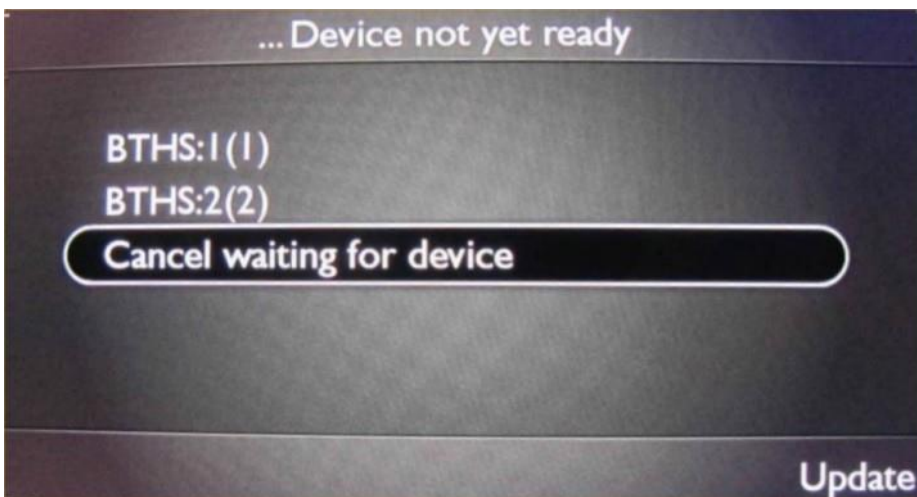
Figure 8.

If the message "*Cancel waiting for device*" is permanently shown – figure 8 – continue the update by depressing the Rotary Push Knob on the Infotainment Control Panel – figure 9 – and follow the steps below.

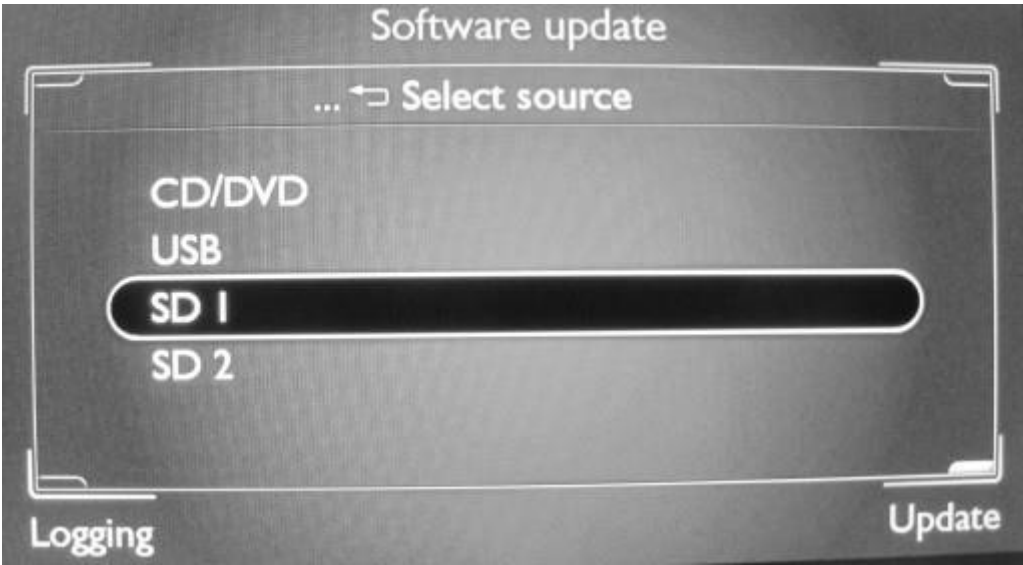
Figure 10.

Using the Rotary Push Knob, select the source on the Infotainment Display Screen to correspond to the location of the SD card within the MediaCard Reader, depress the Rotary Push Knob to confirm the selection– figure 10.

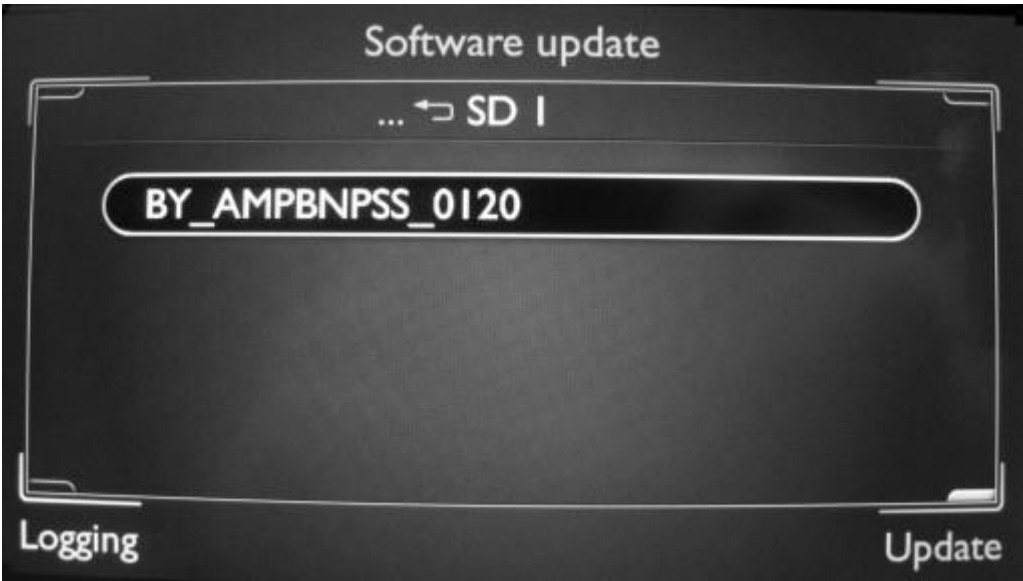
Figure 11.

Ensure the Infotainment Display Screen is showing the software – BY\_AMPBNPSS\_0120 – figure 11

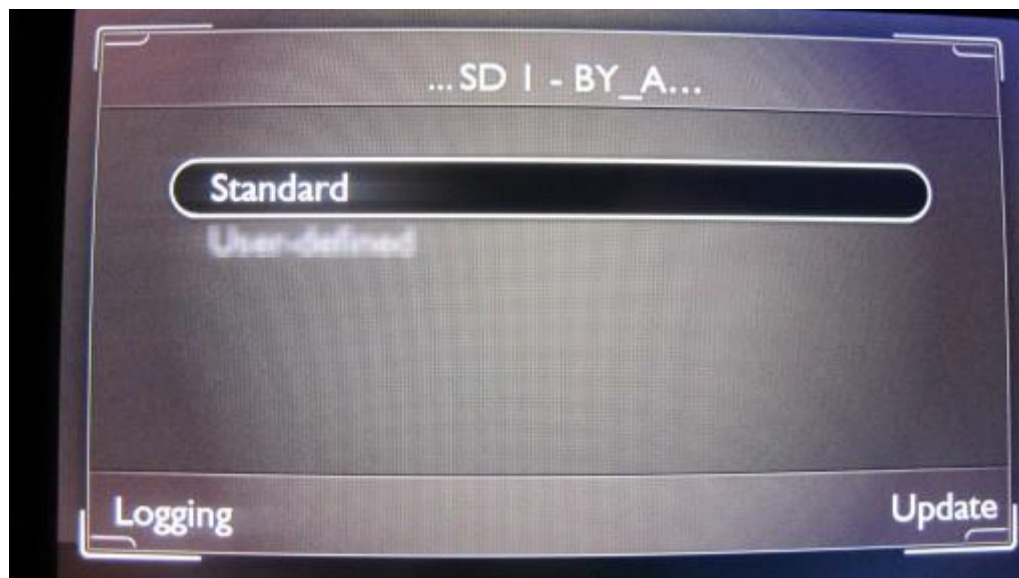
Figure 12.

When requested, select “Standard” – figure 12 – depress the Rotary Push Knob to confirm, then if requested select “Start” and depress the Rotary push Knob.

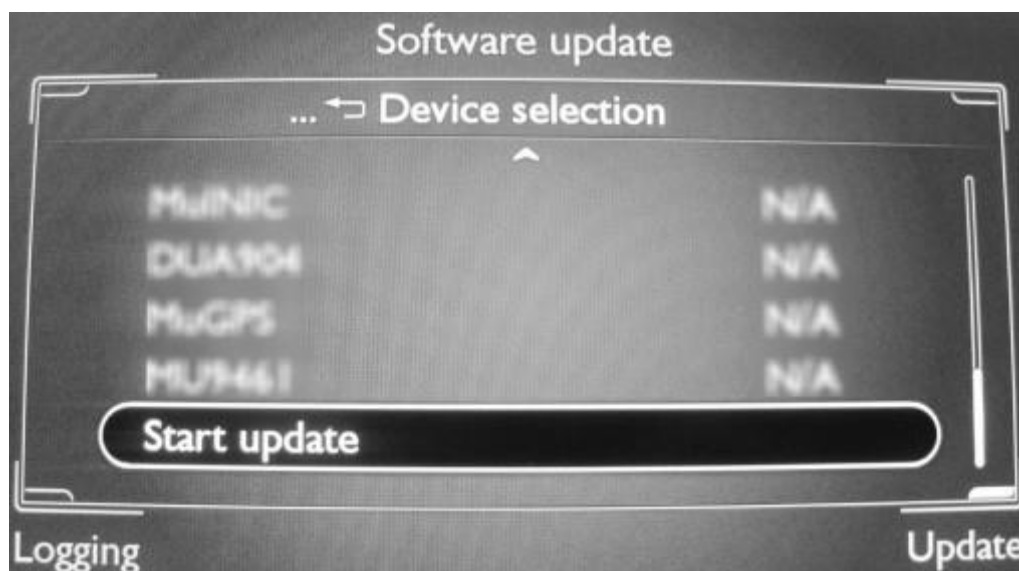
Figure 13.

At the “Device Selection” screen scroll down to the bottom of the list, select “Start Update” – Depress the Rotary Push Knob – figure 13.

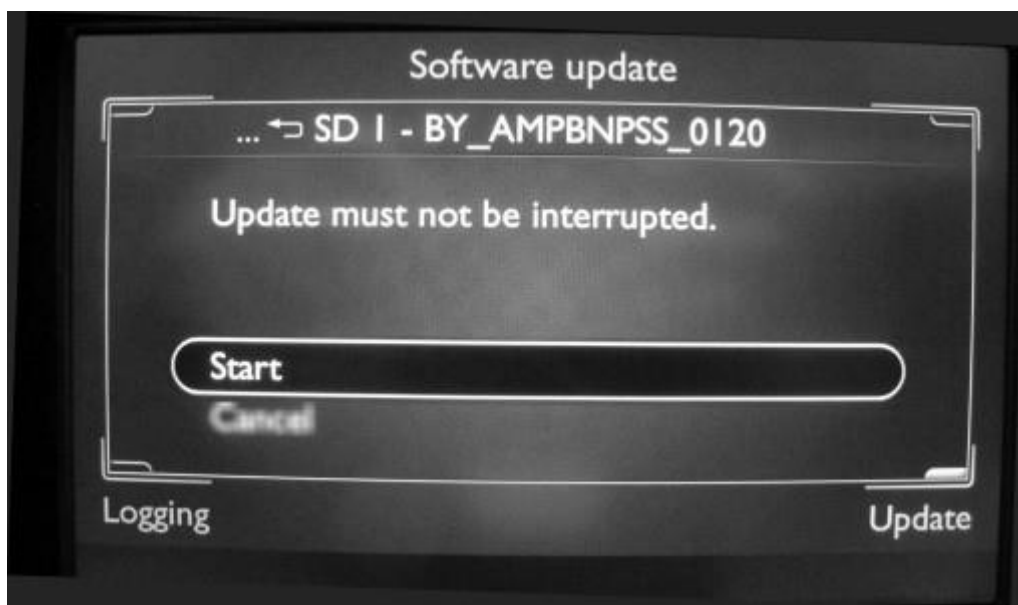
Figure 14.

Next, if requested, select “Start” – Depress the Rotary Push Knob – figure 14.

During the installation the “Update Progress” screen will show the percentage progression of the software installation, the numerical values may increase and decrease during the update.

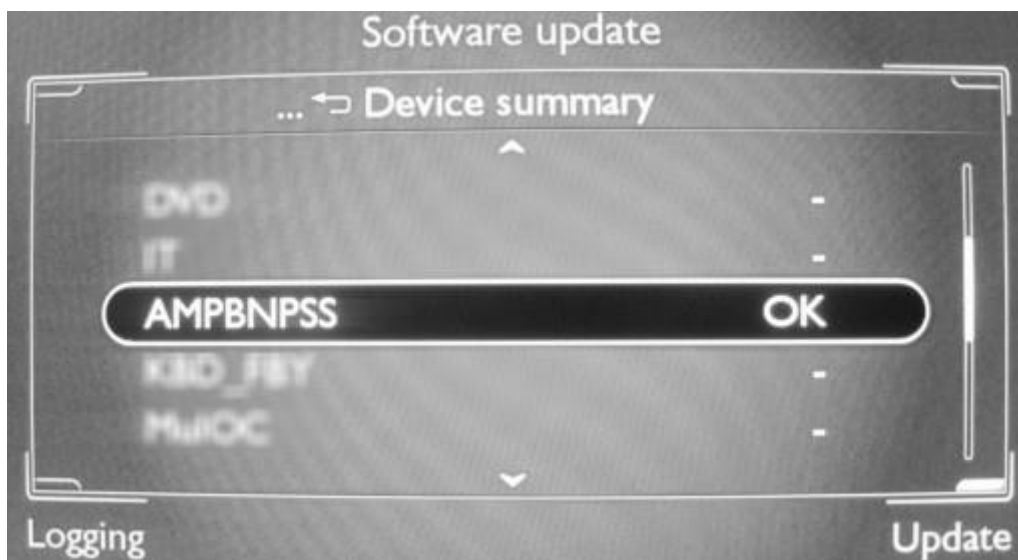
Figure 15.

Once the software installation is complete and at the "Device Summary" screen, scroll down to AMPBNPSS and ensure it is showing "OK" – figure 15.

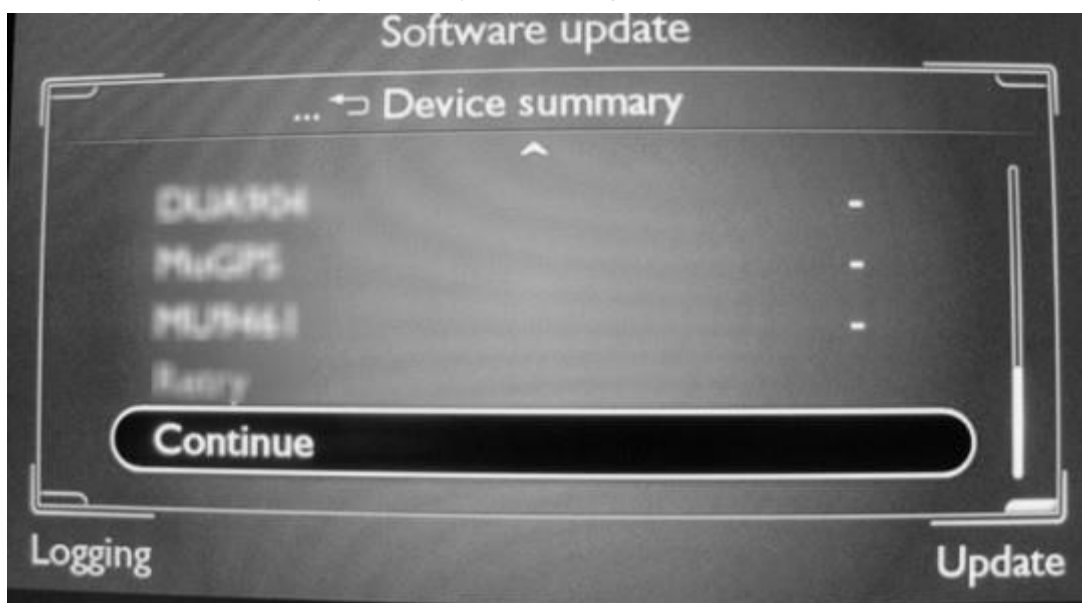
Figure 16.

Scroll down to "Continue" and depress the Rotary Push Knob – figure 16.

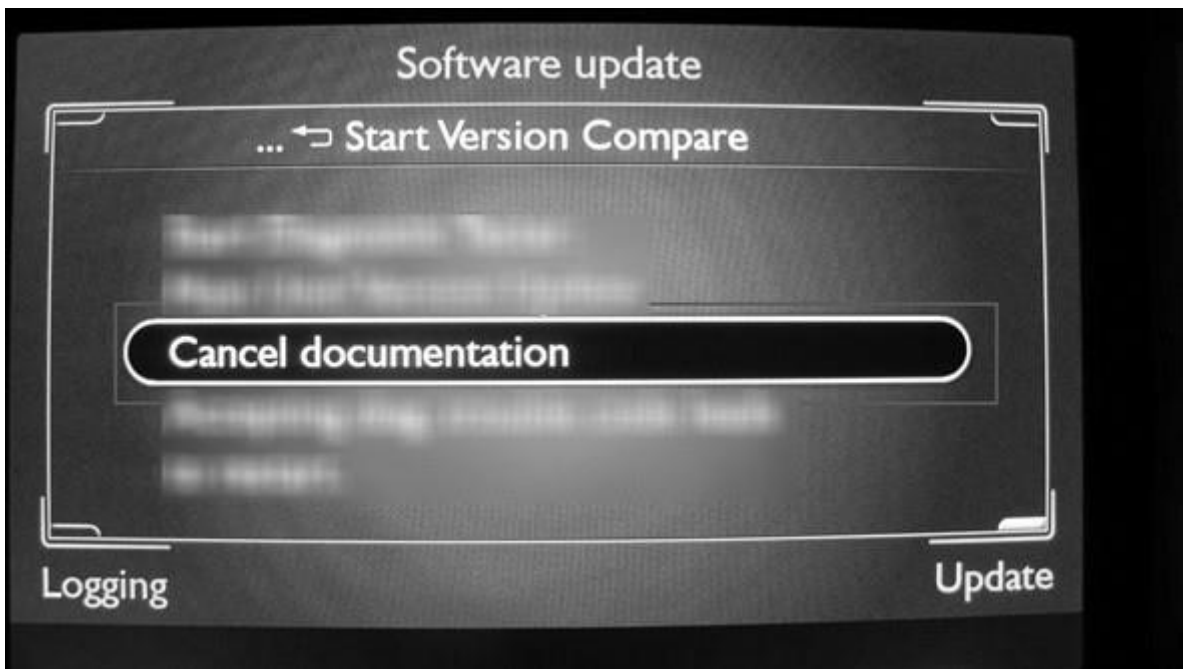
Figure 17.

On the "Start Version Compare" screen scroll to "Cancel Documentation" and depress the Rotary Push Knob – figure 17.

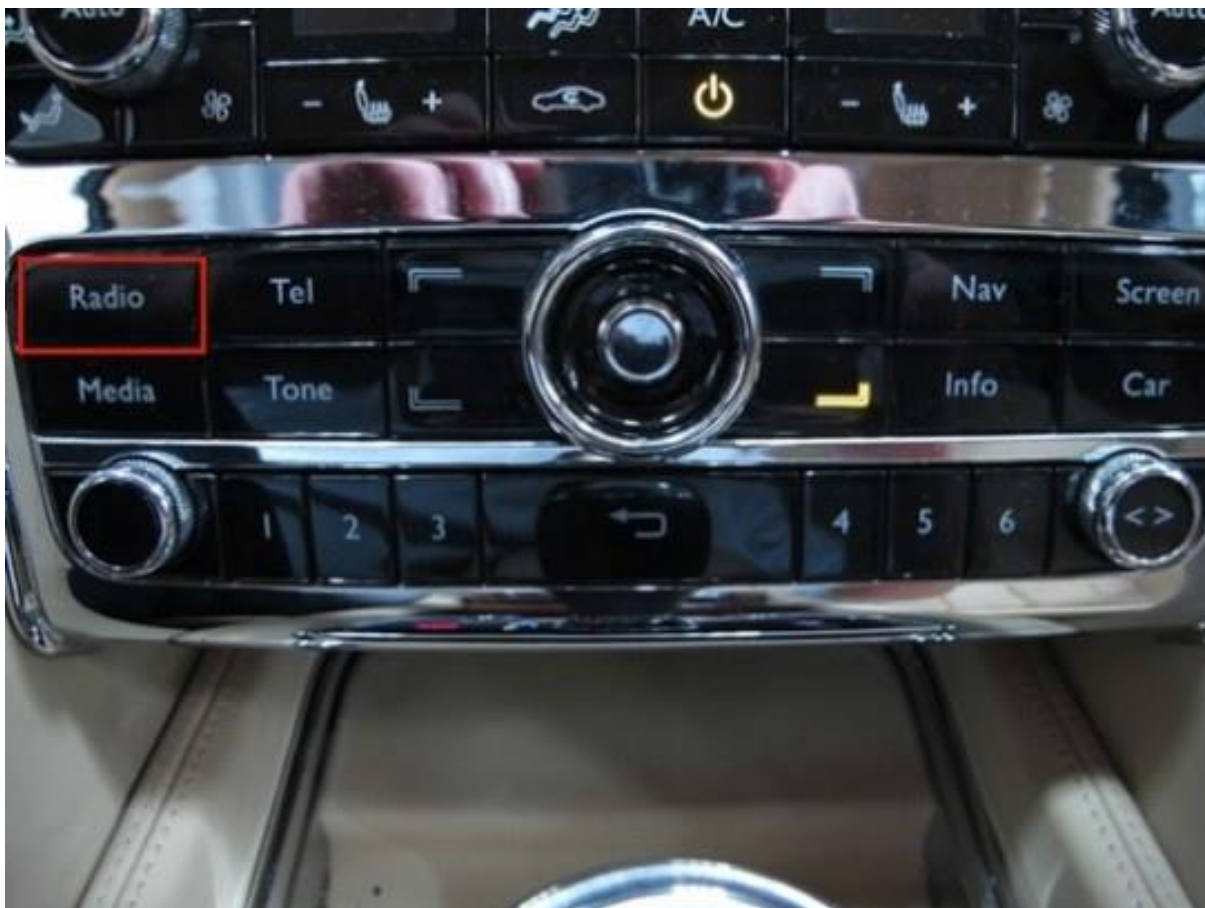
Figure 18.

Depress the "Radio" button on the Infotainment Control Panel and ensure audio output is present – figure 18.

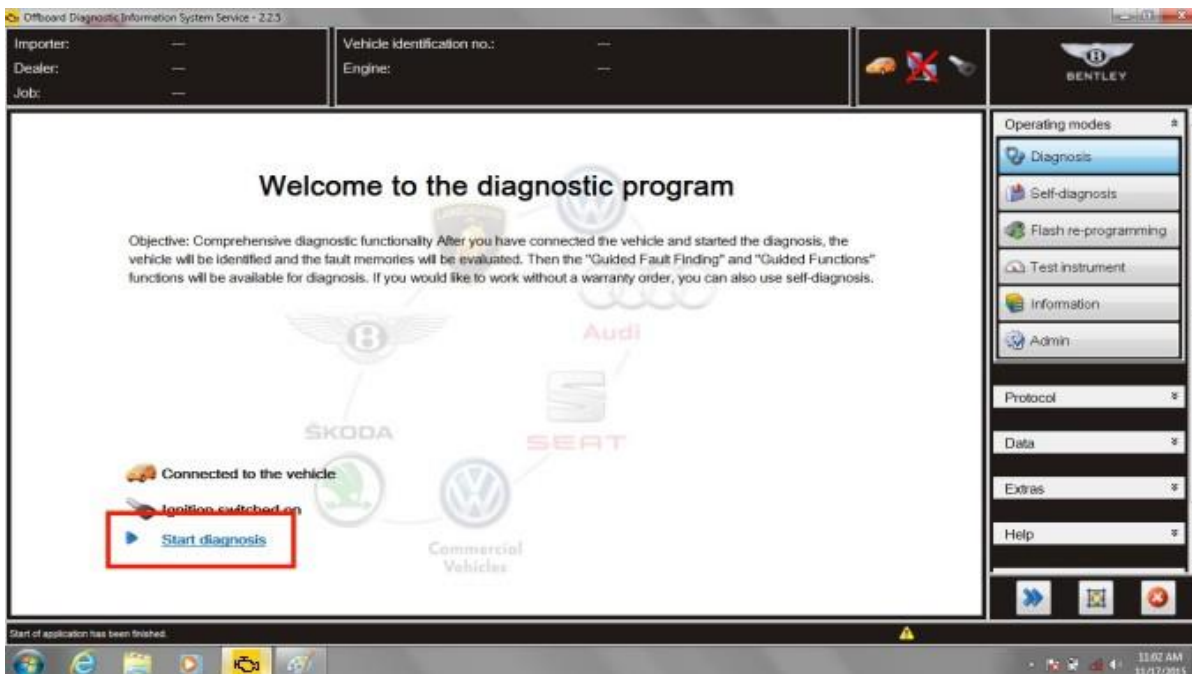
Figure 19

Select "Start Diagnosis" – figure 19.

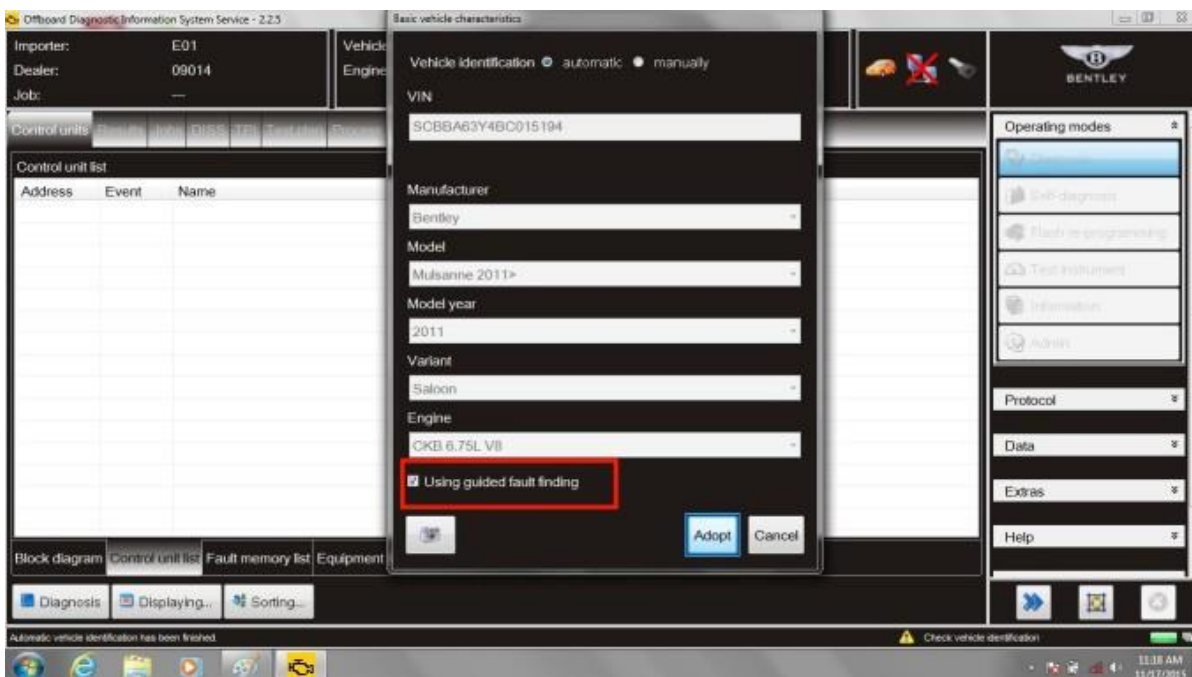
Figure 20

Select Model and Engine type – ensure the “Using Guided Fault Finding” box is ticked – figure 20.

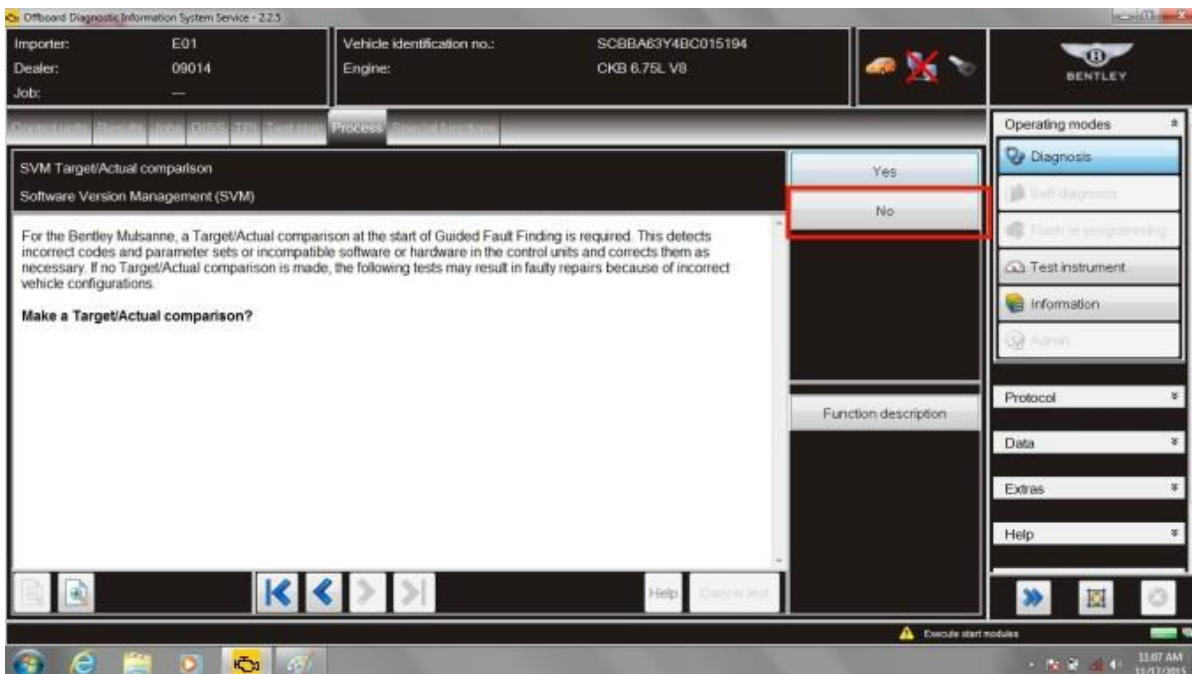
Figure 21.

When requested to make an SVM Target/Actual comparison? Select **NO** – figure 21.

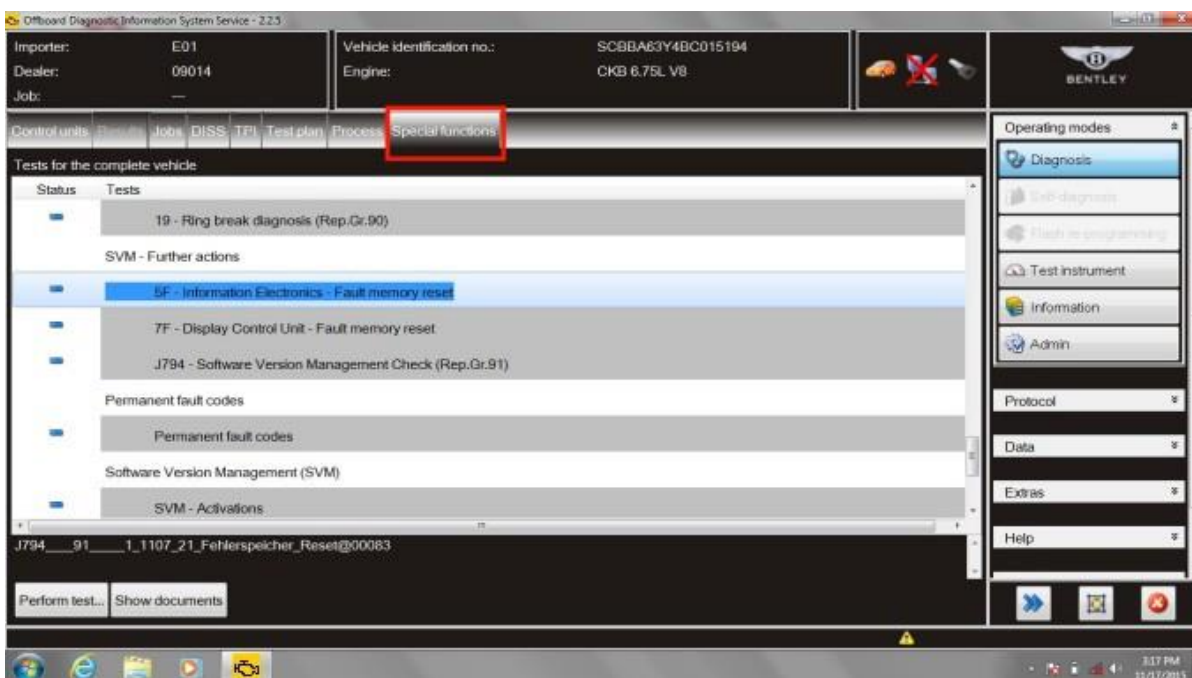
Figure 22

Select "Special Functions" – figure 22.

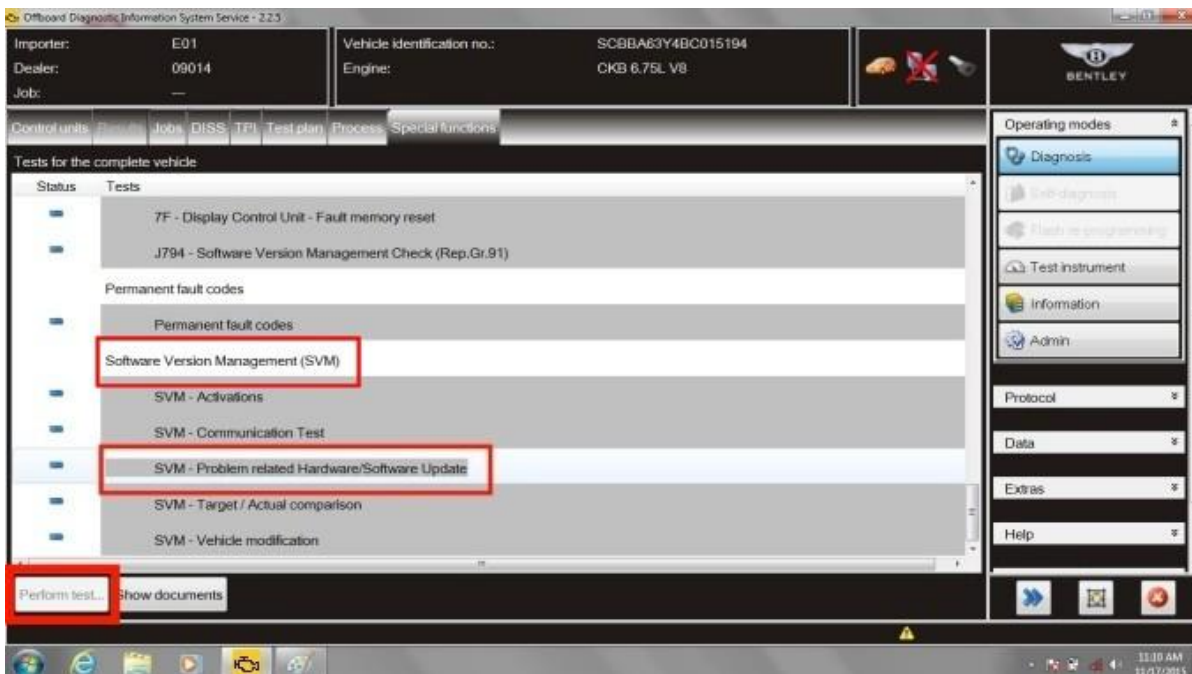
Figure 23

Scroll down to "Software Version Management" and select "SVM – Problem Related Hardware Software Update" and then select "Perform Test" – figure 23.

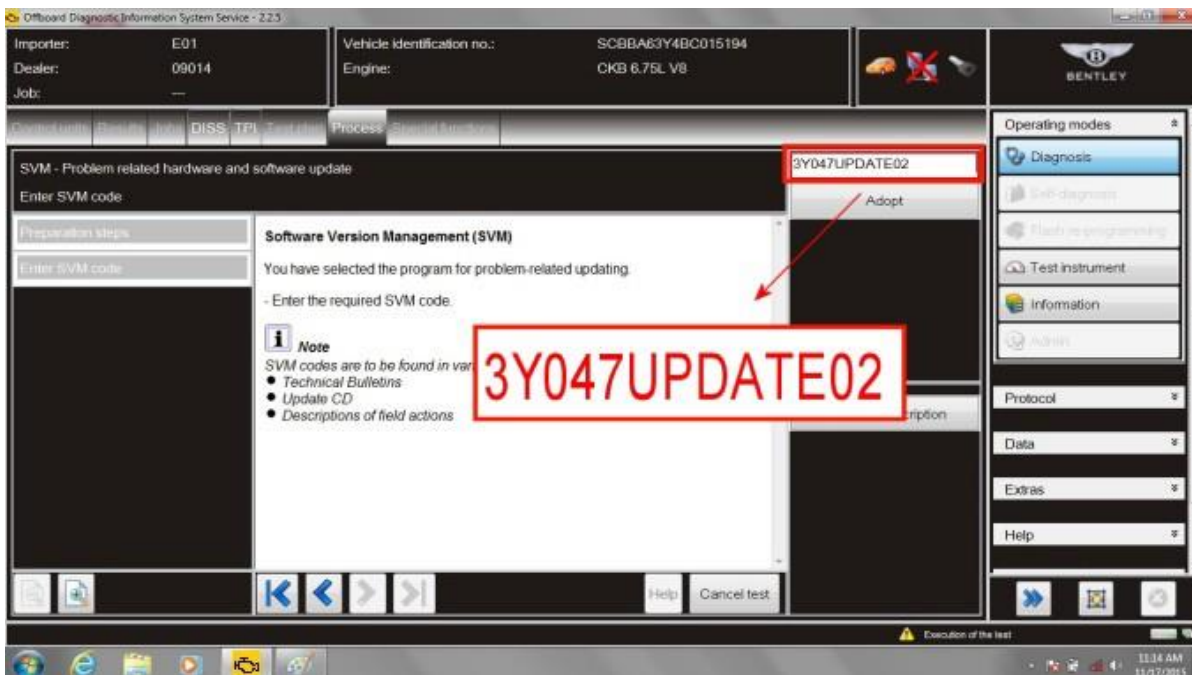
Figure 24

In the red box displayed on the Diagnostic Tool Screen, type in the code 3Y047UPDATE02 and select "Adopt" – figure 24.

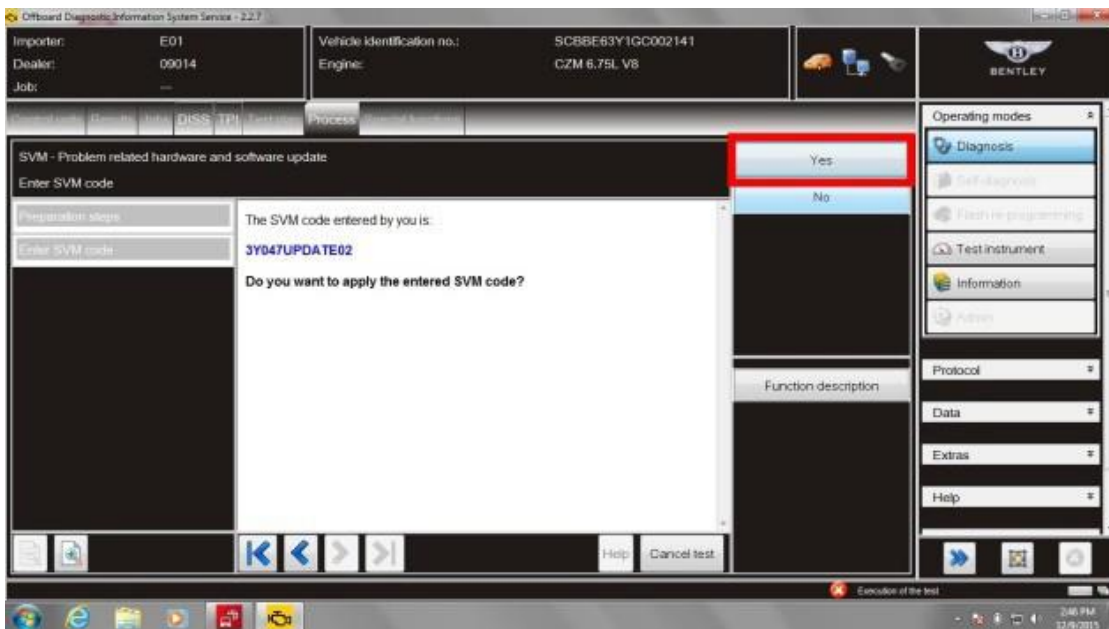
Figure 25

When requested to apply the entered SVM code, select "YES" – figure 25.

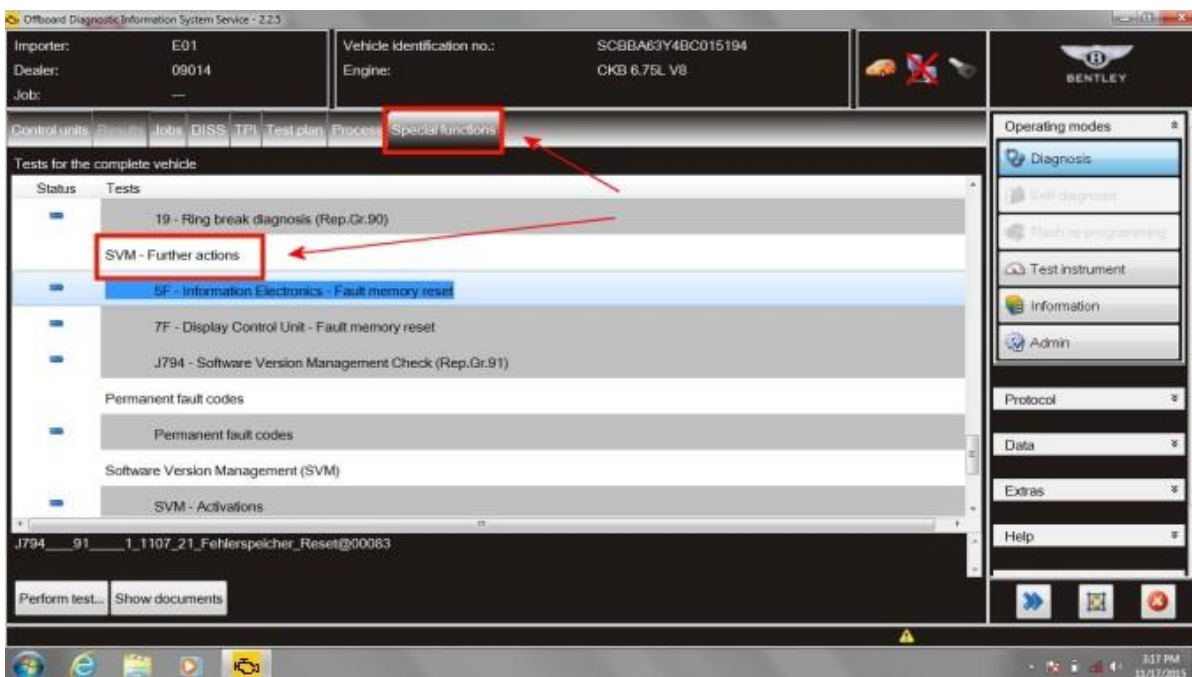
Figure 26.

Next select the “Special Functions” tab and scroll down to “SVM – Further Actions” – figure 26.

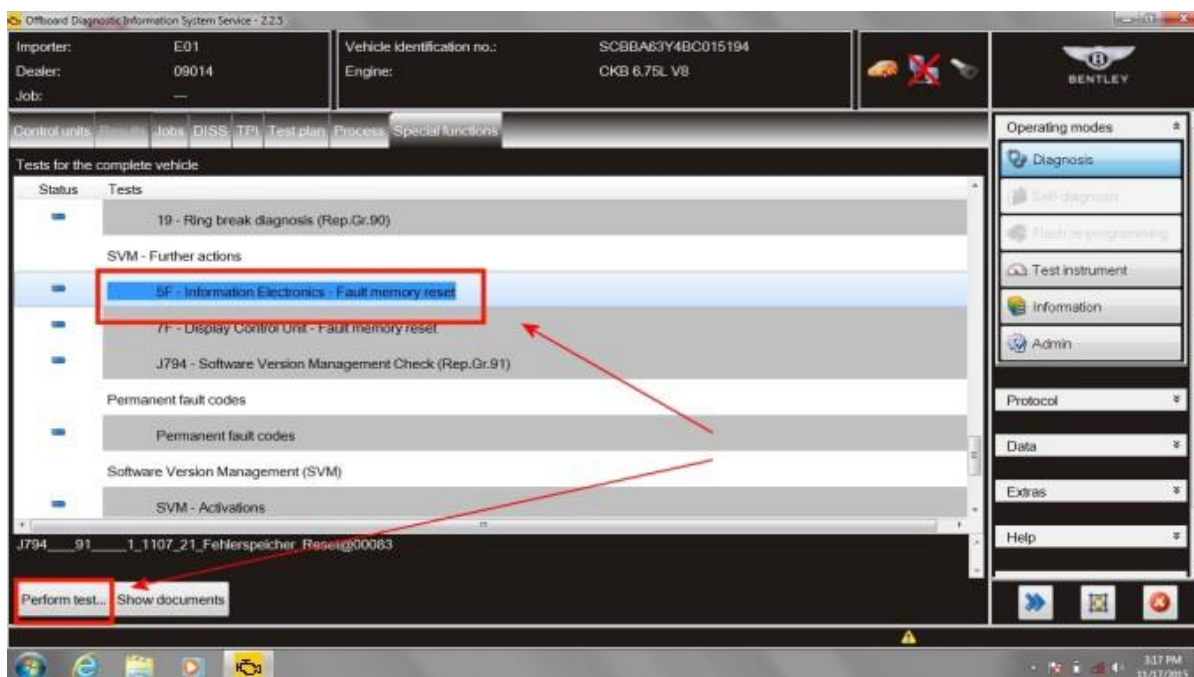
Figure 27.

Select “Information electronics – Fault Memory Reset” and then select “Perform Test” – figure 27.

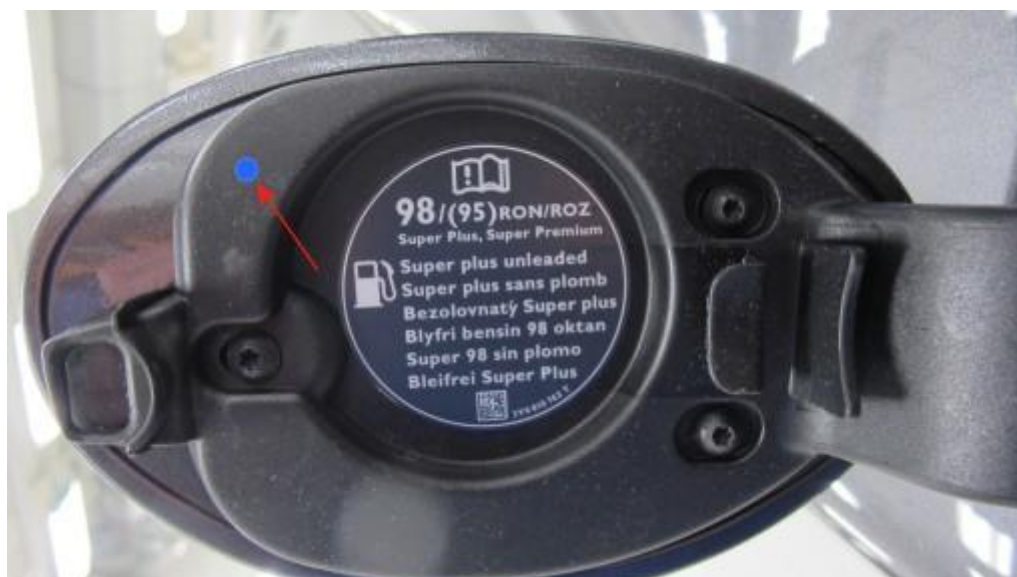
Figure 28.

Upon completion, place a blue paint mark on the inner of the fuel filler door – figure 28.

If the vehicle is not already listed as repaired within the "repair history" (Elsa-Pro) check the fuel filler door for the blue completion mark – figure 28. If neither is evident, continue with the update in accordance with the following instructions.
