SERVICE CAMPAIGN BULLETIN

TITLE:	Vehicle Software Update to Platform 4.2
CAMPAIGN REFERENCE	03V
DOCUMENT NUMBER:	13 M 001
AFFECTED VEHICLES:	Sports Series
SITUATION:	<p>Quality Engineering at McLaren Automotive have released a new software platform for the Sports Series</p> <p>The customer benefits of this software are:</p> <ul style="list-style-type: none">•Improve functionality of nose lift operation•Improve HVAC temperature control•Improve AIS IRIS to prevent system freeze•Introduction of Gen2 12v battery software
PROCEDURE:	<p>It is necessary to update the software and replace the TPMS module on all vehicles within your Aftersales car parc, both when carrying out Pre-Delivery Inspections (PDI) and at the next service centre visit.</p>

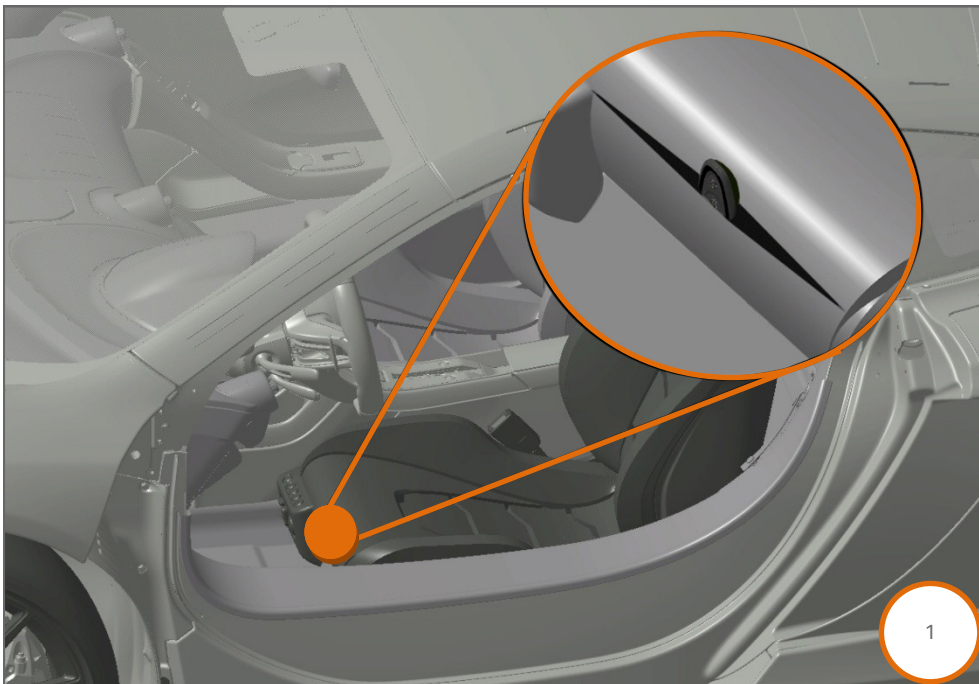
Care Point: The key must be positioned in the driver's seat front pocket (1).

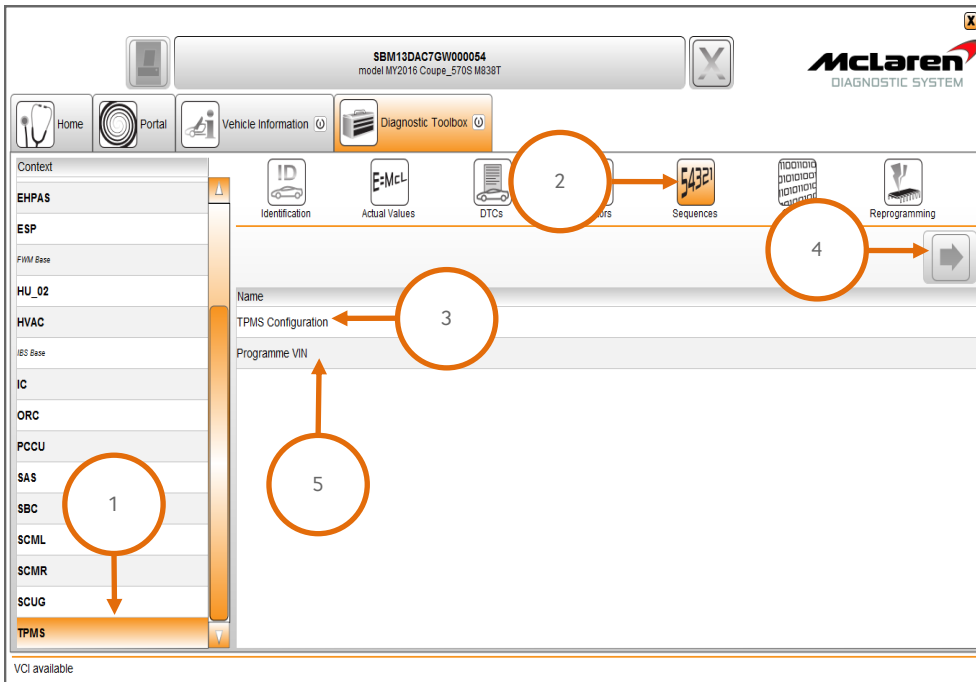
TPMS configuration

9. Select TPMS (1), then Sequences (2), select TPMS Configuration (3). Proceed by selecting the arrow button (4).

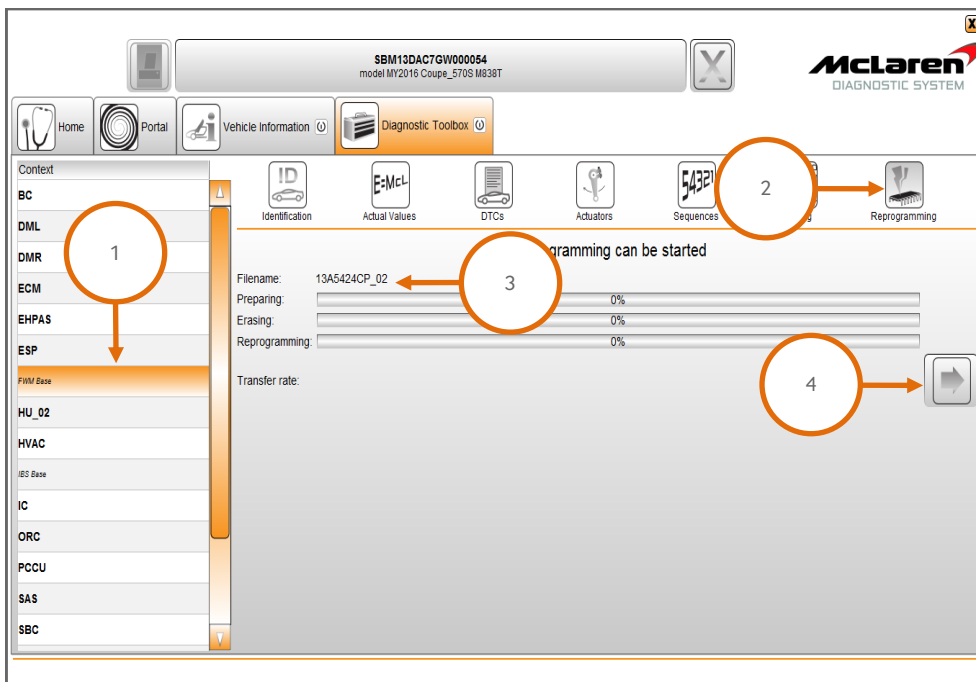
FWM Software Update:

11. Select FWM (1), then Reprogramming (2), the correct software level for the vehicle will be displayed (3). Proceed to the software download by selecting the arrow button (4).

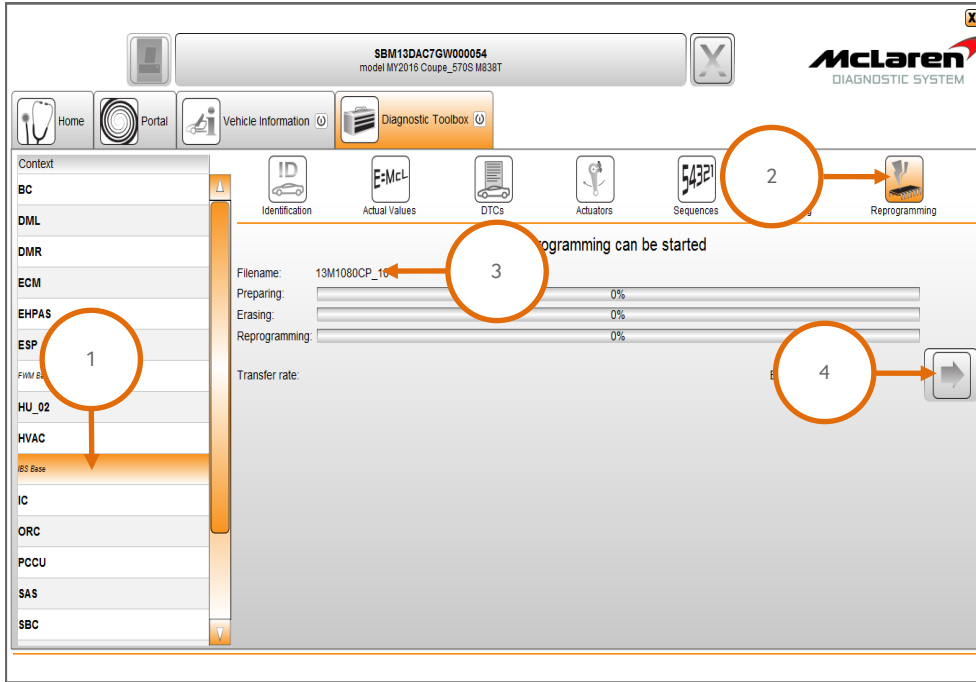
IBS Software Update:

12. Select IBS (1), then Reprogramming (2), the software level 13M1080CP.12 will be displayed (3). Proceed to the software download by selecting the arrow button (4).

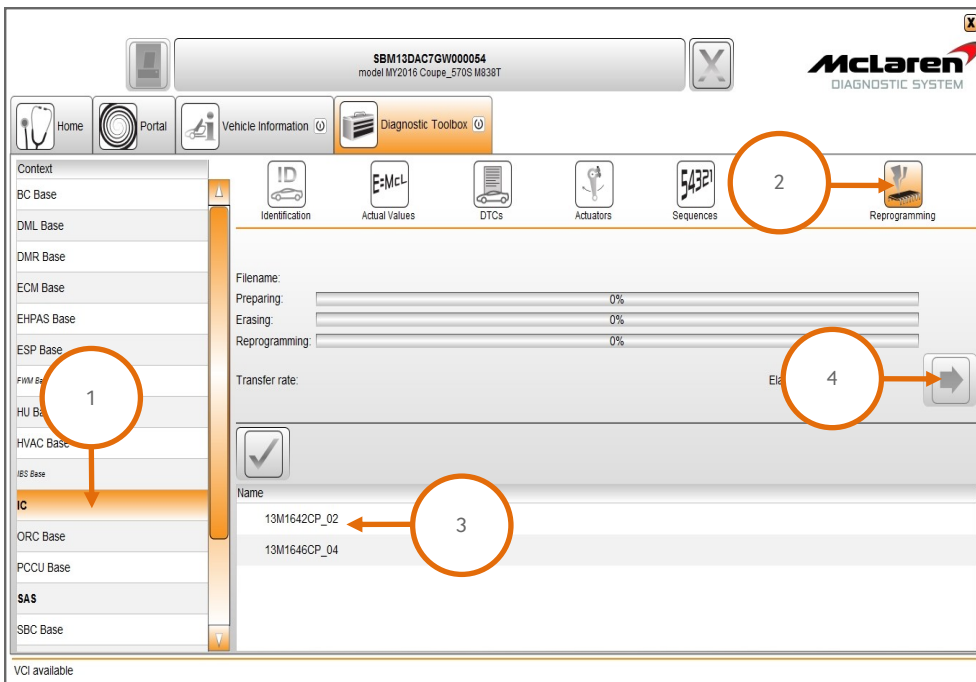
IC Software Update:

13. Select IC (1), then Reprogramming (2), select software level 13M1642CP.02 (3). Proceed to the software download by selecting the arrow button (4).

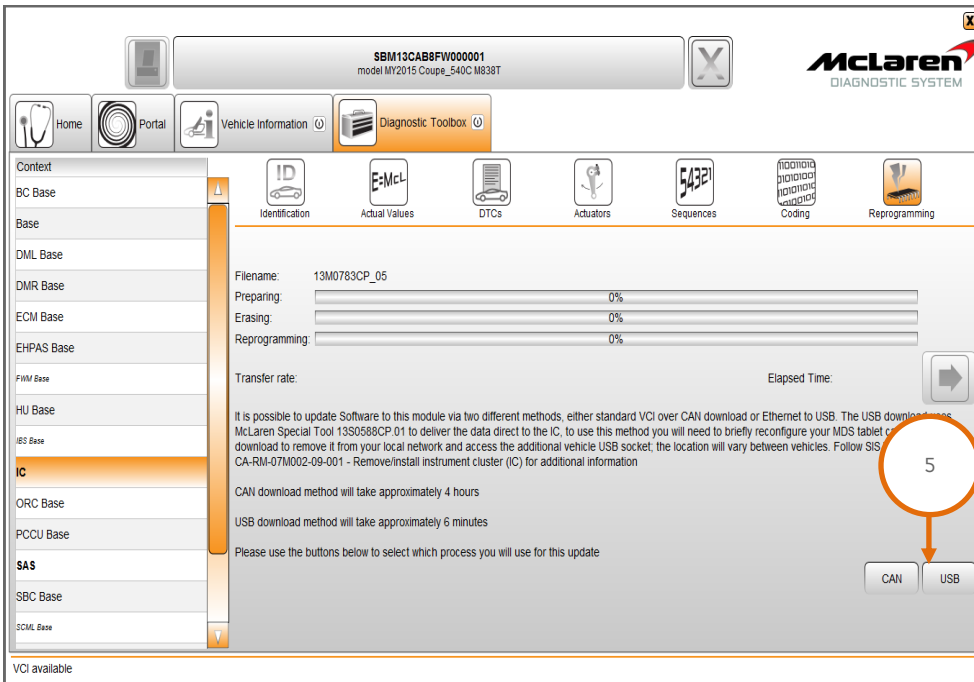
15. Select USB to reprogram the IC via USB to proceed (5).

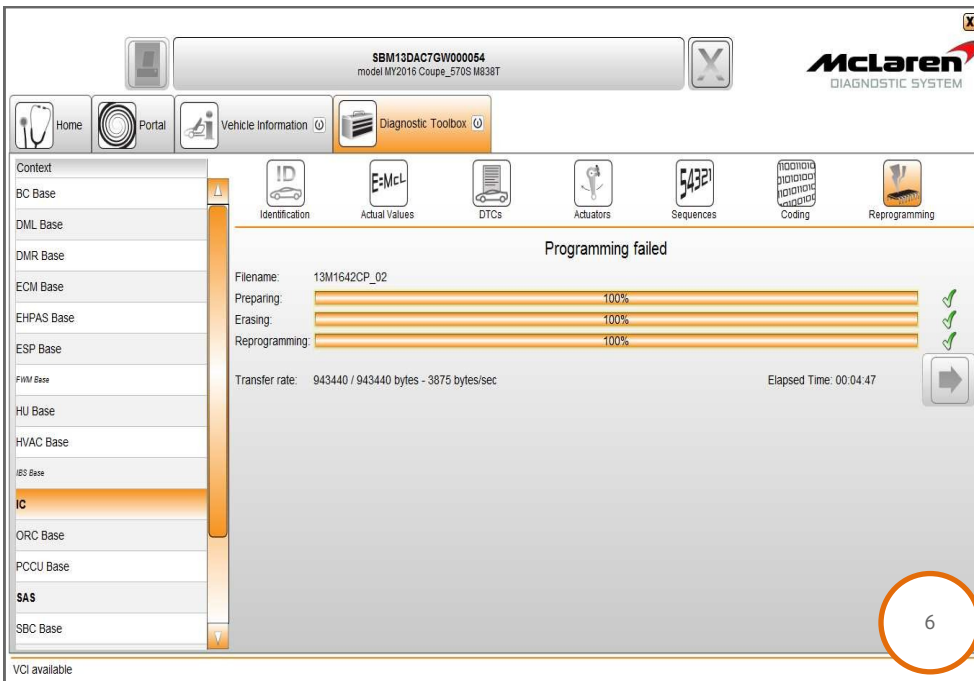
16. Once reprogramming has completed Programming failed will be displayed (6).

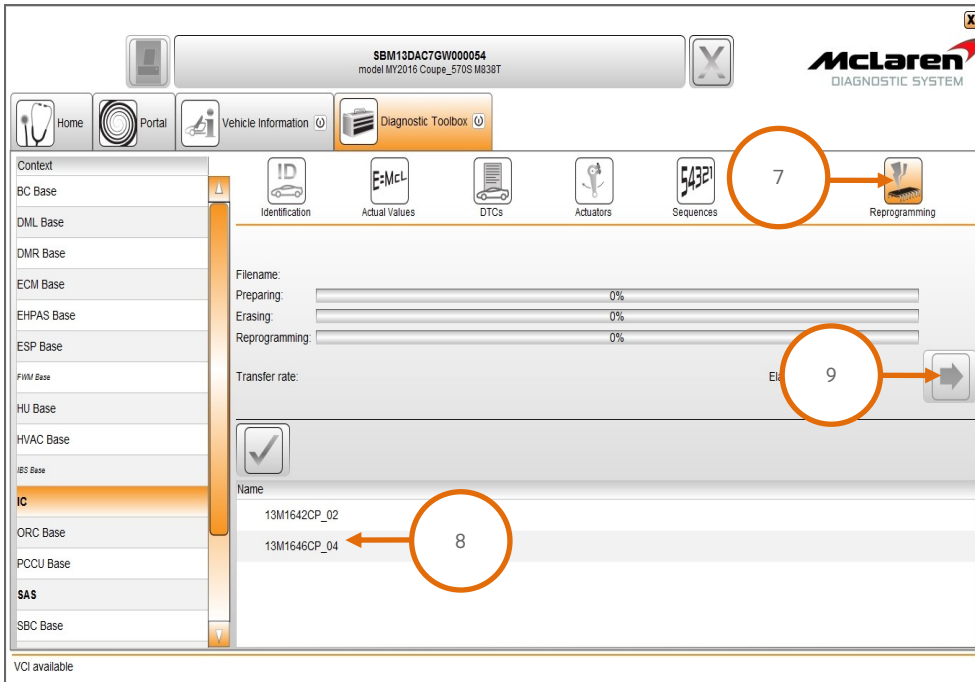
17. Select Reprogramming (7), select software level 13M1646CP.04 (8). Proceed to the software download by selecting the arrow button (9).

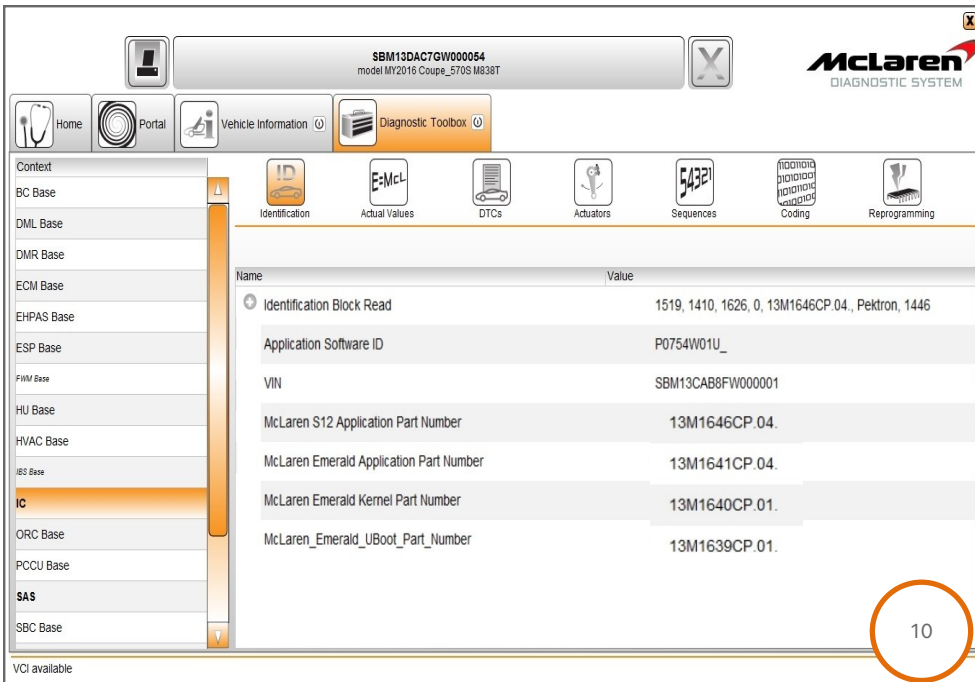
19. IC software level confirmation needs to be performed. Confirm the IC software levels are the same as the screenshot below (10). If they are the same proceed to step 20. If they are incorrect raise a technical request with IC software level information.

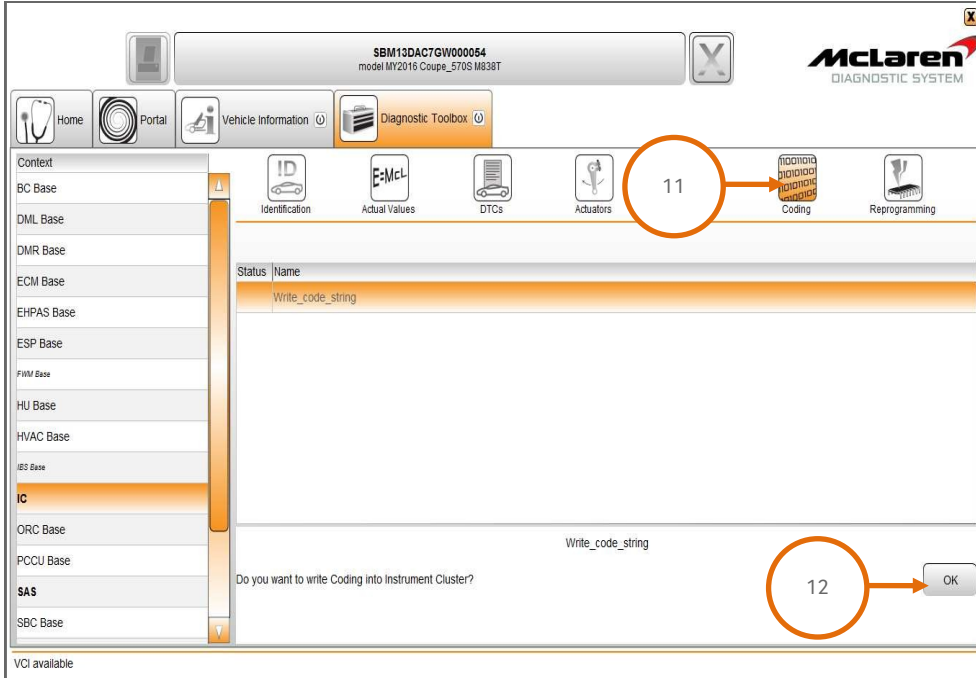
20. Once the reprogramming has been completed successfully the wireless function must be enabled once again if you are using the VCI wireless.
21. Disconnect all the cables from the vehicle and keep them in a safe place.
22. Install components in reverse order and allow vehicle to sleep for 15 minutes before proceeding to next step.
23. Select Coding (11), followed by the arrow key (12) to write the new IC coding string.

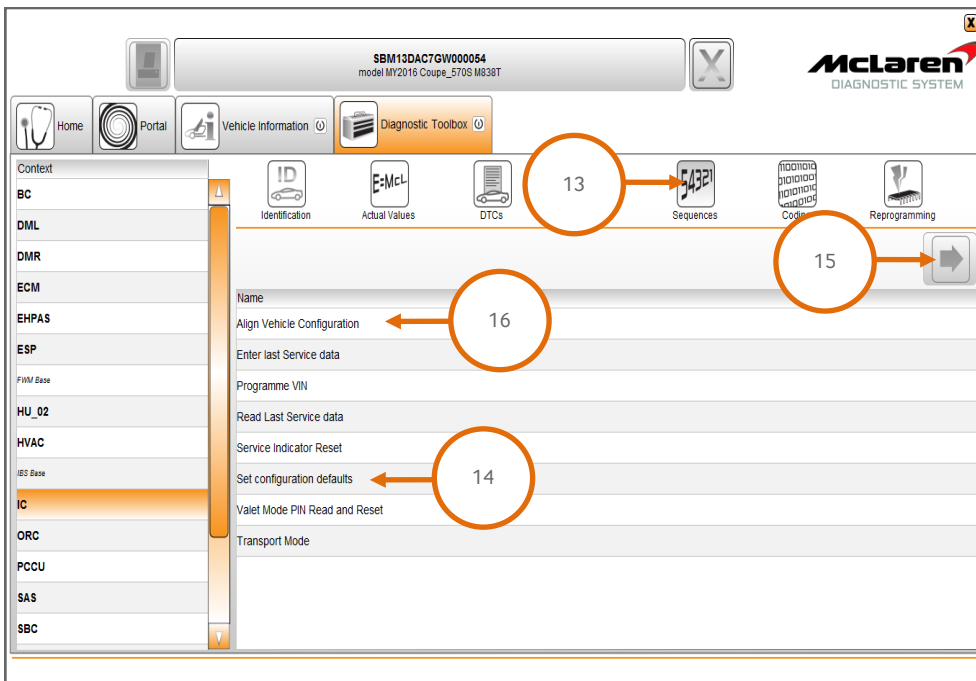
24. Select Sequences (13), select Set configuration defaults (14) then select the arrow button to proceed (15).
25. Select Align Vehicle Configuration (16), followed by the arrow key (15).

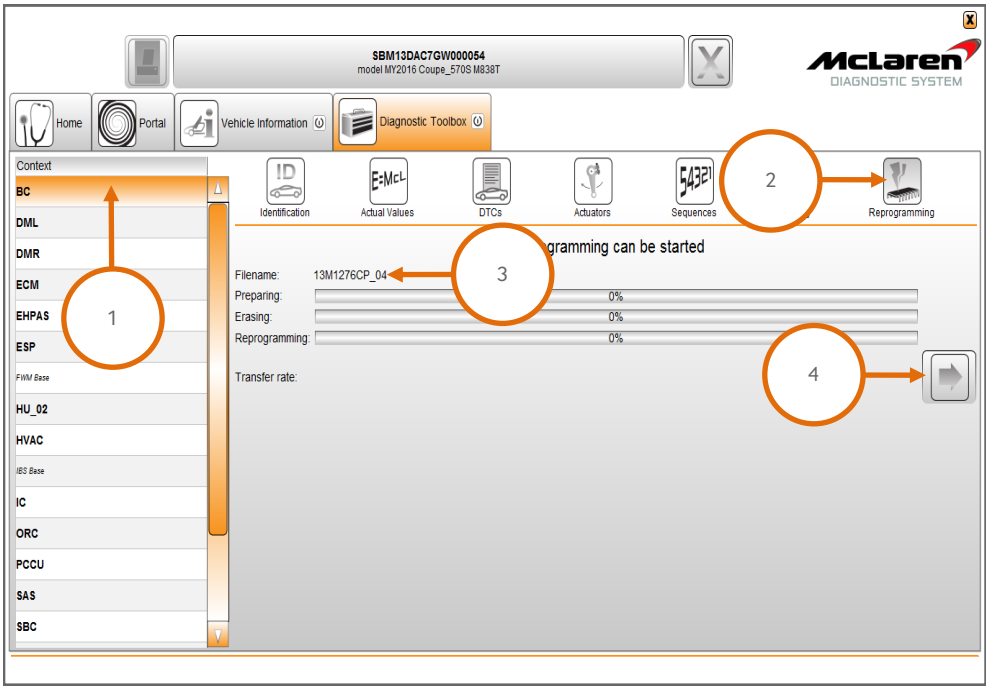
BC Software Update:

26. Select BC (1), then Reprogramming (2), the software level 13M1276CP.06 will be displayed (3). Proceed to the software download by selecting the arrow button (4).

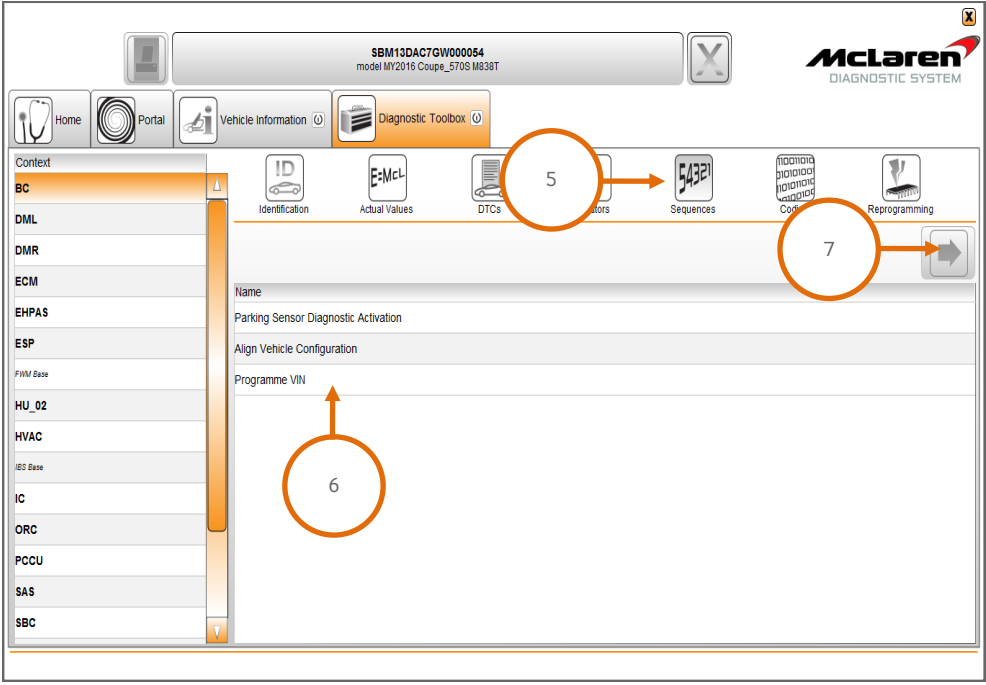
27. Select Sequences (5), then Programme VIN (6), then select the arrow button to proceed (7).

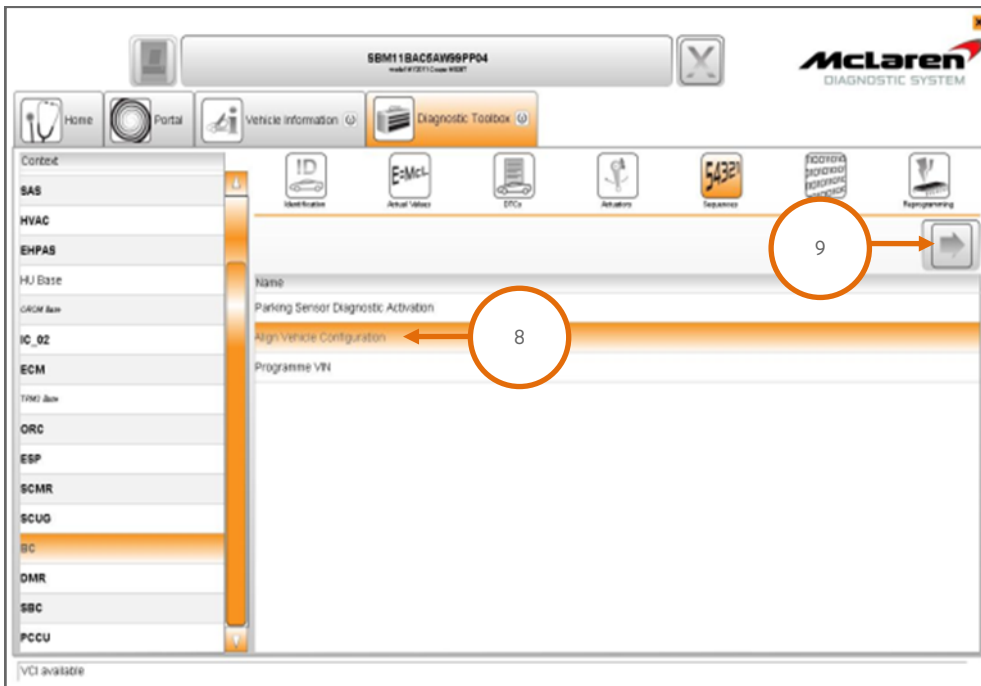
28. Select Align Vehicle Configuration (8), followed by the arrow key (9).

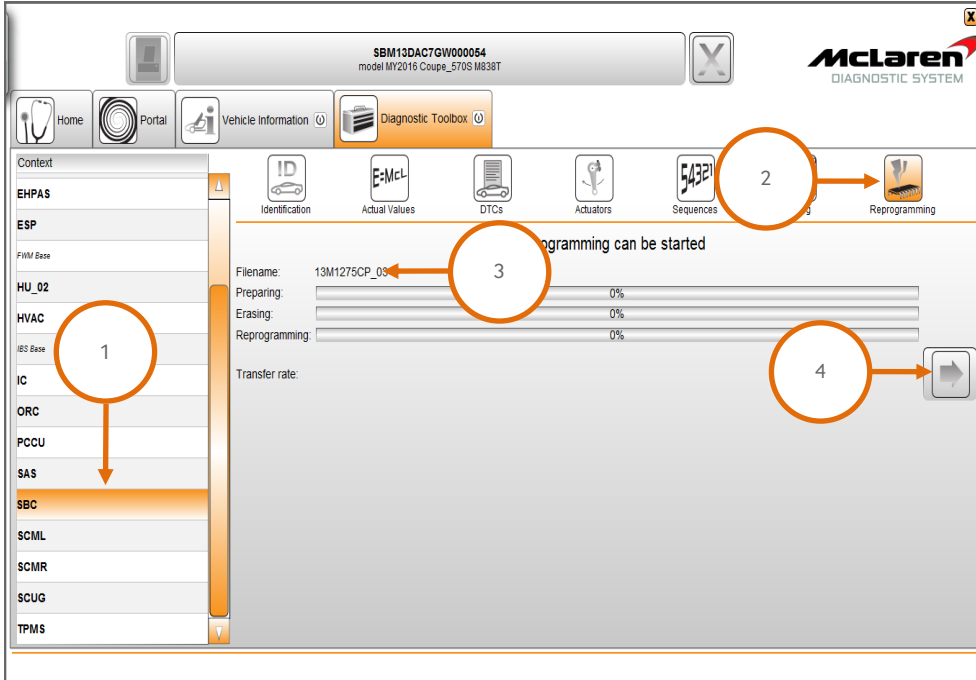
SBC Software Update:

29. Select SBC (1), then Reprogramming (2), the software level 13M1275CP.07 will be displayed (3). Proceed to the software download by selecting the arrow button (4).

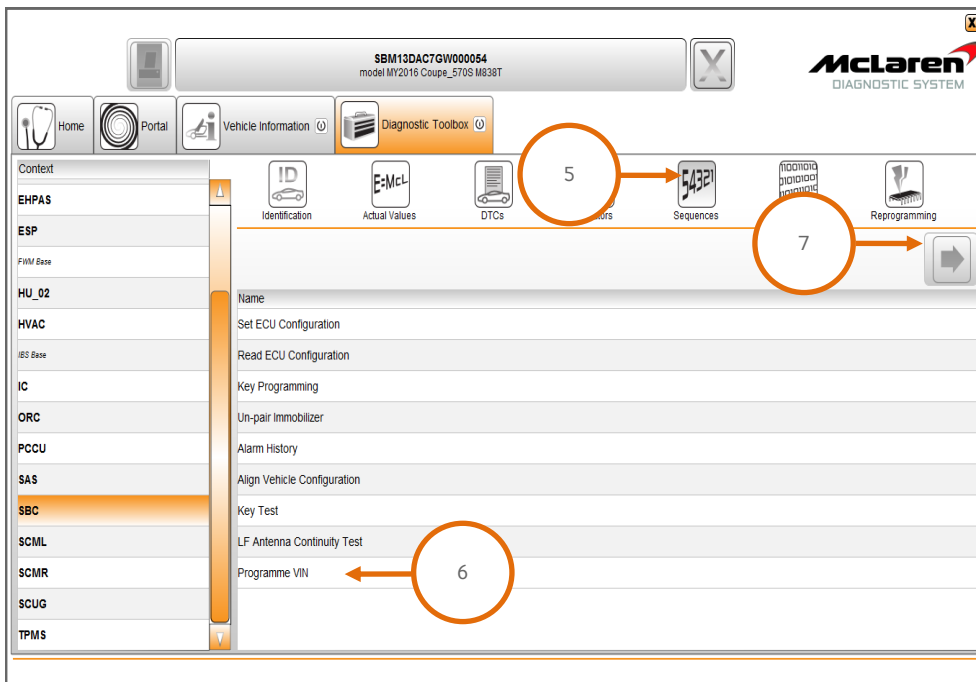
32. Select Sequences (5), then Programme VIN (6) then select the arrow button to proceed (7). The programme VIN procedure will force a sleep cycle to occur after the programming is complete.

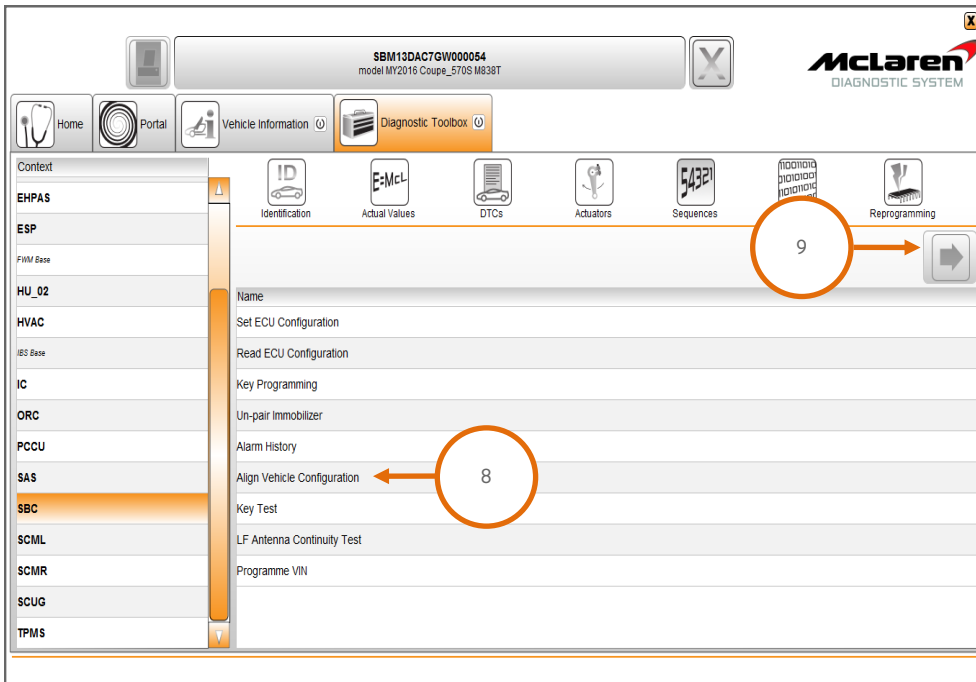
34. Select Align Vehicle Configuration (8), followed by the arrow key (9).

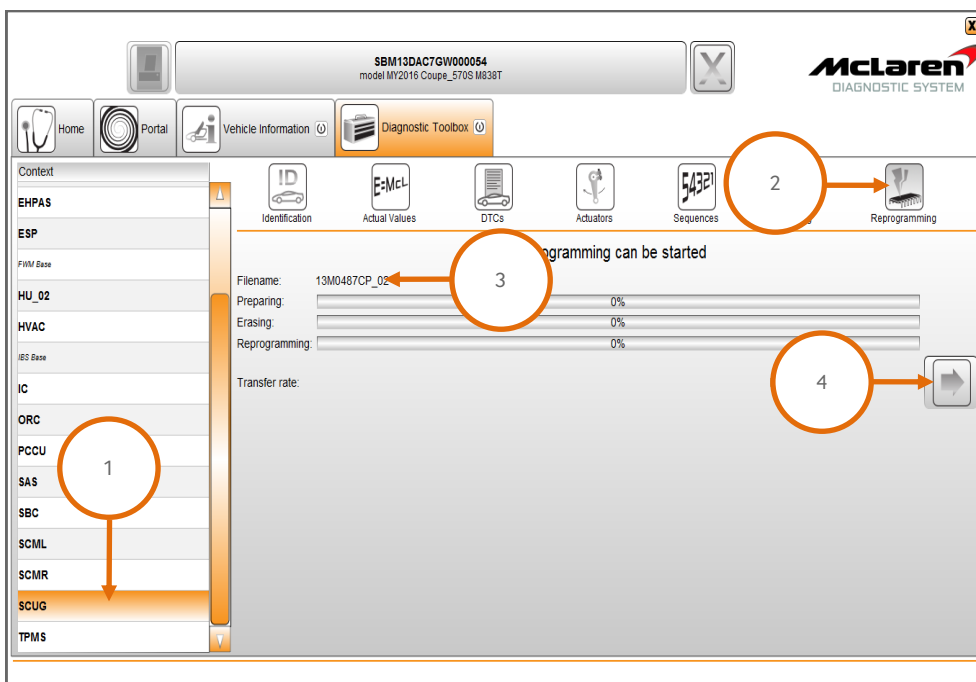
SCUG Software Update:

36. Select SCUG (1), then Reprogramming (2), the software level 13M0487CP.04 will be displayed (3). Proceed to the software download by selecting the arrow button (4).

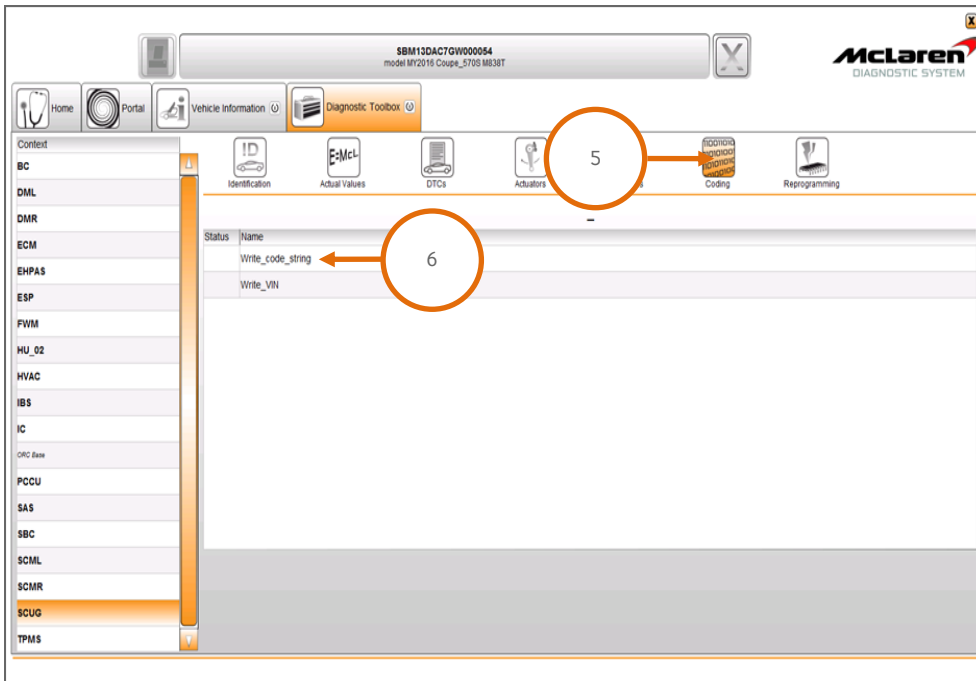
37. Select Coding (5), then Write_code_string (6), then select the arrow button to proceed.

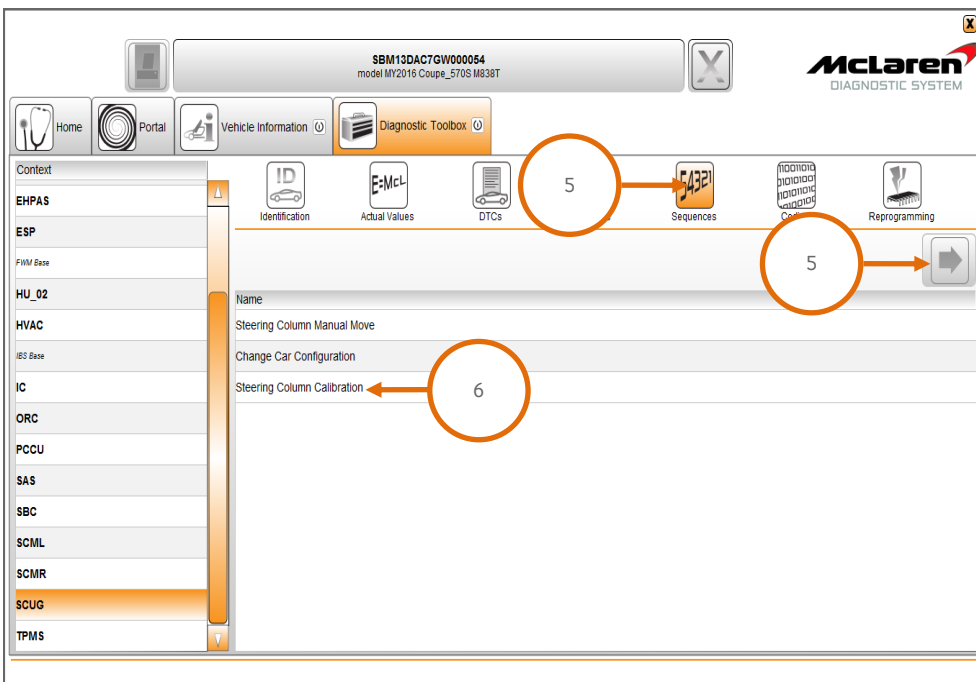
38. Select Sequences (5), select Steering Column Calibration (6) then select the arrow button to proceed (7).

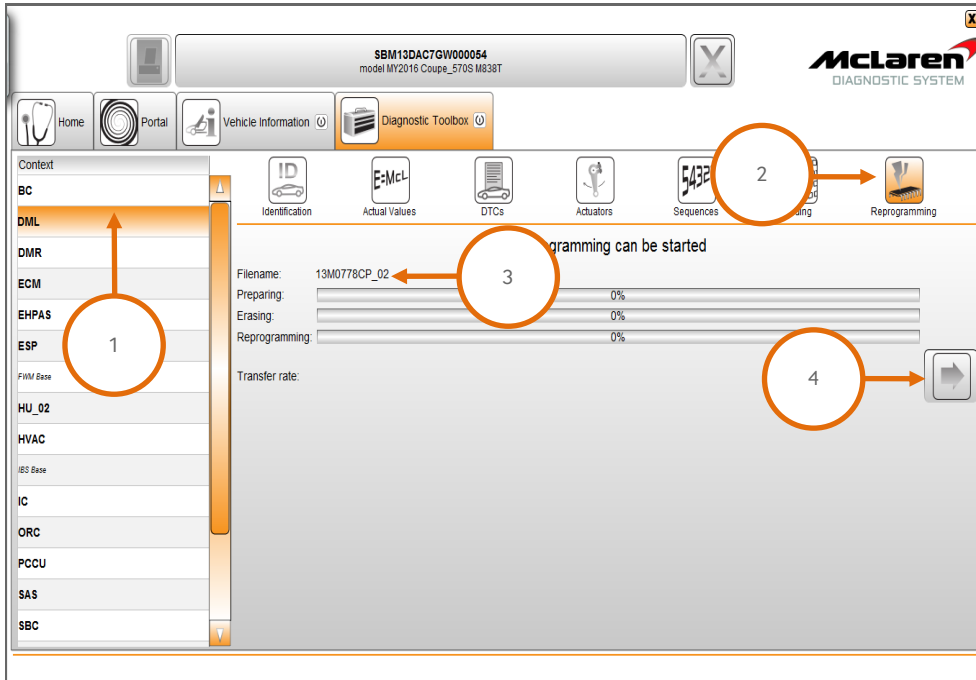
DML Software Update:

39. Select DML (1), then Reprogramming (2), the software level 13M0778CP.04 will be displayed (3). Proceed to the software download by selecting the arrow button (4).

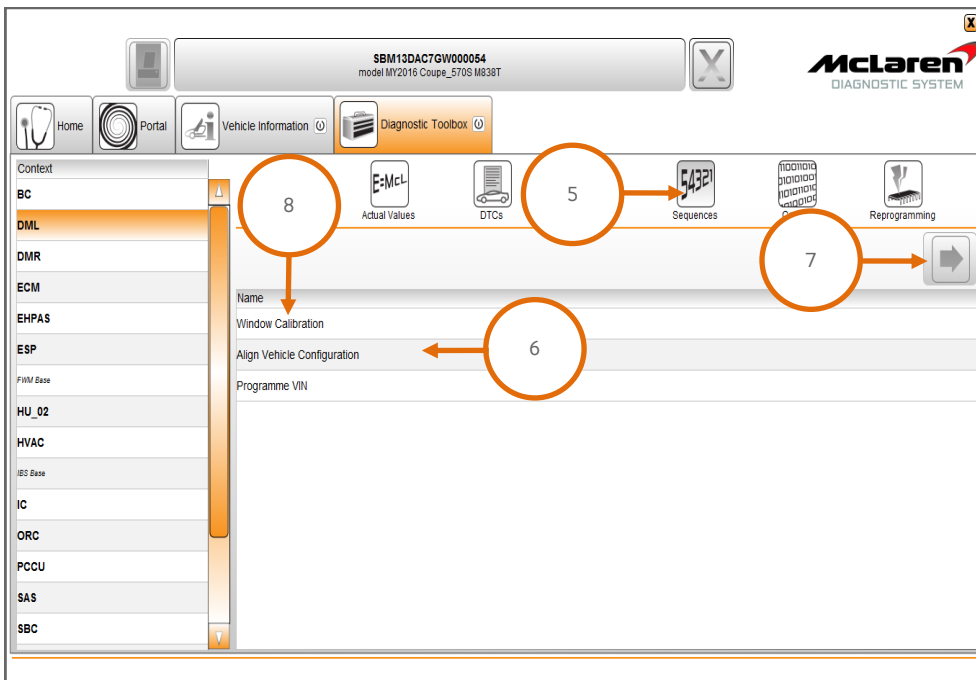
40. Select Sequences (5), select Align Vehicle Configuration (6), followed by the arrow key (7).

41. Select Window Calibration (8), followed again by the arrow key (7).

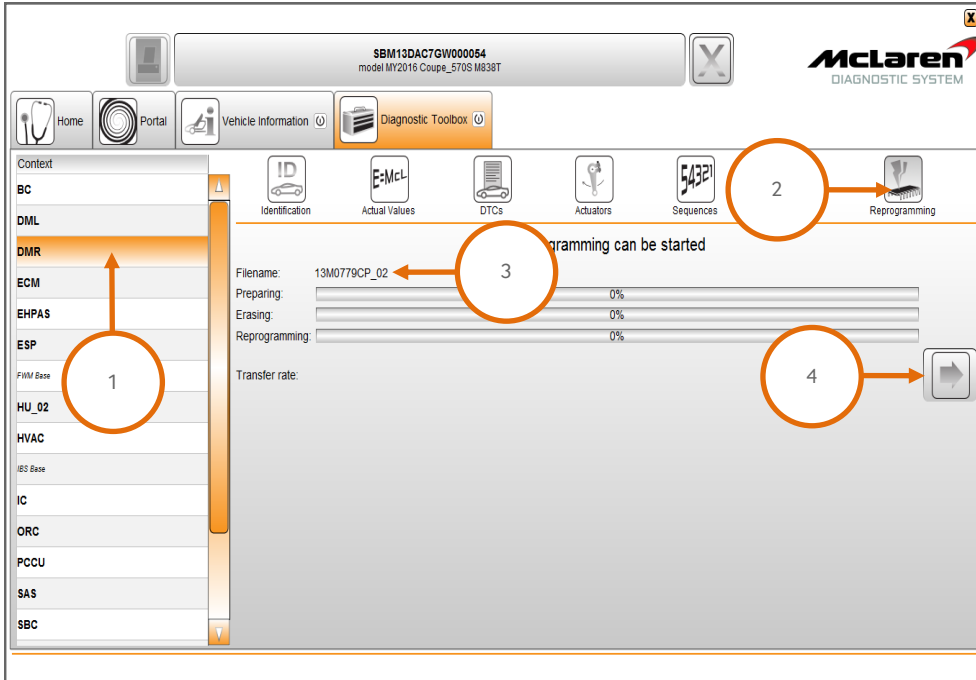
DMR Software Update:

42. Select DMR (1), then Reprogramming (2), the software level 13M0779CP.04 will be displayed (3). Proceed to the software download by selecting the arrow button (4).

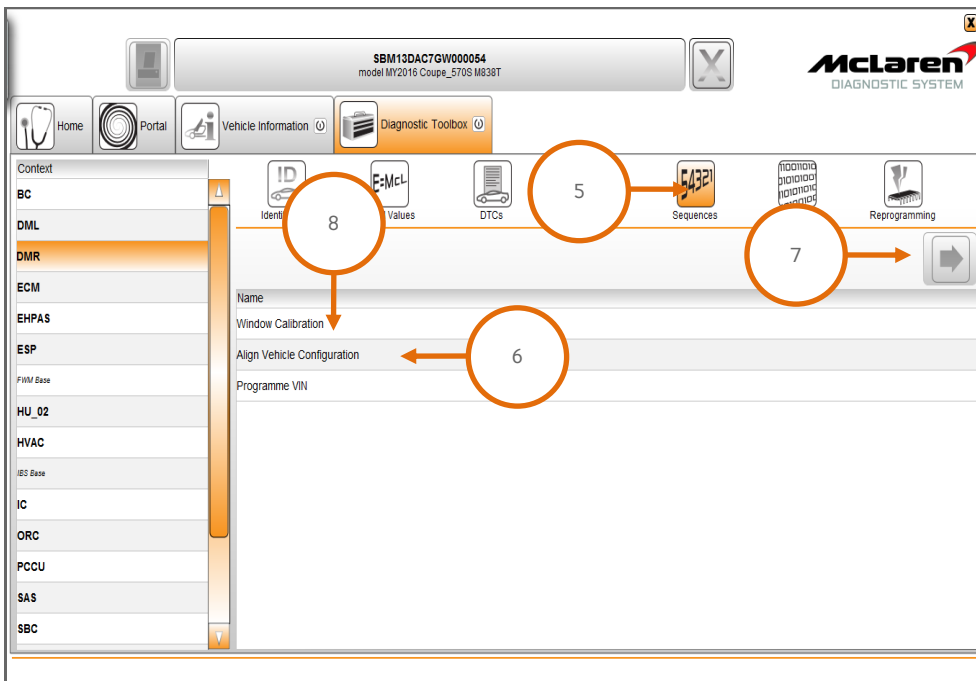
43. Select Sequences (5), select Align Vehicle Configuration (6), followed by the arrow key (7).
44. Select Window Calibration (8), followed again by the arrow key (7).

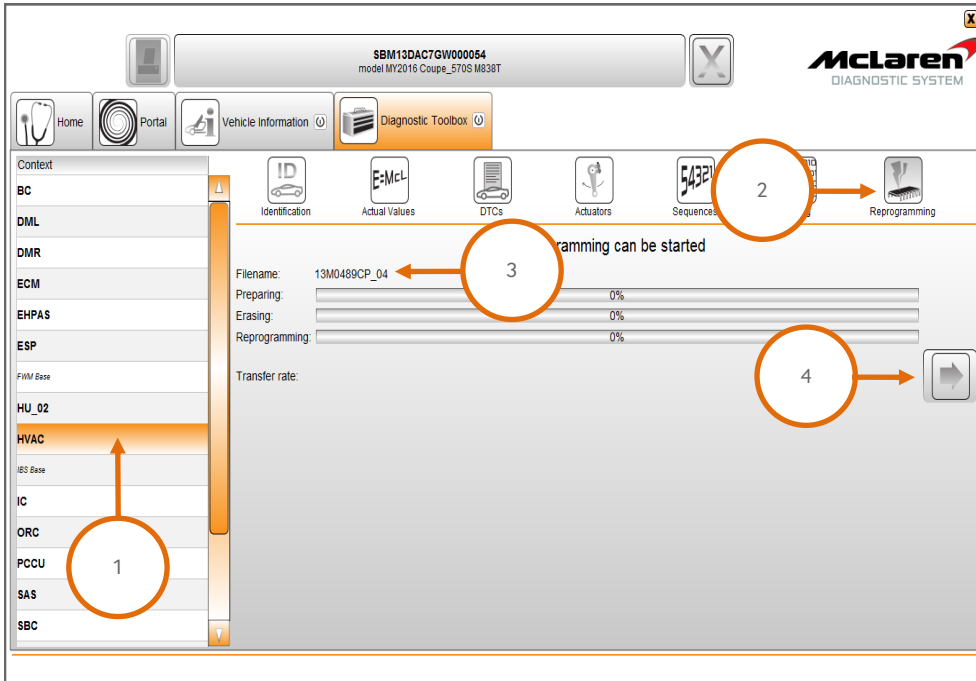
HVAC Software Update:

45. Select HVAC (1) then Reprogramming (2), the software level 13M0489CP.08 will be displayed (3). Proceed to the software download by selecting the arrow button (4).

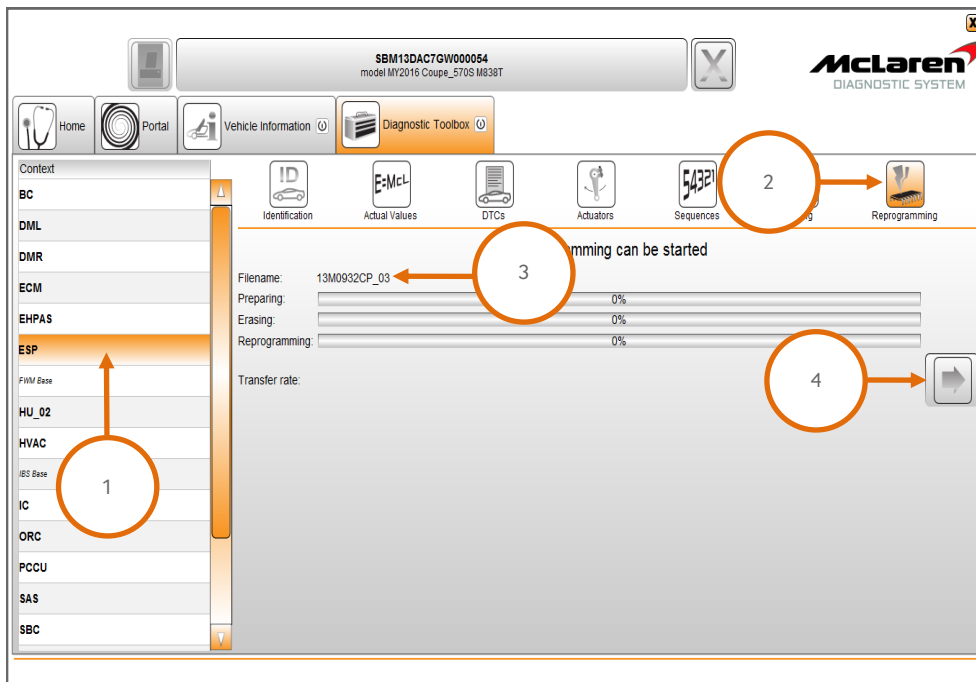
ESP Software Update:

46. Select ESP (1), then Reprogramming (2), the software level 13M0932CP.08 will be displayed (3). Proceed to the software download by selecting the arrow button (4).

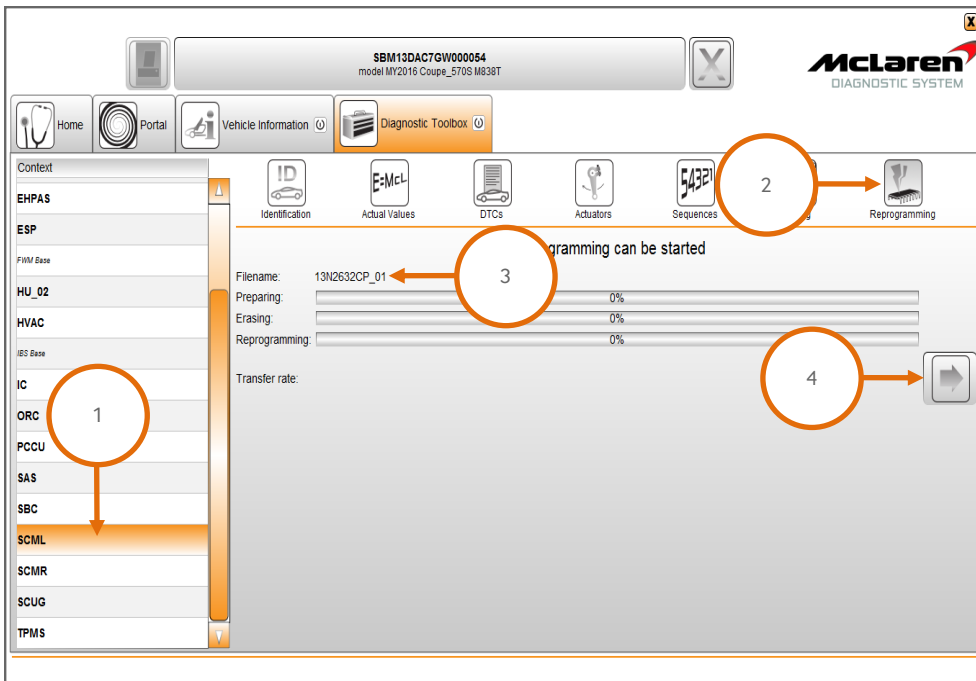
SCML Software Update:

47. Select SCML (1), then Reprogramming (2), the software level 13N2632CP.10 will be displayed (3). Proceed to the software download by selecting the arrow button (4).

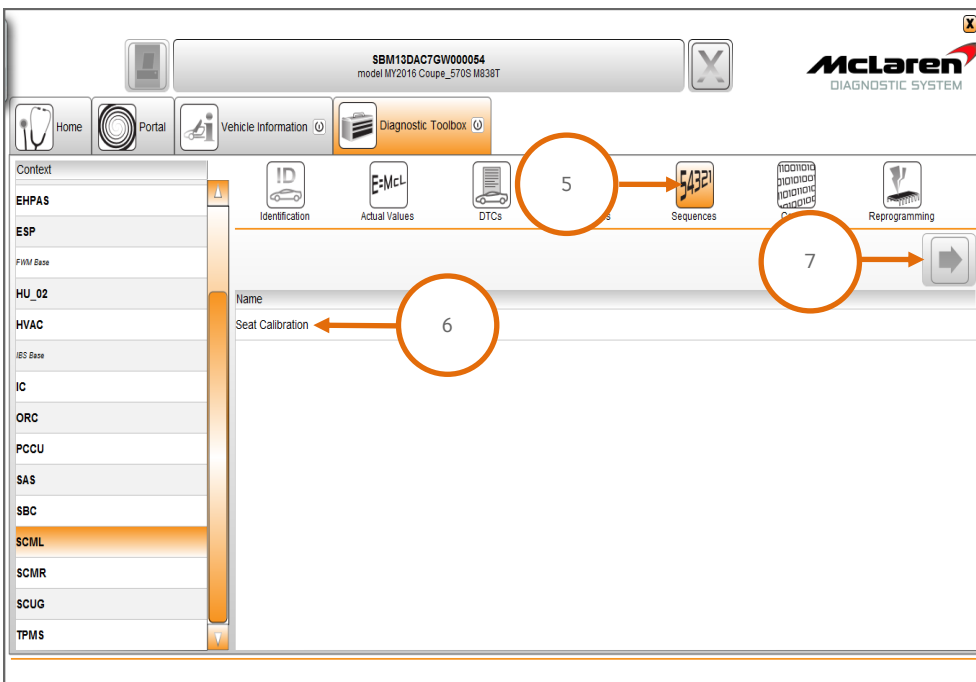
48. Select Sequences (5), select Seat Calibration (6), followed by the arrow key (7).

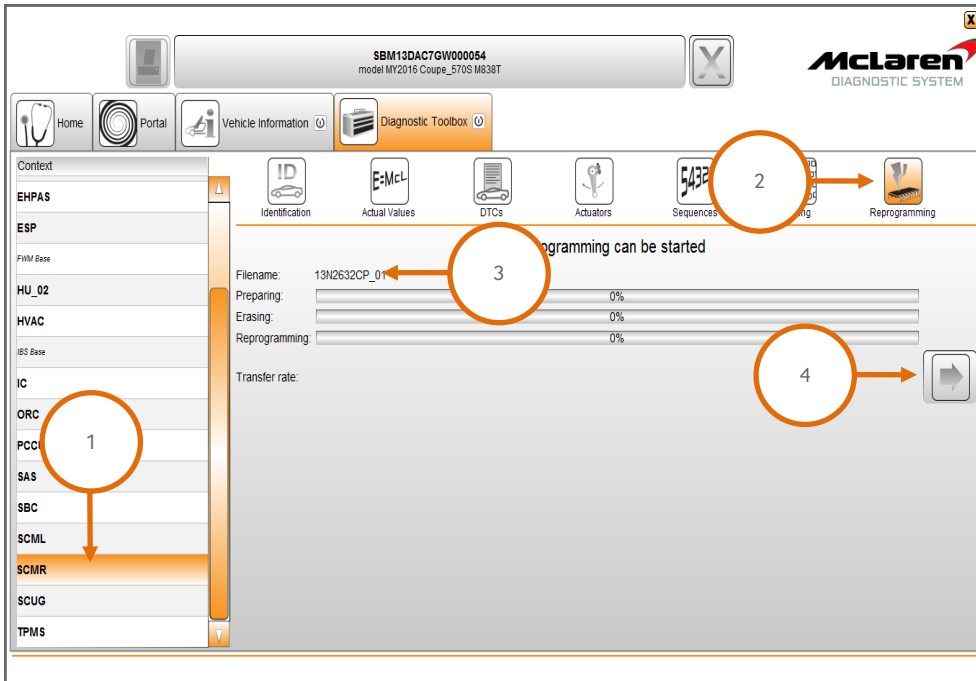
SCMR Software Update:

49. Select SCMR (1), then Reprogramming (2), the software level 13N2632CP.10 will be displayed (3). Proceed to the software download by selecting the arrow button (4).

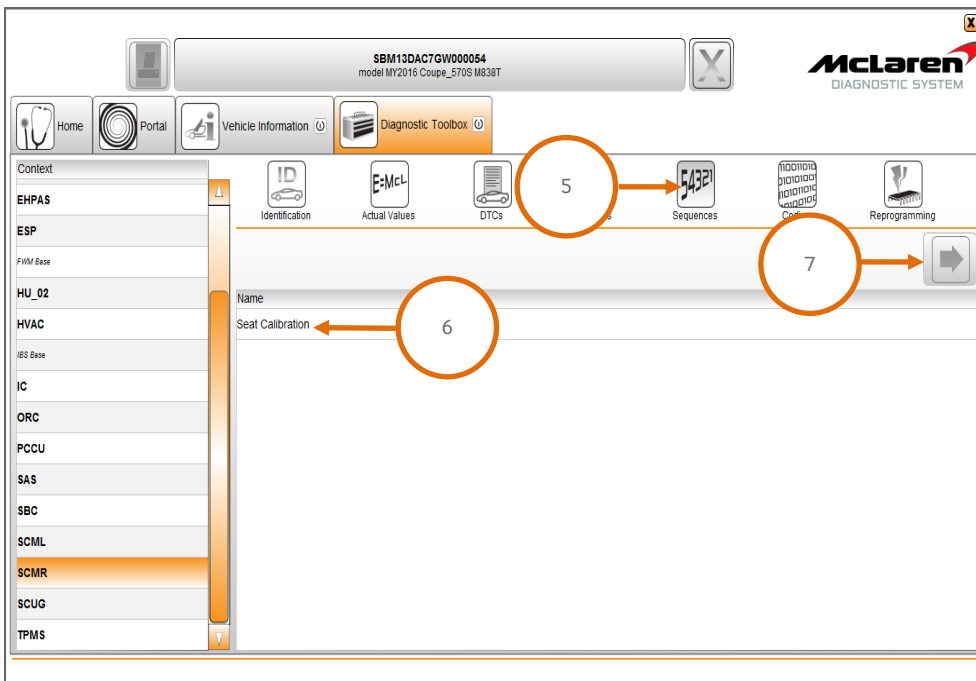
50. Select Sequences (5), select Seat Calibration (6), followed by the arrow key (7).

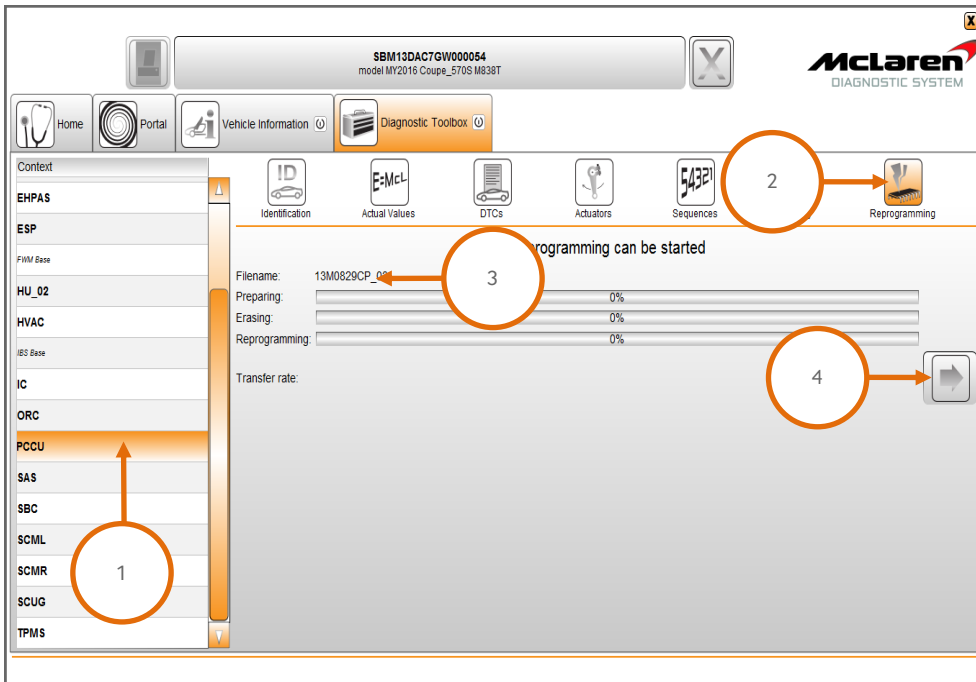
PCCU Software Update:

53. Select PCCU (1), then Reprogramming (2), the software level 13M0829CP.07 will be displayed (3). Proceed to the software download by selecting the arrow button (4).

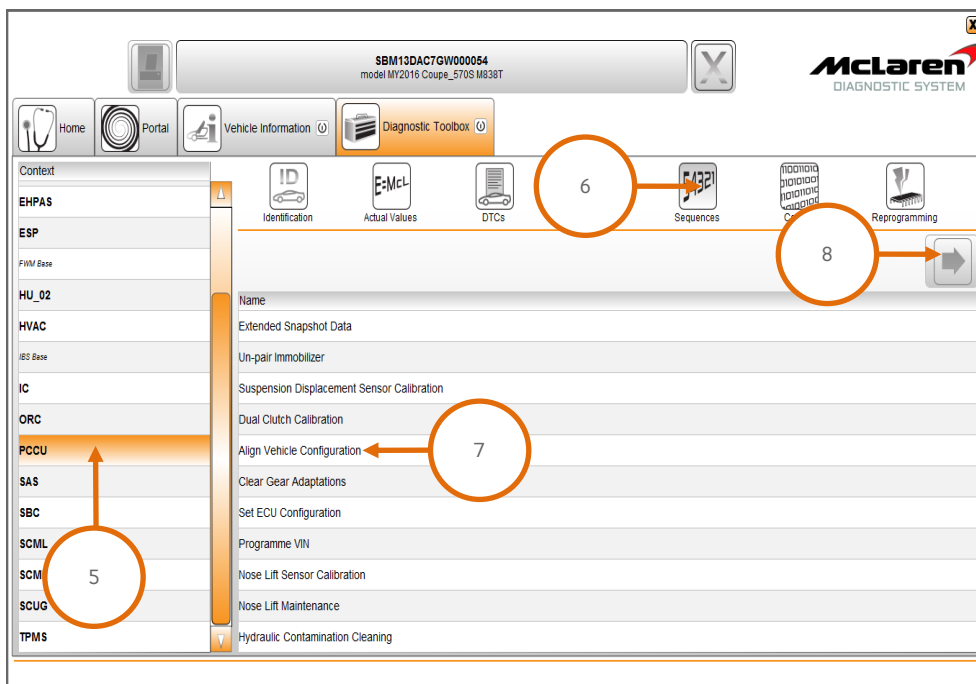
55. Select PCCU (5), then Sequences (6), select Align Vehicle Configuration (7), followed by the arrow key (8).
