SERVICE CAMPAIGN BULLETIN

TITLE:	Vehicle Software Update to Platform 4.2
CAMPAIGN REFERENCE	03V
DOCUMENT NUMBER:	13 M 001
AFFECTED VEHICLES:	Sports Series
SITUATION:	<p>Quality Engineering at McLaren Automotive have released a new software platform for the Sports Series</p> <p>The customer benefits of this software are:</p> <ul style="list-style-type: none">•Improve functionality of nose lift operation•Improve HVAC temperature control•Improve AIS IRIS to prevent system freeze•Introduction of Gen2 12v battery software
PROCEDURE:	<p>It is necessary to update the software and replace the TPMS module on all vehicles within your Aftersales car parc, both when carrying out Pre-Delivery Inspections (PDI) and at the next service centre visit.</p>

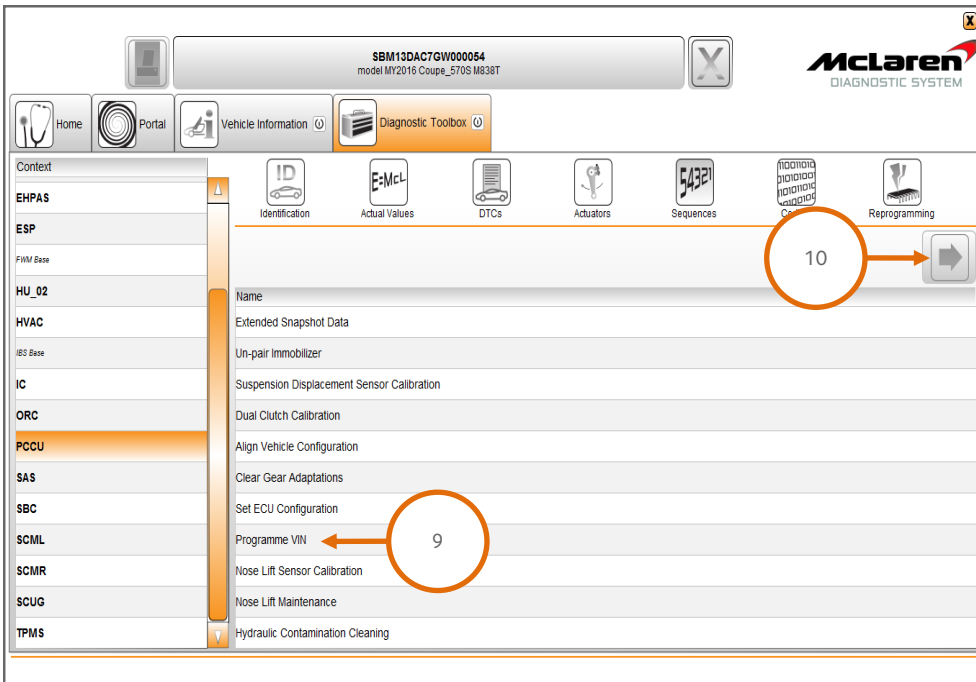
56. Select Programme VIN (9), followed by the arrow key (10).

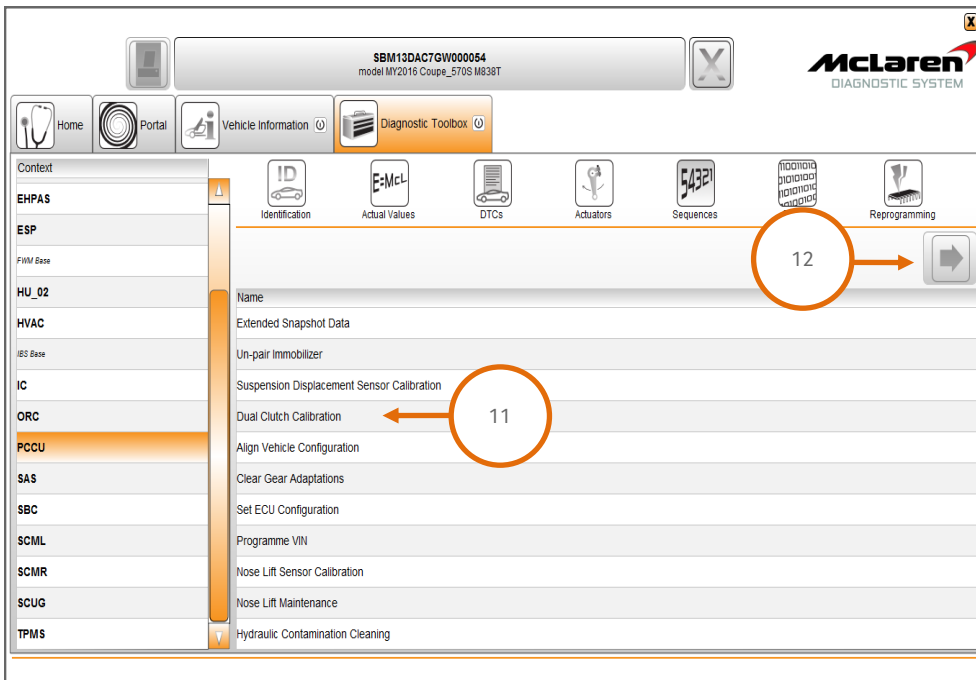
57. Select Dual Clutch Calibration (11), followed by the arrow key (12) and the clutch calibration will be performed.

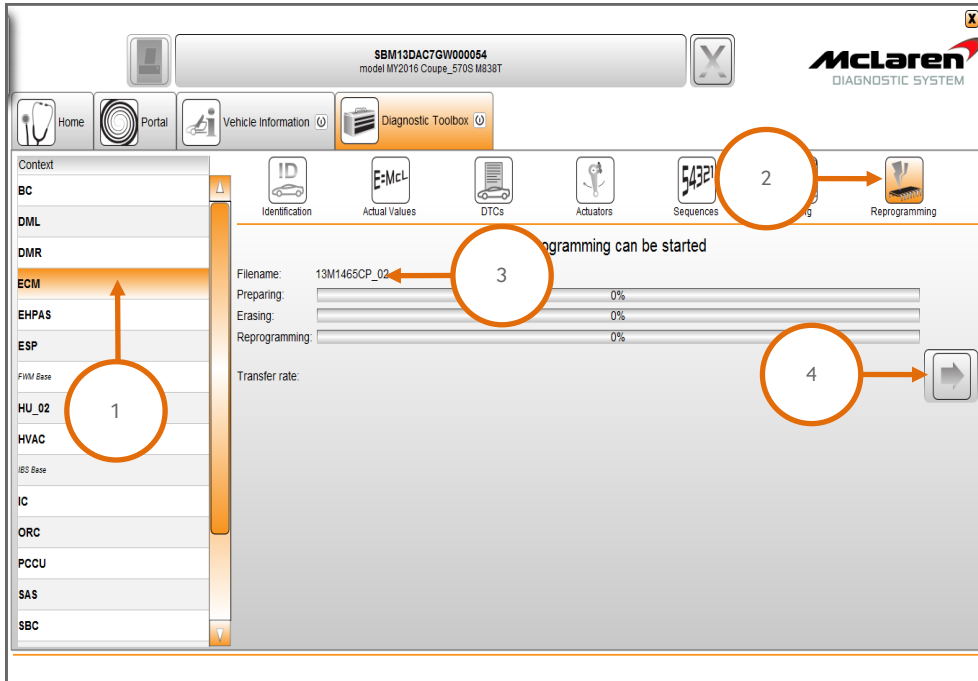
ECM Software Update:

59. Select ECM (1), then Reprogramming (2), the software variant applicable to your market will be displayed (3). Proceed to the software download by selecting the arrow button (4).

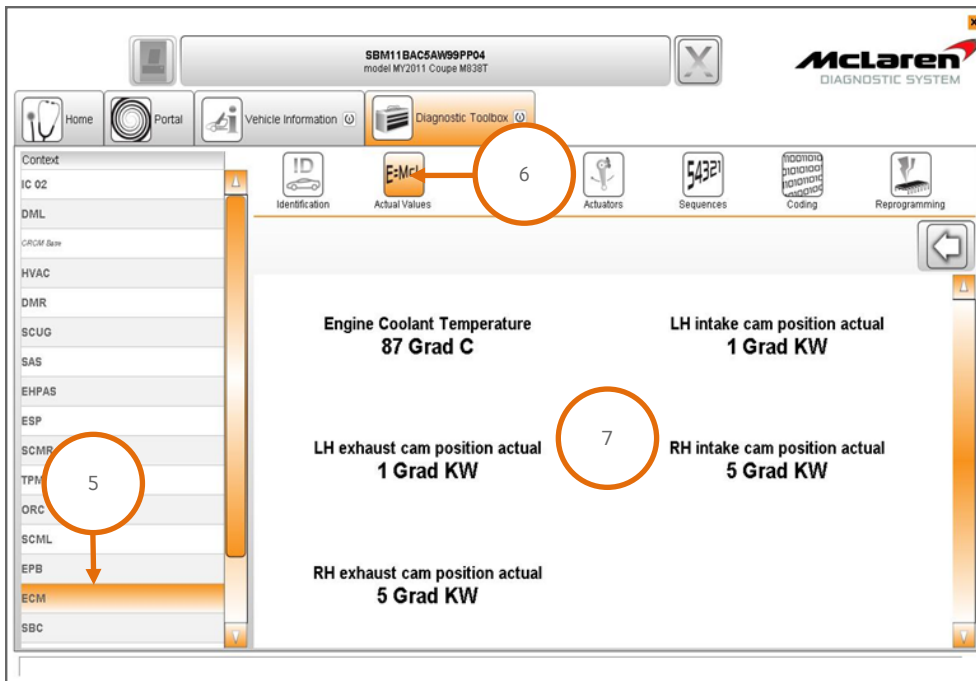
62. Select ECM (5), then Actual Values (6), select the following values as per the screenshot below (7), then select the play button to access the required data screen.

63. The inlet camshaft values should be between 9 and 12 and exhaust values should be between -9 and -12 both values will fluctuate slightly. If all values are correct no further action is required proceed to step 65. If any values are incorrect proceed to step 64 to carry out the camshaft adaption.

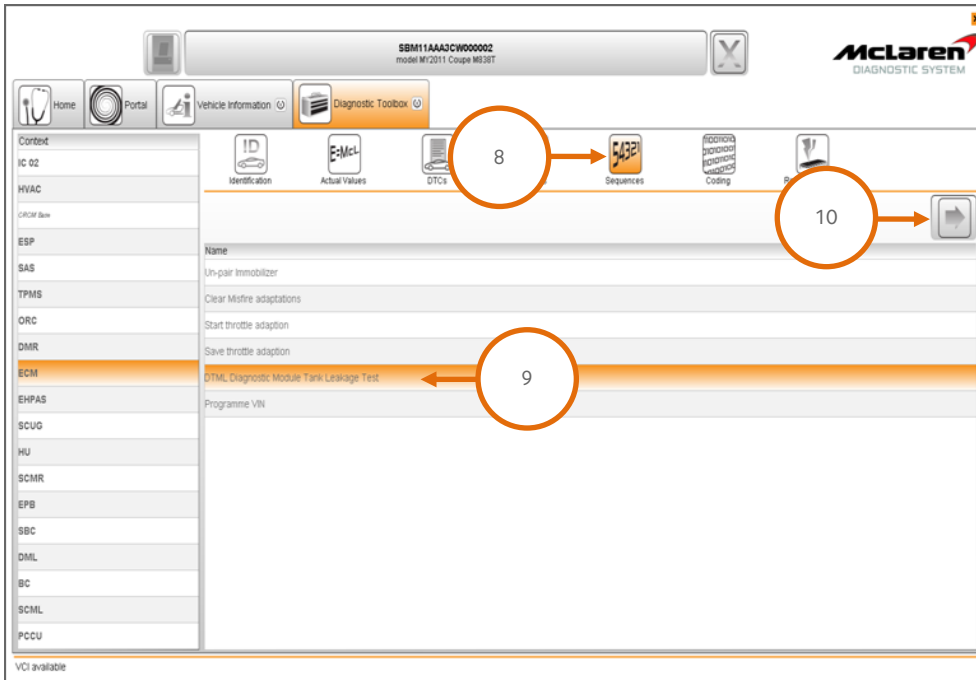
65. Select Sequences (8), then DMTL Diagnostic Module Leakage Test (9), followed by the arrow button to proceed (10).

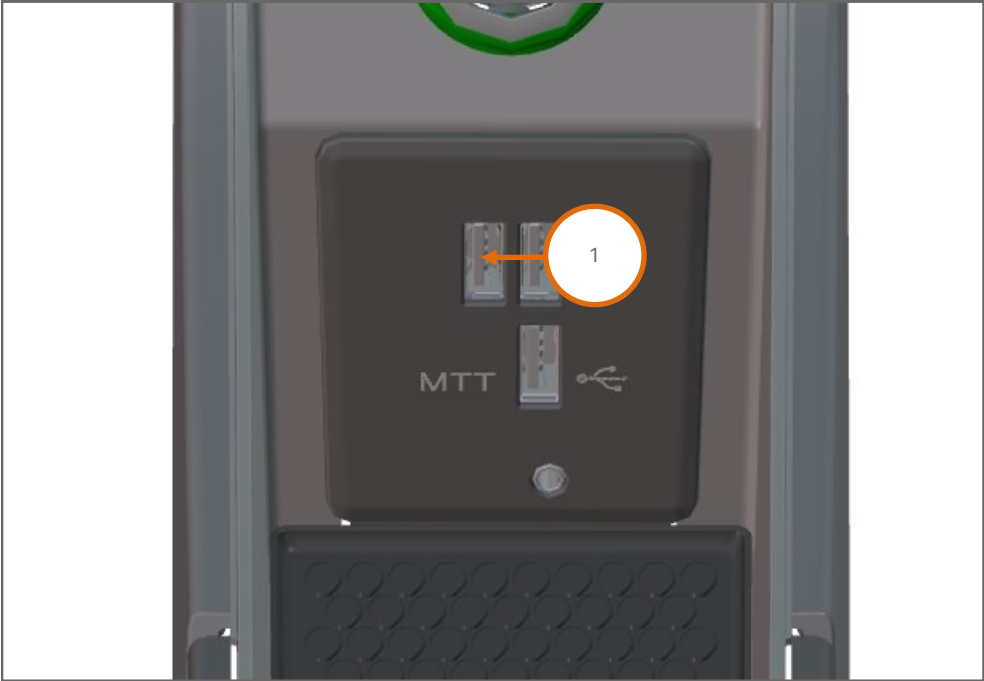
- 68. Switch the ignition ON to ignition state 5 and start the engine.
- 69. Make a note of the options displayed on the Home Screen as this information will be required to configure the head unit.
- 70. Insert the USB drive with the application software into the USB socket (1).

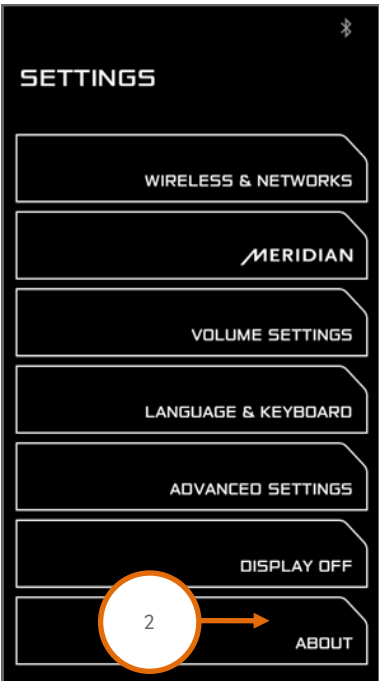
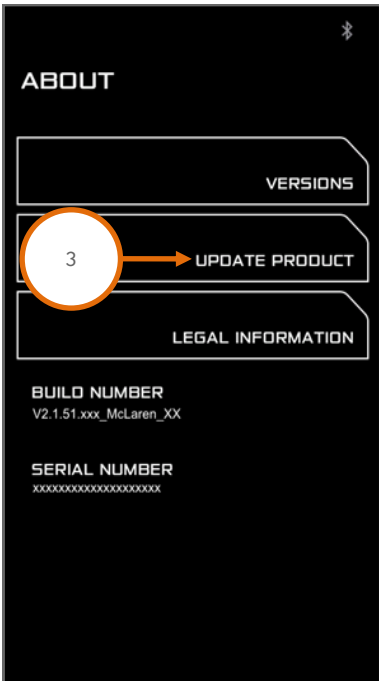
- 71. Once the USB has been inserted, the system should provide a message stating a USB device has been detected.
- 72. Press the Settings hard button on the IRIS console.
- 73. Select About (2) and then Update Product (3).

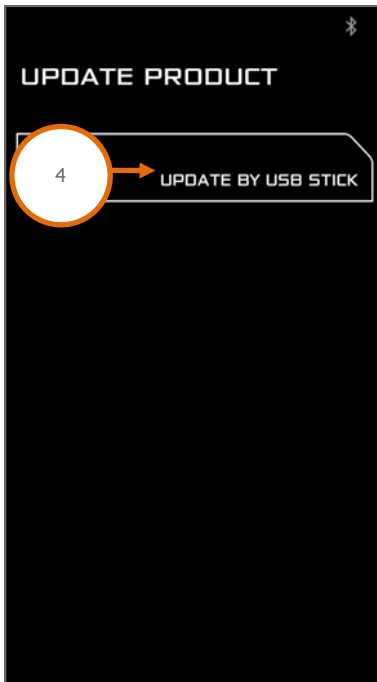
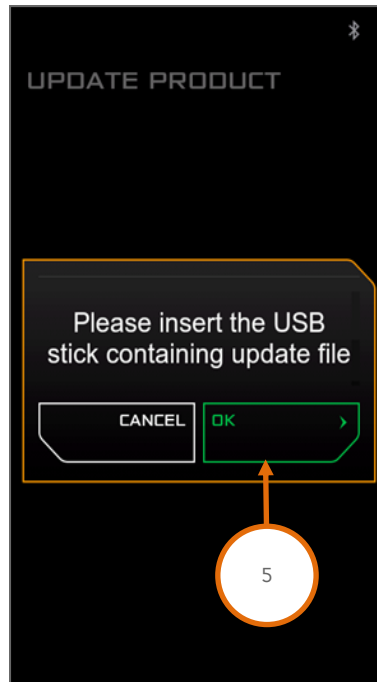
74. On the following screen select Update by USB Stick (4). A pop up message will be displayed. Press OK (5) to start the loading operation.

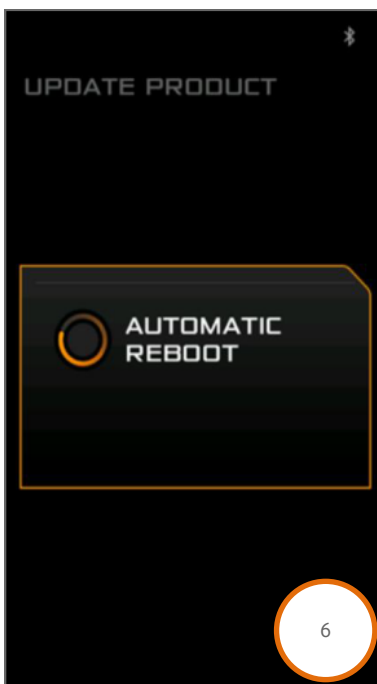
75. The following screen will be displayed (6) and the system will reboot.

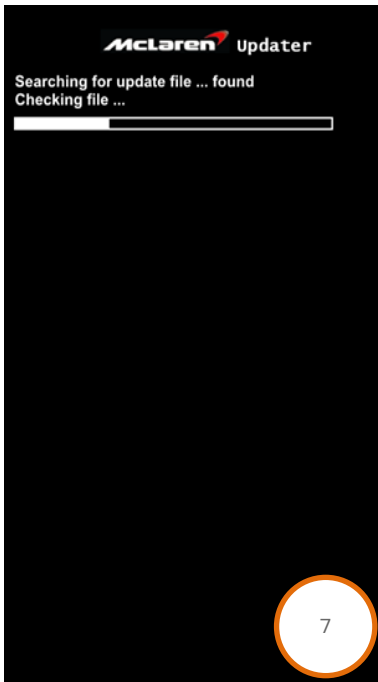
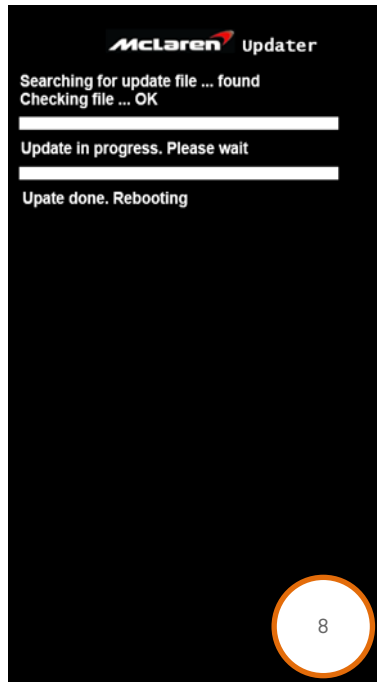
76. After the system has rebooted it will search for and check the update file (7). Once the installation has finished the following screen will be displayed (8) and the system will reboot.

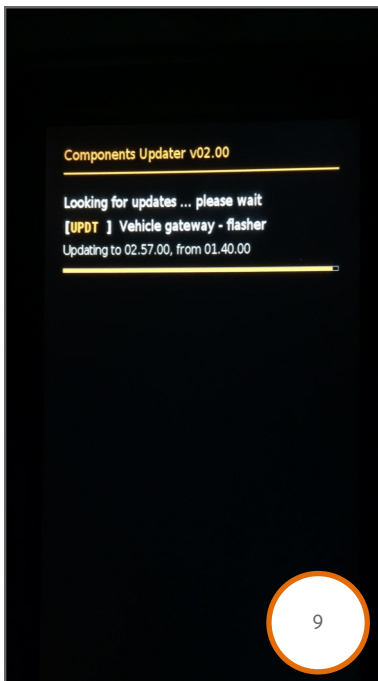
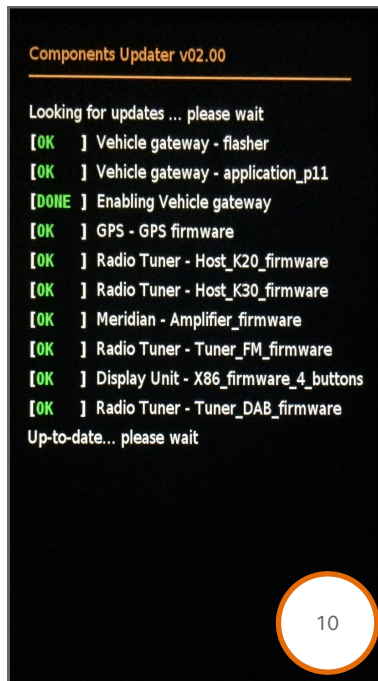
77. Following the reboot the system will start to update the individual system components (9), (10). During the update the system may reboot multiple times. This is normal, **do not attempt a manual reset**.

Care Point: In case the system should get stuck on the update screen if one of the component updates has failed, press and hold the home button for 45s to force the system to reboot.

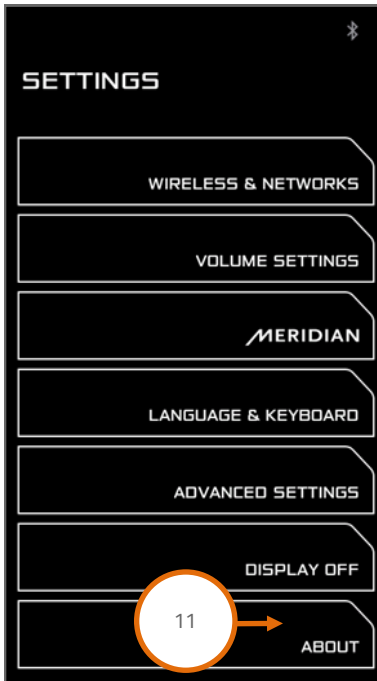
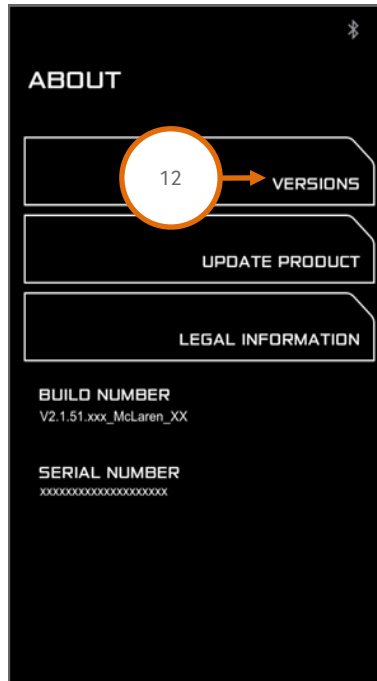
79. Select About (11) and then select Versions (12).

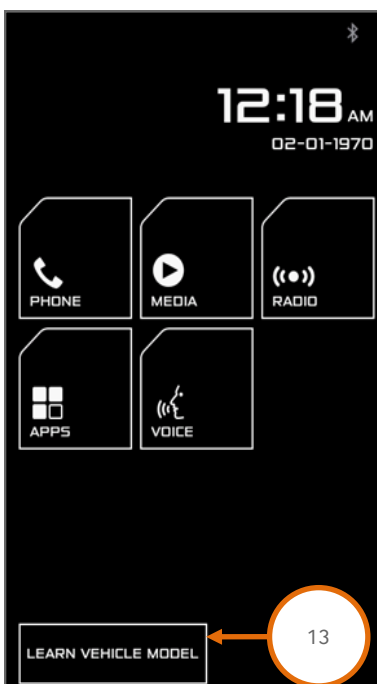
82. Select Learn Vehicle Model (13) from the Home Screen. The system will perform a configuration update and reboot. Wait until the system has fully booted to the Home screen before proceeding to the next step.

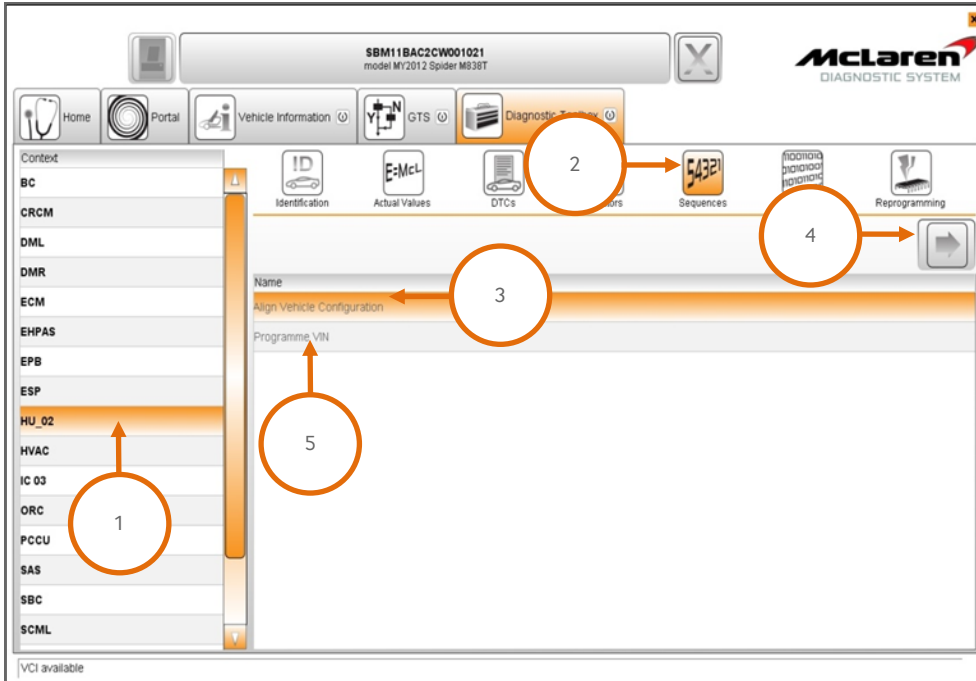
83. Select HU_02 (1), then select Sequences (2), select Align Vehicle Configuration (3), followed by the arrow key (4).

84. Select Programme VIN (5), followed by the arrow key (4).

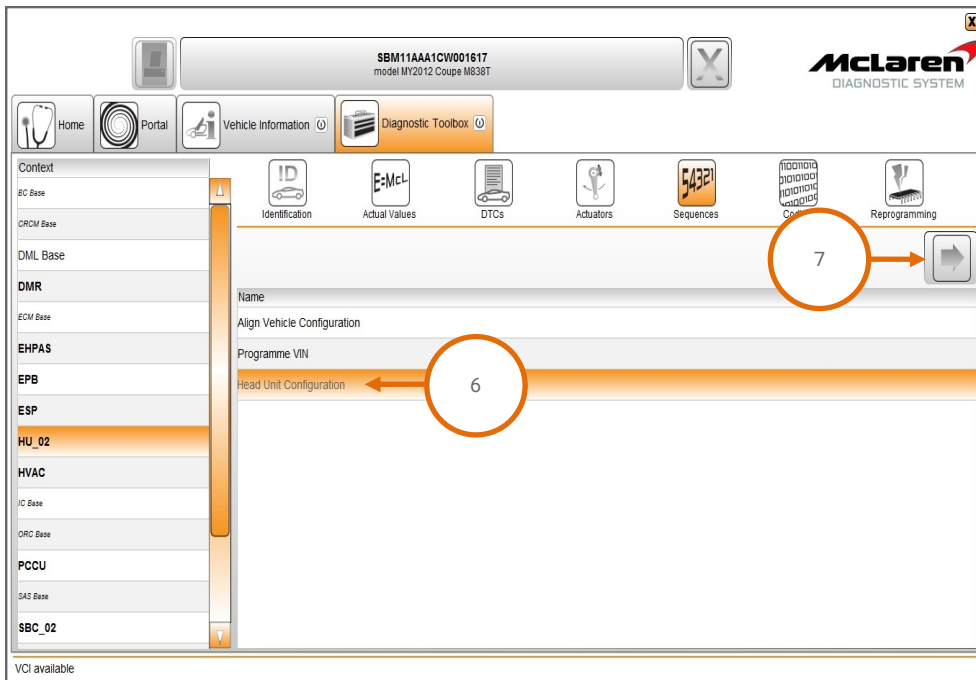
85. Select Head Unit Configuration (6), followed by the arrow key (7).

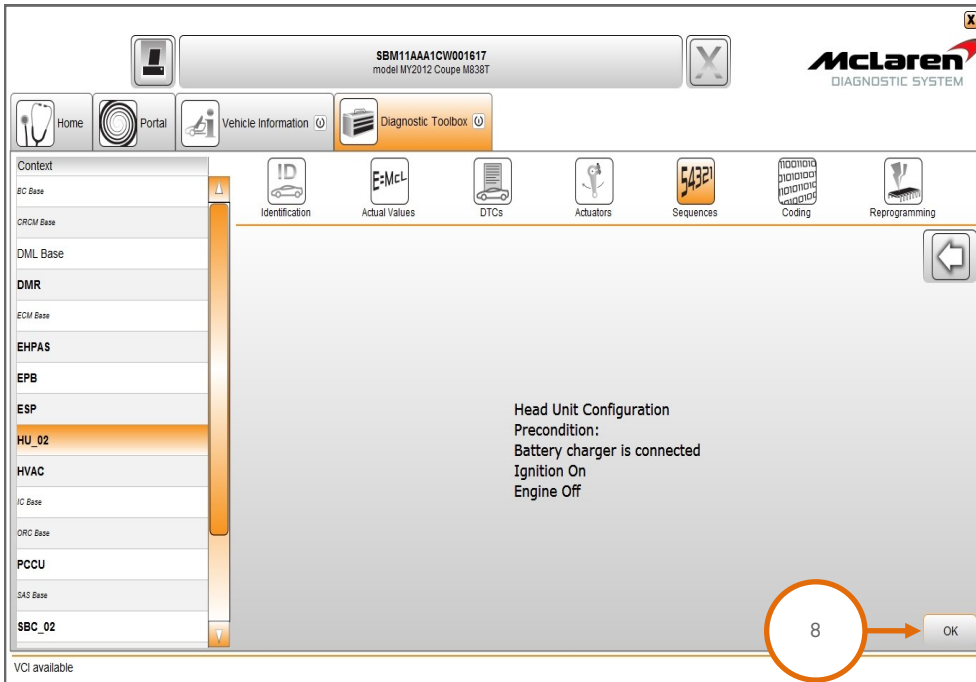
86. The following screen will appear, select OK (8).

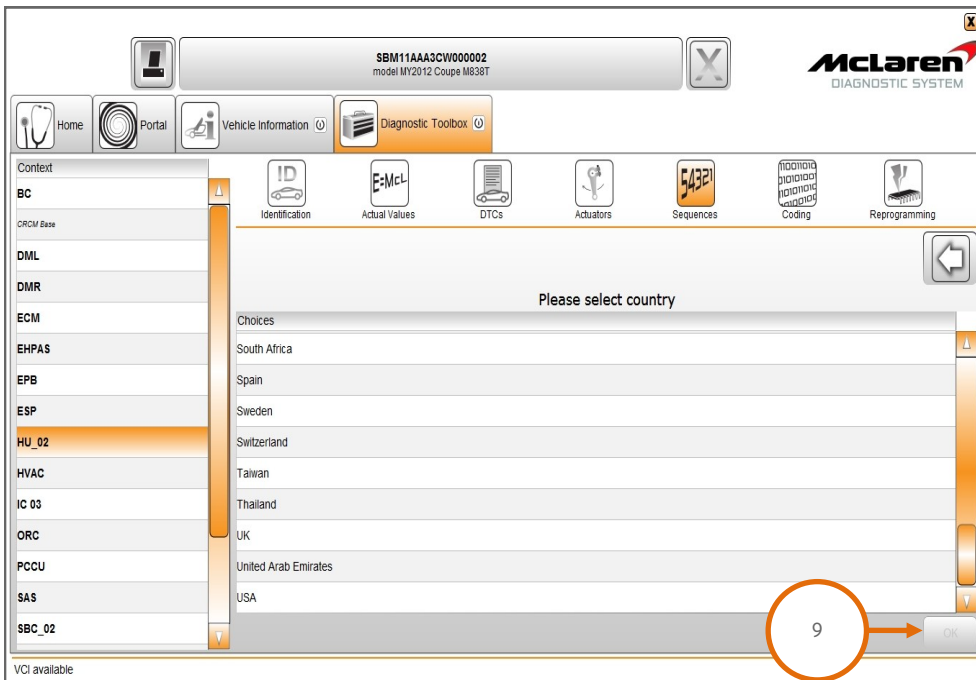
87. Select the relevant country followed by OK (9)

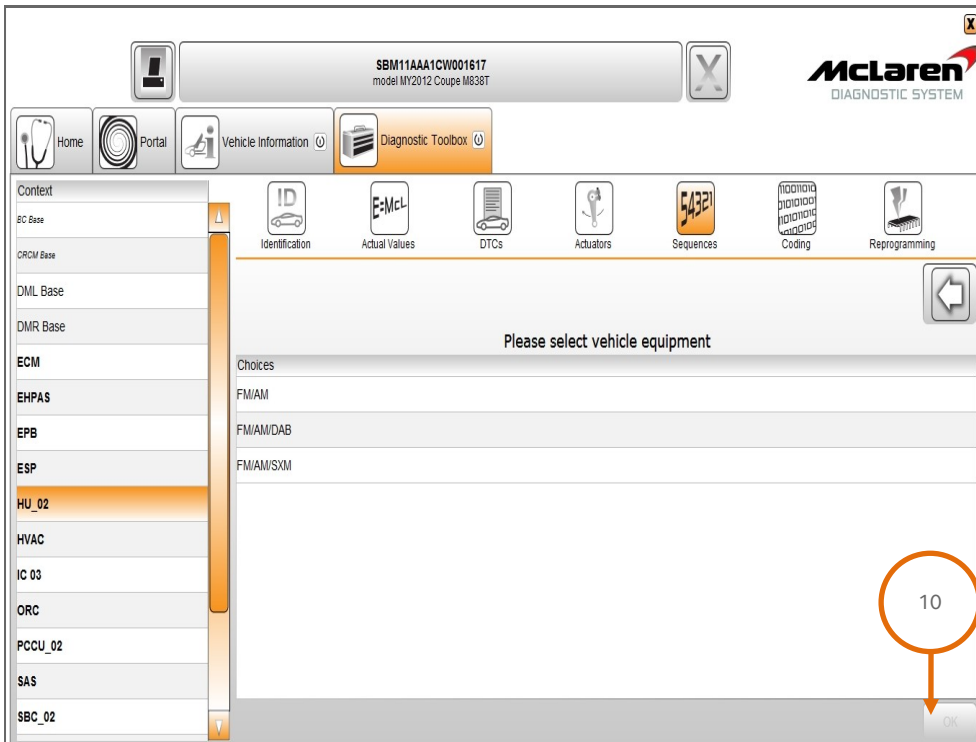
88. Select the relevant radio frequency option, followed by OK (10).

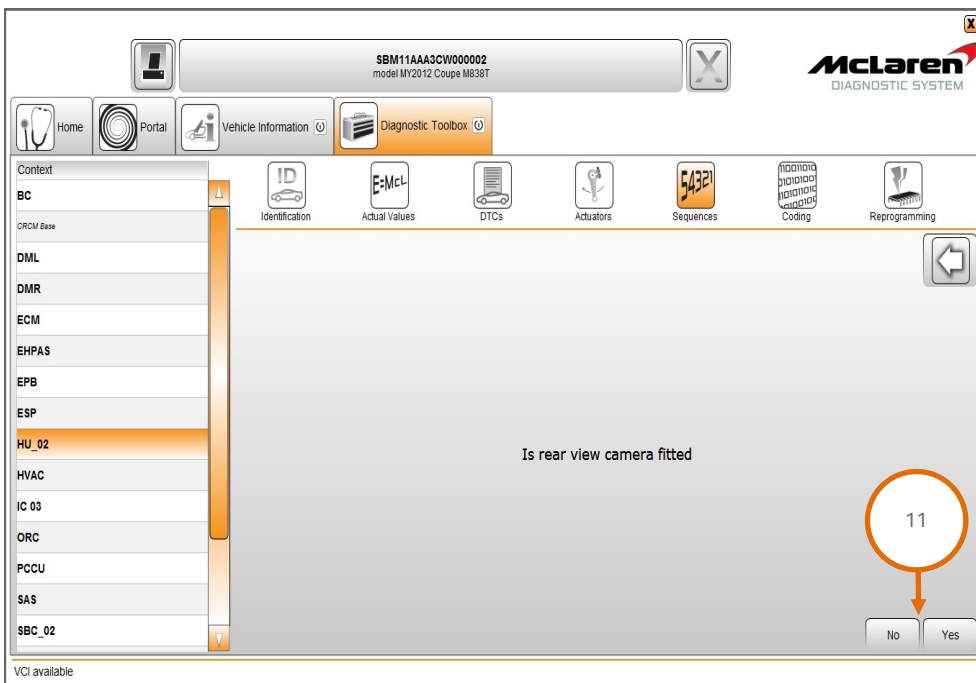
89. Is rear view camera fitted, select Yes or No (11).

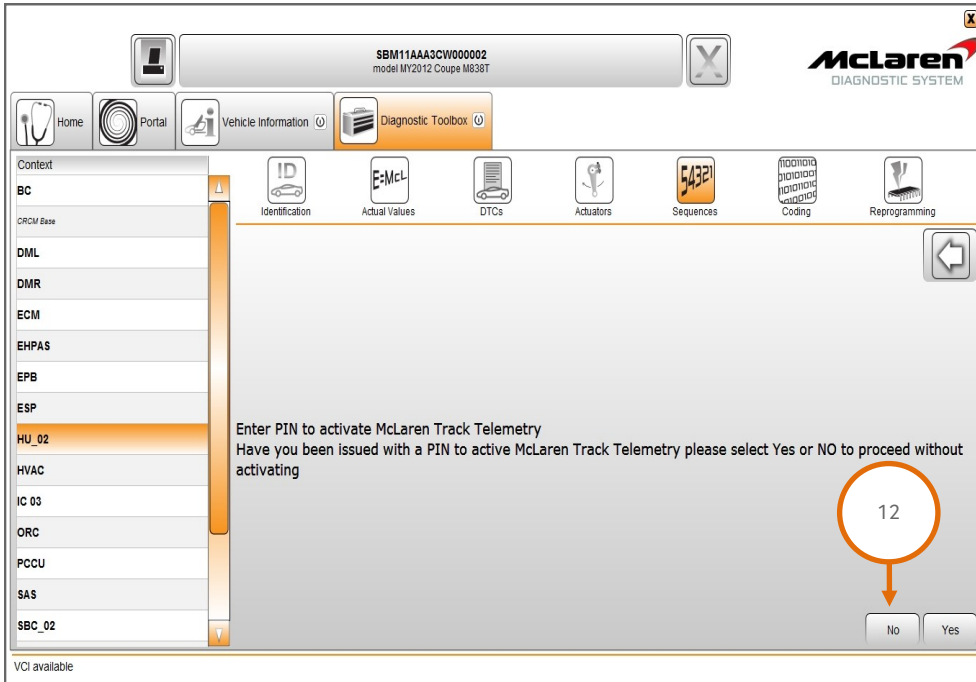
Care Point: The screenshot below may not appear due to database stored on the MDS may contain the VIN number.

90. Proceed and select No (12).

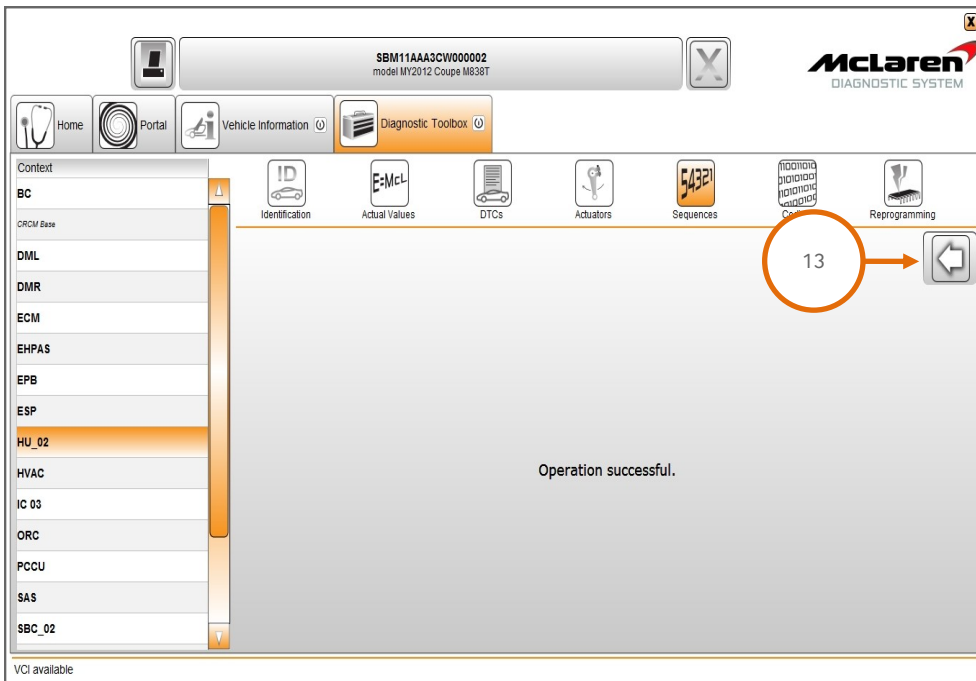
91. Operation successful will be displayed. Select the back arrow to exit the sequence (13).

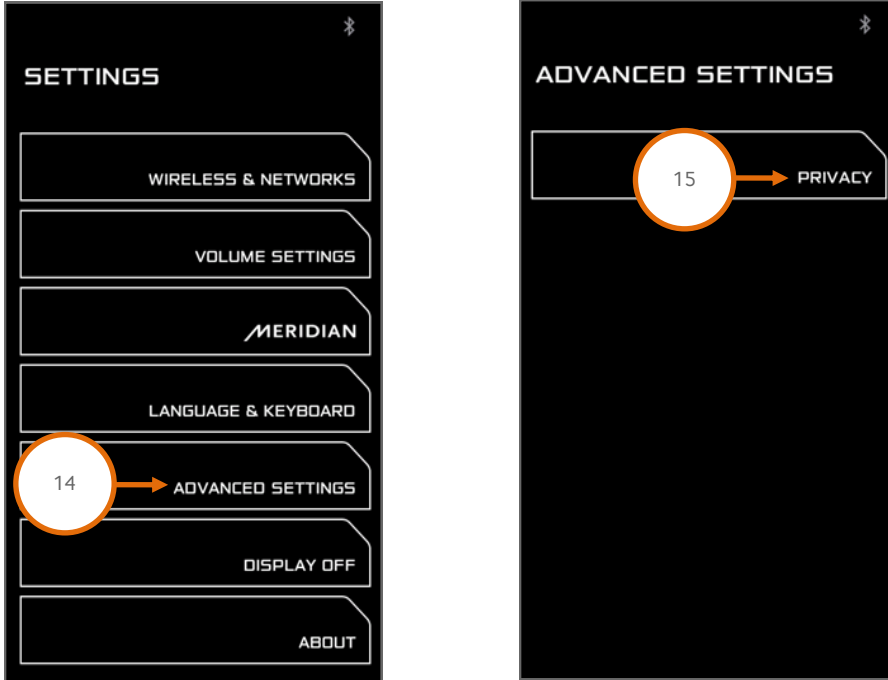
93. Select Advanced Settings (14) and then Privacy (15) in order to access the Factory Data Reset.

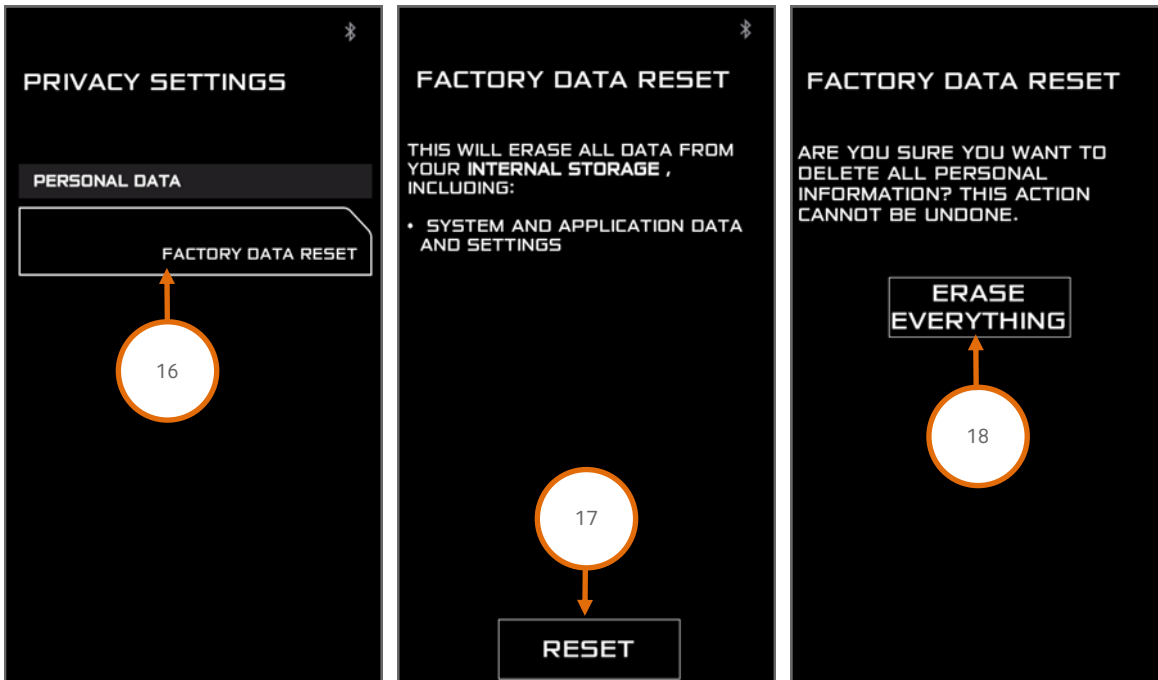
94. Select Factory Data Reset (16) followed by Reset (17) and then Erase Everything (18).

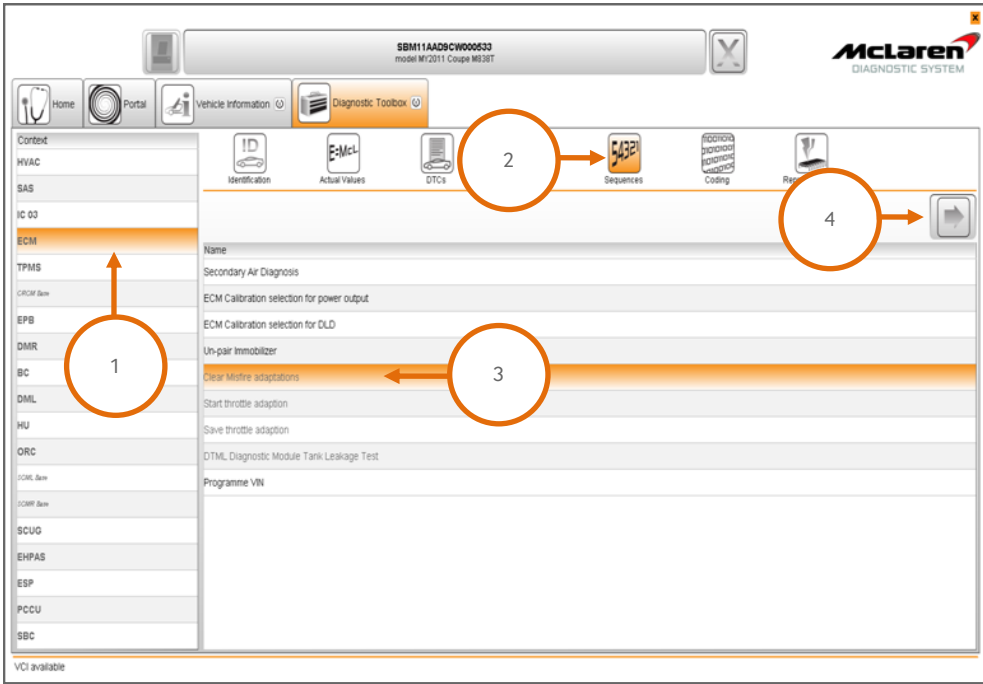
97. Select ECM (1), then Sequences (2), then Clear Misfire adaptations (3), followed by the arrow button (4) to proceed.

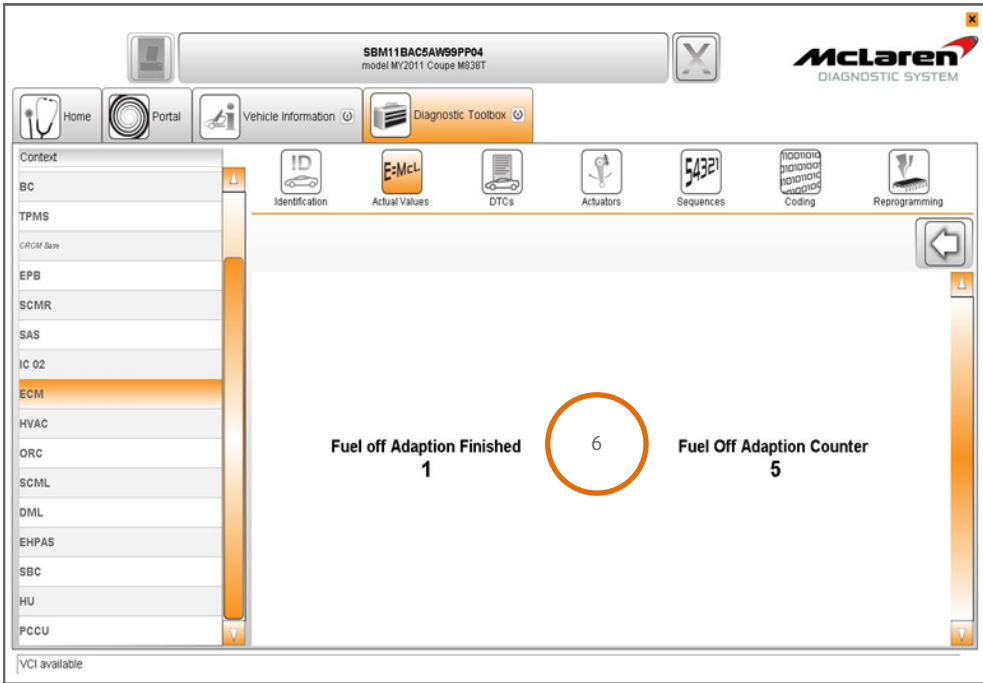
98. Select Actual Values (5), select the following values as per the screenshot below (6), then select the play button to access the required data screen.

99. Misfire adaptations are performed whilst the car is driven with the gearbox set to manual mode and with the A/C off. Perform eleven successive fuel cuts from above 4000rpm for a 5 second duration (a fuel cut off will occur when the accelerator pedal is fully released).

100. Once the Fuel off Adaption Counter reaches 11, the Fuel off Adaption Finished Counter will display 1; the misfire adaptations have been learned. The Fuel off Adaption Counter will display Zero and then start to count again when further fuel cut offs occur, this is correct operation and no further action is required.
