MODEL  
2016MY  
Sorento (UMa)  
w/2.4L GDI

## TECHNICAL SERVICE BULLETIN

SUBJECT: VCM LOGIC IMPROVEMENT - DTC P200A00 (SA 220)

### DTC P200A00 - Intake Manifold Runner Performance

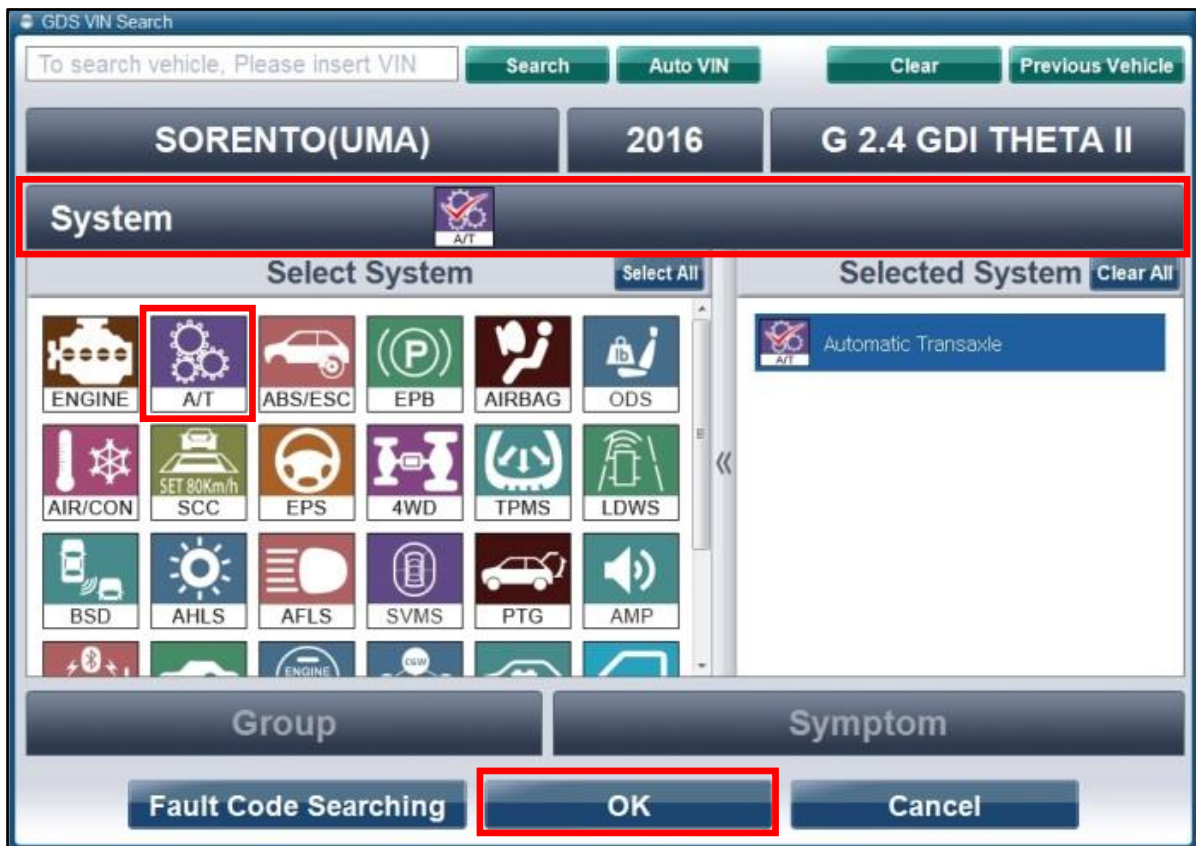
8. After performing event #275, return the GDS home screen, select **A/T System** and click **OK**.

9. Select **ECU Upgrade** from the bottom right-hand corner. Next select **Auto Mode**, and then **A/T**. Perform the event #277 in accordance with normal GDS upgrade procedures.
