# SERVICE BULLETIN

| Classification:<br>AT14-014b | Reference:<br>NTB15-014b | Date:<br>April 5, 2016 |

## ENHANCED DIAGNOSTIC LOGIC FOR CVT JUDDER

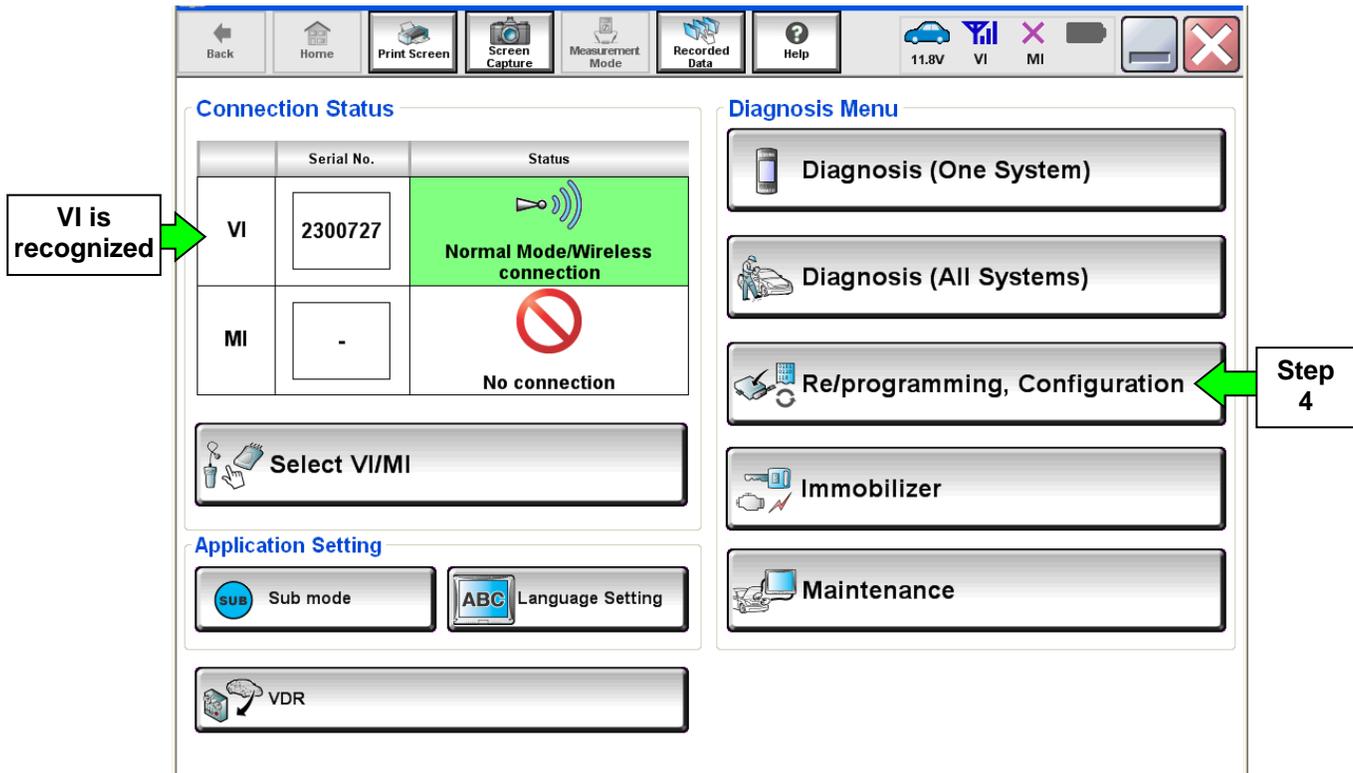
Figure 1

1. Connect the CONSULT PC to the vehicle to begin the reprogramming procedure.
2. Start C-III plus.
3. Wait for the plus VI to be recognized.
  - The serial number will display when the plus VI is recognized.
4. Select **Re/programming, Configuration**.

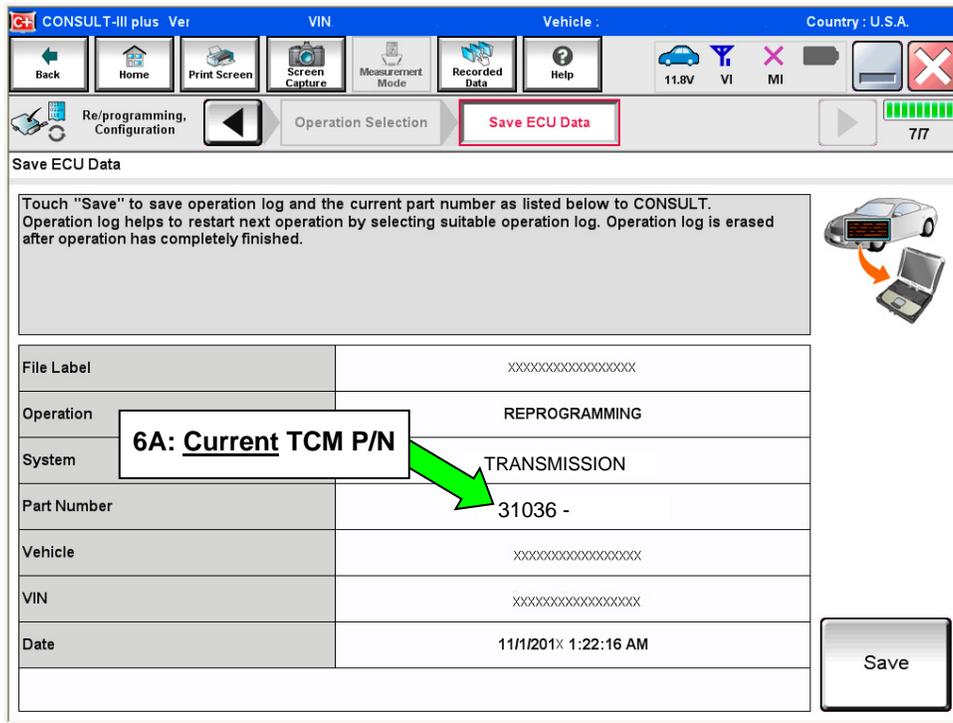
6. When you get to the screen shown in Figure 2, confirm this bulletin applies as follows.

A. Find the TCM **Part Number** and write it on the repair order.

**NOTE:** This is the current TCM Part Number (P/N).

5. Follow the on-screen instructions and navigate the C-III plus to the screen shown in Figure 2 on the next page.

B. Compare the P/N you wrote down to the numbers in the **Current TCM Part Number** column in **Table A** on the next page.

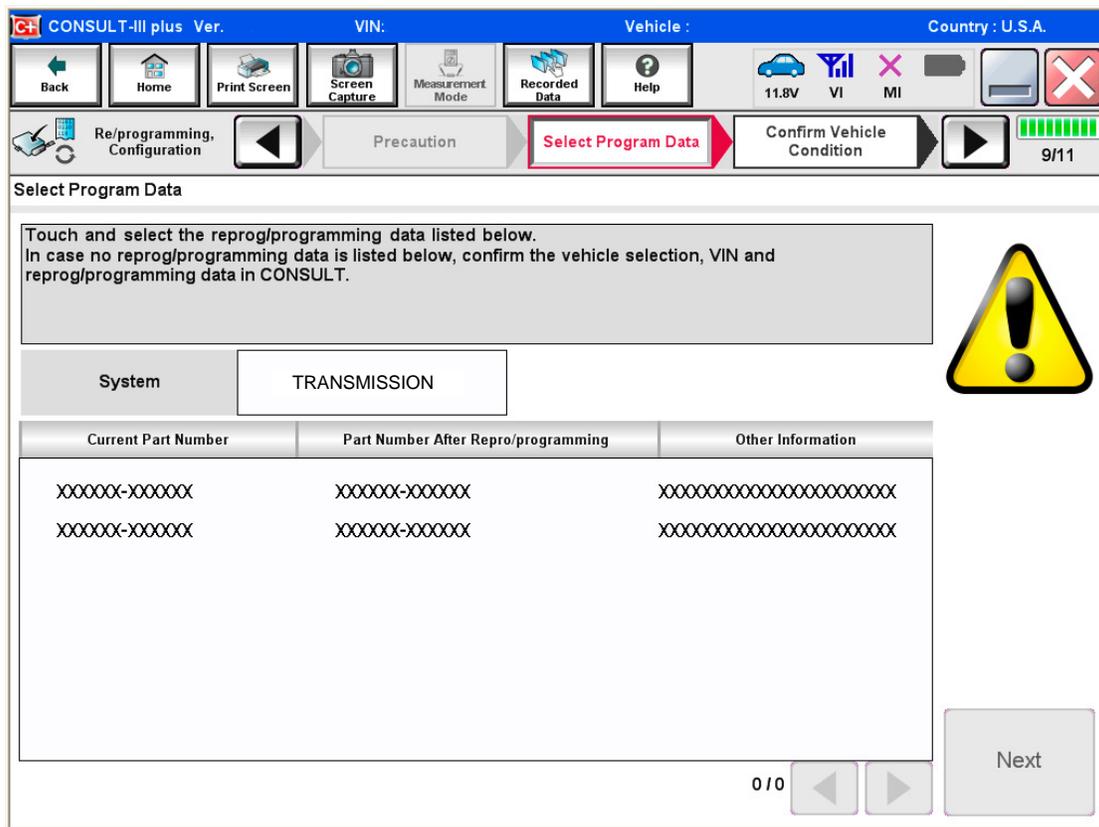
- In some cases, more than one new P/N for reprogramming is available.
  - If more than one new P/N is available, the screen in Figure 3 displays.
  - Select and use the reprogramming option that **does not** have the message “Caution! Use ONLY with NTBXX-XXX”.
- If you get this screen and it is blank (no reprogramming listed), it means there is no reprogramming available for this vehicle. This bulletin does not apply.

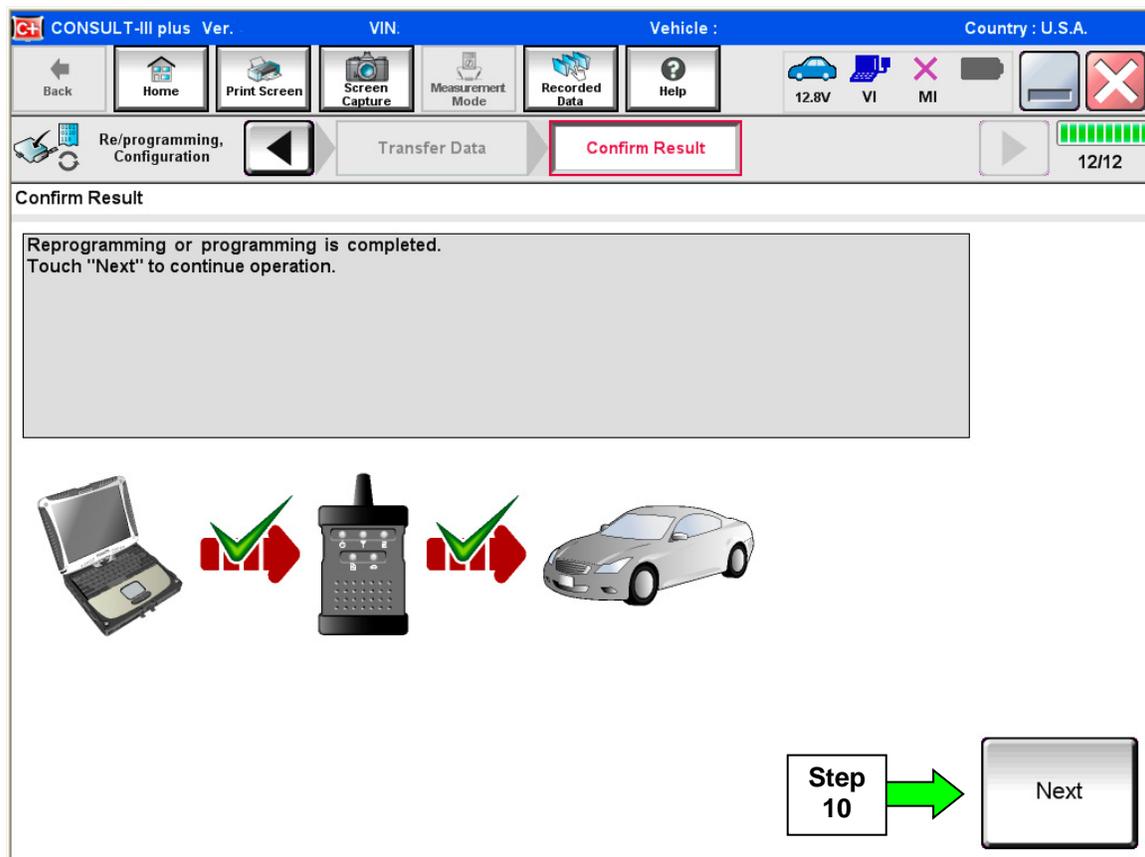
8. When the screen in Figure 4 displays, reprogramming is complete.

**NOTE:** If the screen in Figure 4 does not display (indicating that reprogramming did not complete), refer to the information on the next page.

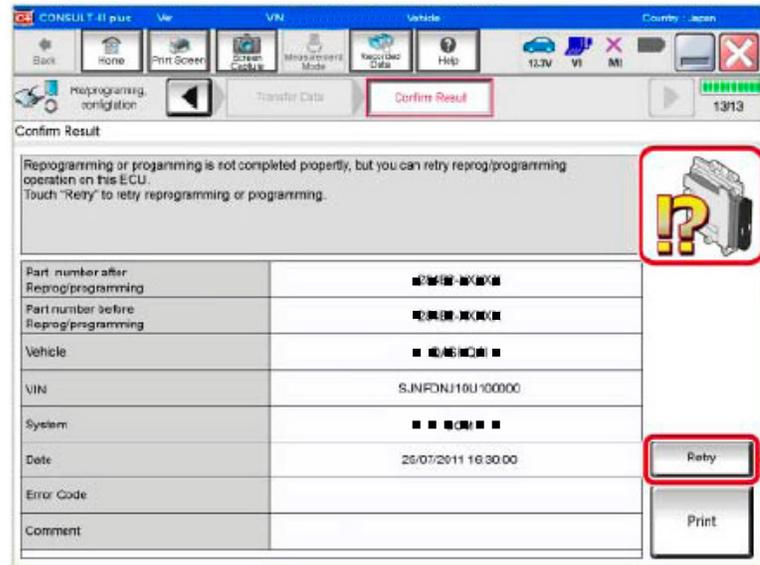
Figure 5

If reprogramming does not complete and the “!?” icon displays as shown in Figure 5:

- Check battery voltage (12.0–15.5 V).
- Ignition is ON, engine OFF.
- External Bluetooth® devices are OFF.
- All electrical loads are OFF.
- **Select retry and follow the on screen instructions.**
- “Retry” may not go through on first attempt and can be selected more than once.

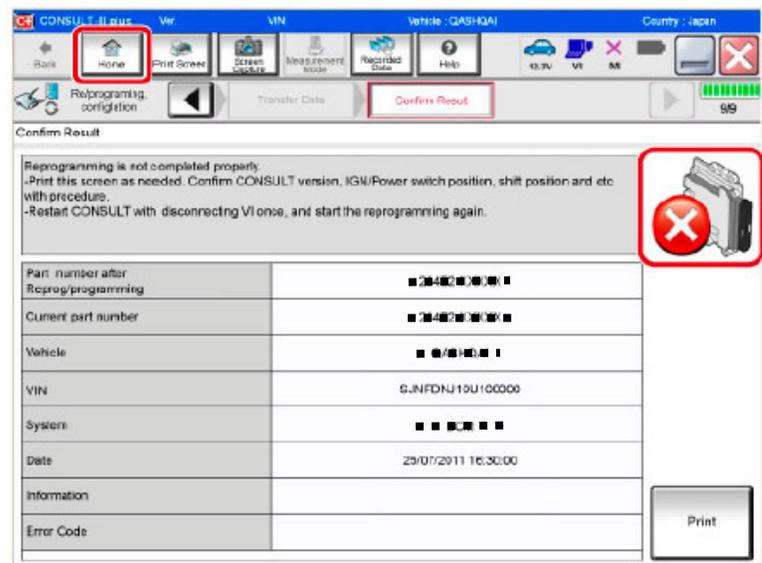
Figure 6

If reprogramming does not complete and the “X” icon displays as shown in Figure 6:

- Check battery voltage (12.0 – 15.5 V).
- CONSULT A/C adapter is plugged in.
- Ignition is ON, engine OFF.
- Transmission is in Park.
- All C-III plus / VI cables are securely connected.
- All C-III plus updates are installed.
- **Select Home, and restart the reprogram procedure from the beginning.**

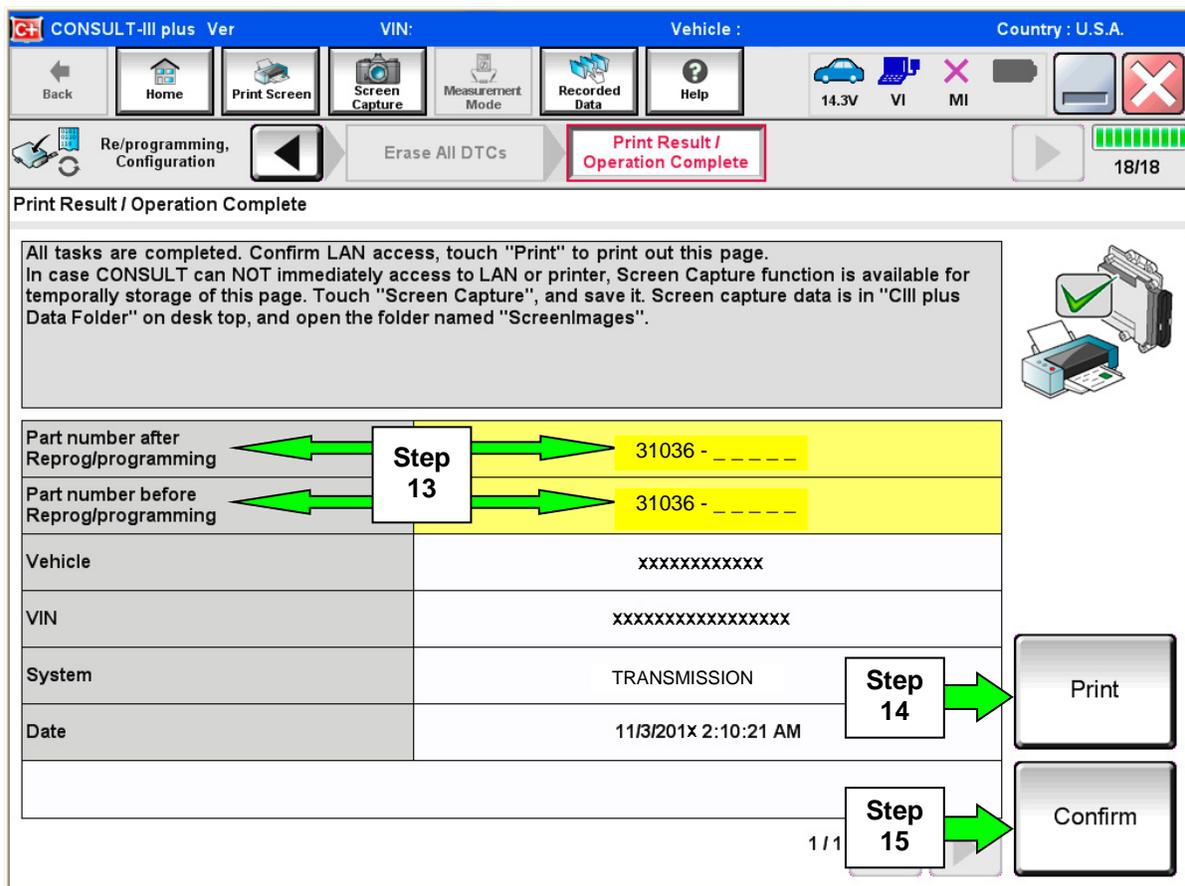
11. Follow the on-screen instructions to **Erase All DTCs**.
12. When the entire reprogramming process is complete, the screen in Figure 7 will display.
13. Verify the before and after part numbers are different.
14. Print a copy of this screen (Figure 7) and attach it to the repair order for warranty documentation.
15. Select **Confirm**.
