# QUALITY ACTION

### Front Camera Dealer Service Action

Reference: PC499  
Date: November 22, 2016

# PC499 - 2017 ROGUE (T32) FRONT CAMERA REPROGRAM

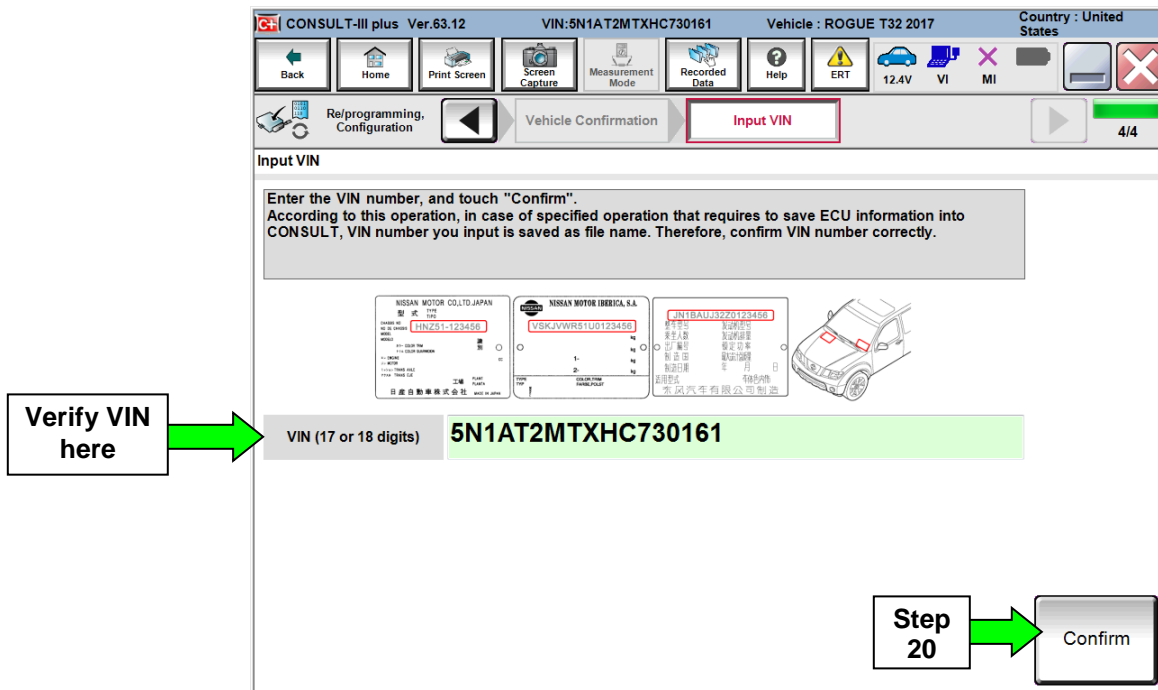
Figure 8

20. Verify the correct VIN is displayed, then select **Confirm**.
