# SERVICE CAMPAIGN BULLETIN

SUBJECT:			No: <b>SC-16-001</b>
<b>ECM REPROGRAMMING FOR ENGINE KNOCKING NOISE – SERVICE CAMPAIGN</b>			DATE: <b>February, 2016</b>
			MODEL: <b>2014-15 Mirage</b>
CIRCULATE TO:	<input checked="" type="checkbox"/> GENERAL MANAGER	<input checked="" type="checkbox"/> PARTS MANAGER	<input checked="" type="checkbox"/> TECHNICIAN
<input checked="" type="checkbox"/> SERVICE ADVISOR	<input checked="" type="checkbox"/> SERVICE MANAGER	<input checked="" type="checkbox"/> WARRANTY PROCESSOR	<input checked="" type="checkbox"/> SALES MANAGER

During cold start, the engine ECU may order inappropriate fuel amounts which may cause engine noise. This campaign bulletin instructs dealers to reprogram the ECM with new software on all affected vehicles. In rare cases, if the vehicle exhibits an engine knocking noise, the engine may need to be replaced.

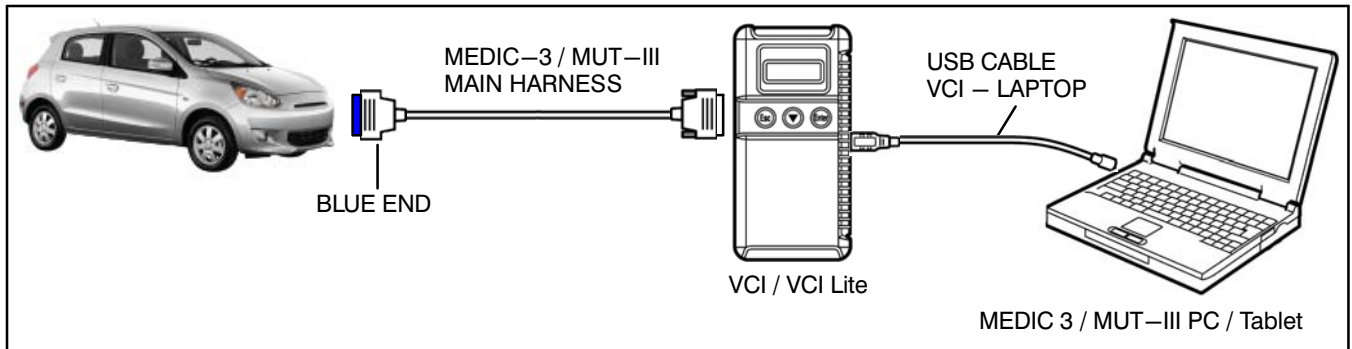
1. Connect the equipment as follows:

- Turn the MEDIC PC/tablet on. If the battery indicator in the lower right hand corner of the screen does not show a full charge, it is recommended that either the battery be charged prior to beginning, or be used with the A/C power adaptor connected.
- Connect the USB cable to the VCI/VCI Lite.
- When the laptop/tablet displays the MUT-III main screen, connect the USB cable to the device.
- Connect the MUT-III main harness with the blue DLC connection to the VCI/VCI Lite.
- Connect the blue connection of the MUT-III main harness to the vehicle’s data link connector.
- Turn the VCI power switch ON . Verify that the indicator lamp in the upper right corner of the screen is green.

**NOTE:** VCI and MEDIC 3.5 Laptop shown for illustration purposes only.

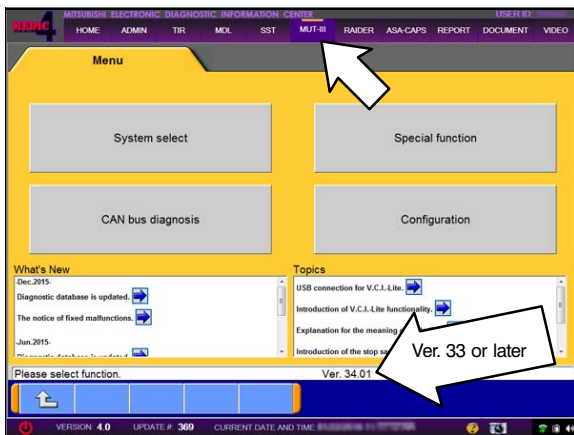
3. If using MEDIC, from the main page, click the MUT-III STV icon at the top center of the screen to open MUT-III.

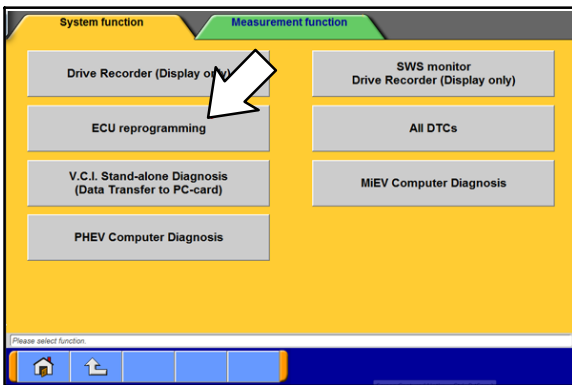
5. Select “ECU reprogramming.”

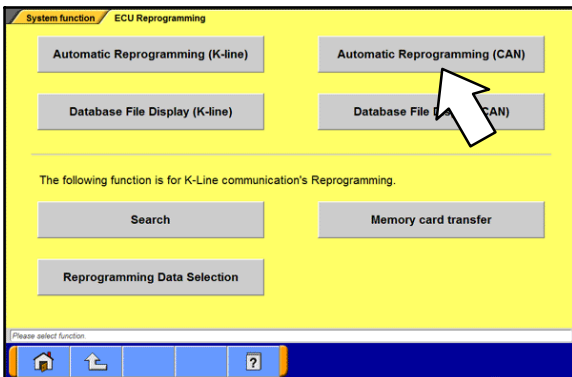
6. In ECU reprogramming, select “Automatic Reprogramming (CAN).”

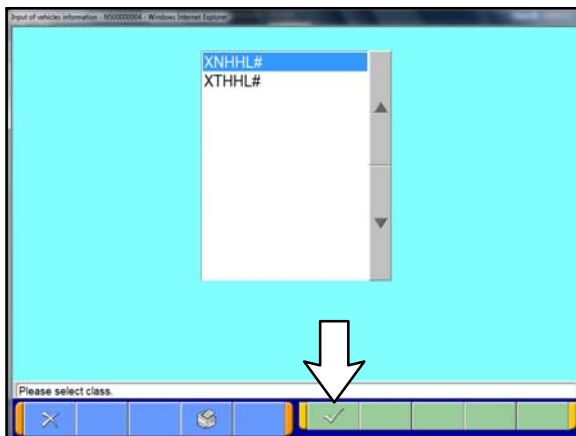
- d. Look at the label on the passenger side B-pillar to identify the appropriate class. Select it and click the check mark at the bottom of the page.

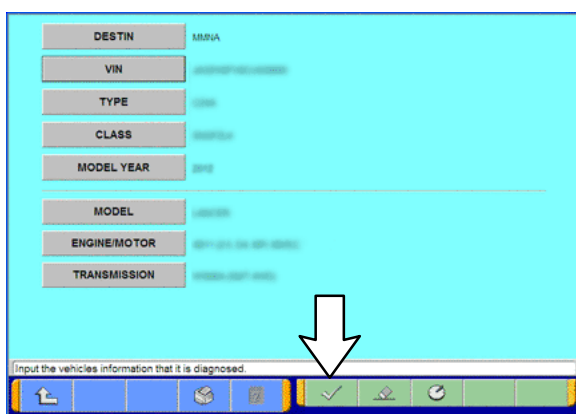
- e. Confirm all data matches the vehicle, then click the check mark at the bottom of the page.

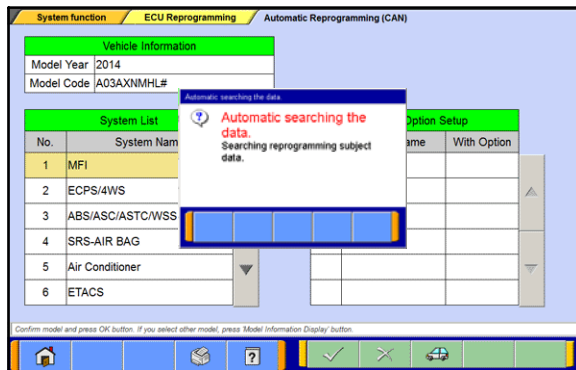
9. A message will advise the system will “Automatic search the data.”

Click the check mark to continue.

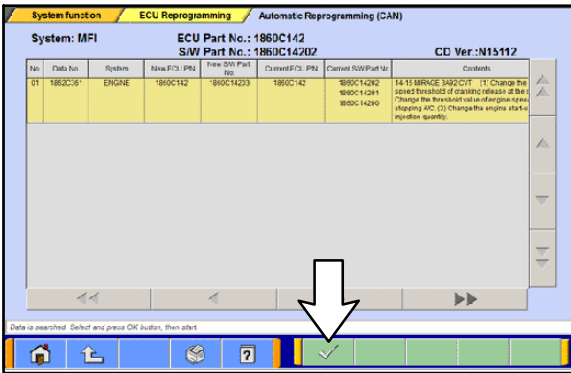
10. The Automatic Reprogramming (CAN) database screen will display.

- Verify that the new ECU and S/W part numbers are listed in the table.
- Confirm the database number at the top right of the table is N15112 or higher.
- If more than one row is displayed in the table, refer to the ECM Reprogramming Chart on page 2 to highlight and select the correct row.
- Click the check mark to continue.

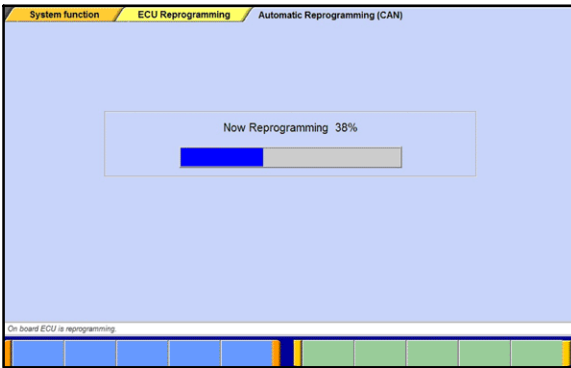
13. Once the reprogramming is initiated, the screen as shown will indicate the reprogramming progress.

**NOTE:** Do not disturb the cables or turn off the ignition during reprogramming.

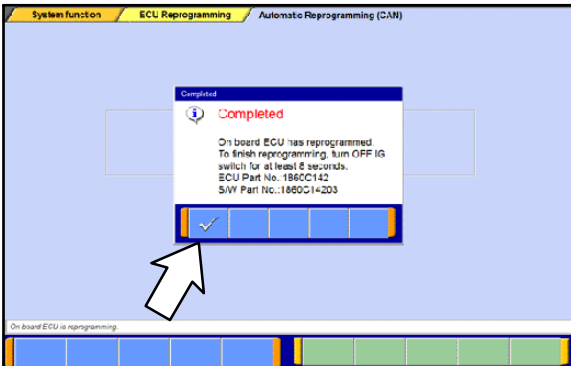
14. Reprogramming is completed.

- Verify that the S/W Part No. Is correct.
- Click on the check mark.
- Turn OFF ignition switch for at least 8 seconds.
- Turn ignition switch ON, then proceed to the next step.

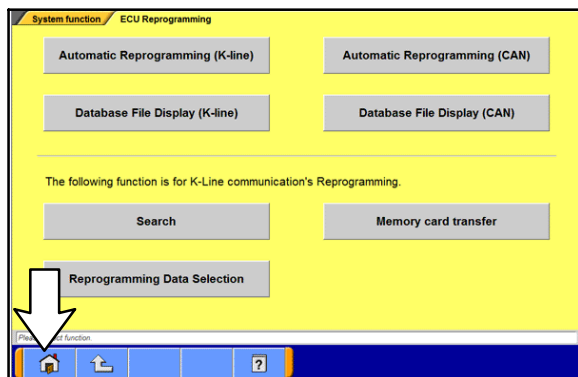
15. Click on the "home" button.

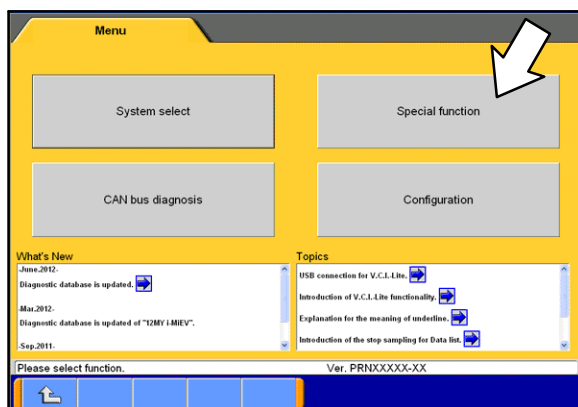
16. Perform an "Erase and Read all DTCs."

a. Select "Special function."

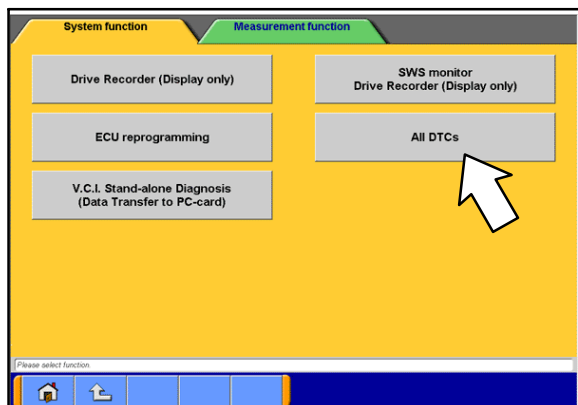
b. Select "All DTCs."

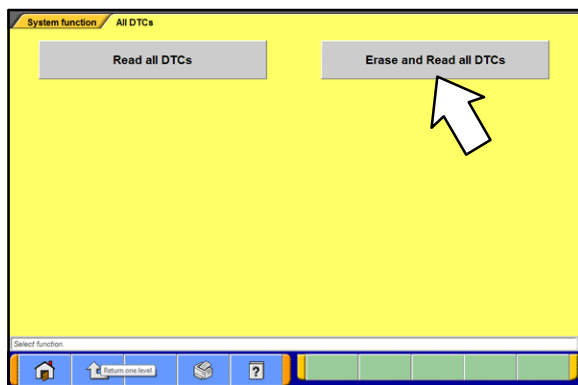
c. Select "Erase and Read All DTCs."

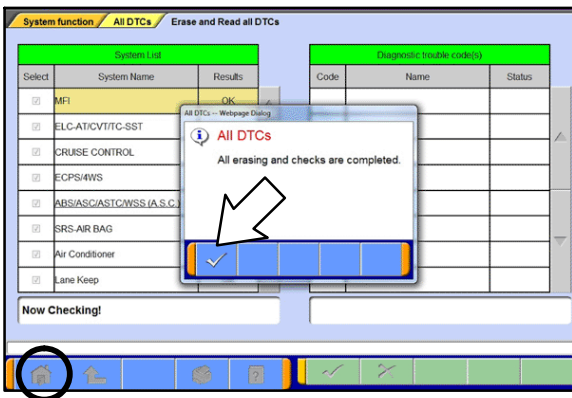
- f. A window will pop up asking you to confirm DTC erasing. Click the check mark for DTC erasing and reading to begin.
17. When DTC erasing is completed, click the check mark in the pop-up message that reads “All erasing and checks are completed.”
- a. If DTCs return after reprogramming, click the check mark to clear the window. Diagnose and repair per the Service Manual.
  - b. If DTCs do not return, click the check mark to clear the window, then click the home icon at the lower left of the screen to return to the main menu.
