# SERVICE CAMPAIGN BULLETIN

NTB16-044

## VOLUNTARY EMISSION SERVICE CAMPAIGN 2015 TAXI ECM REPROGRAM

**CAMPAIGN ID #:** PM652  
**APPLIED VEHICLE:** 2015 Taxi

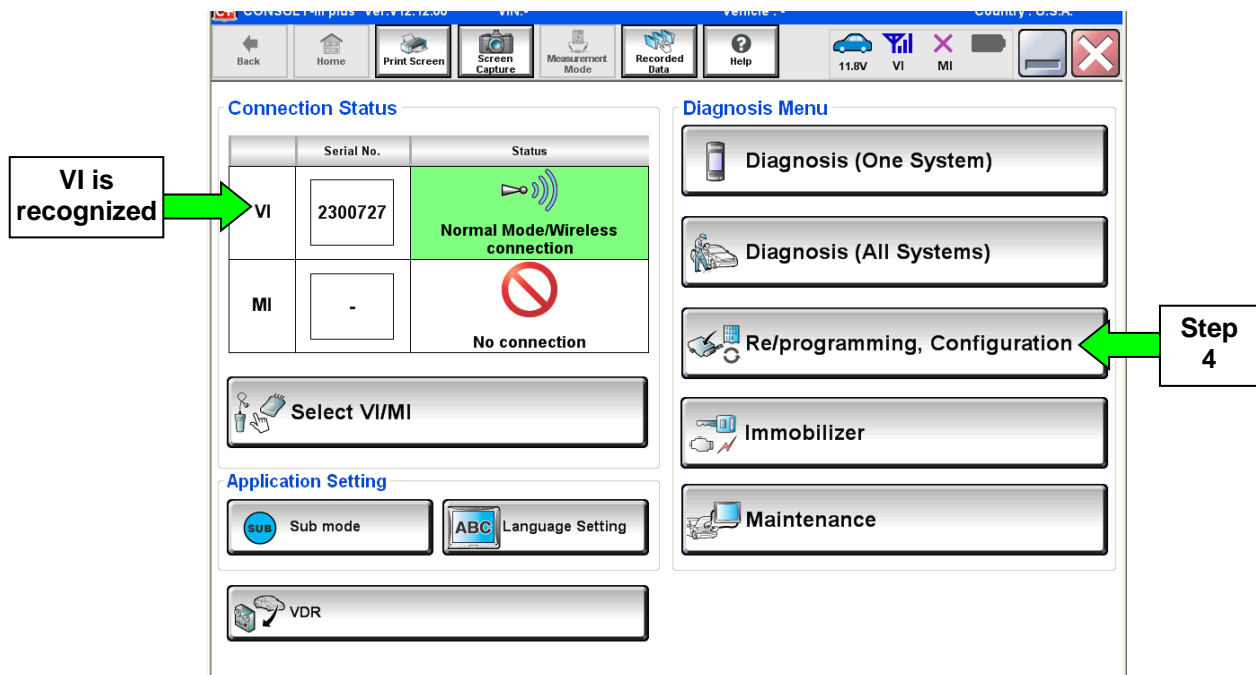
Figure 1

1. Connect the CONSULT PC to the vehicle to begin the reprogramming procedure.
- 2 Start C-III plus.
3. Wait for the plus VI to be recognized.
  - The serial number will display when the plus VI is recognized.
4. Select **Re/programming, Configuration**.

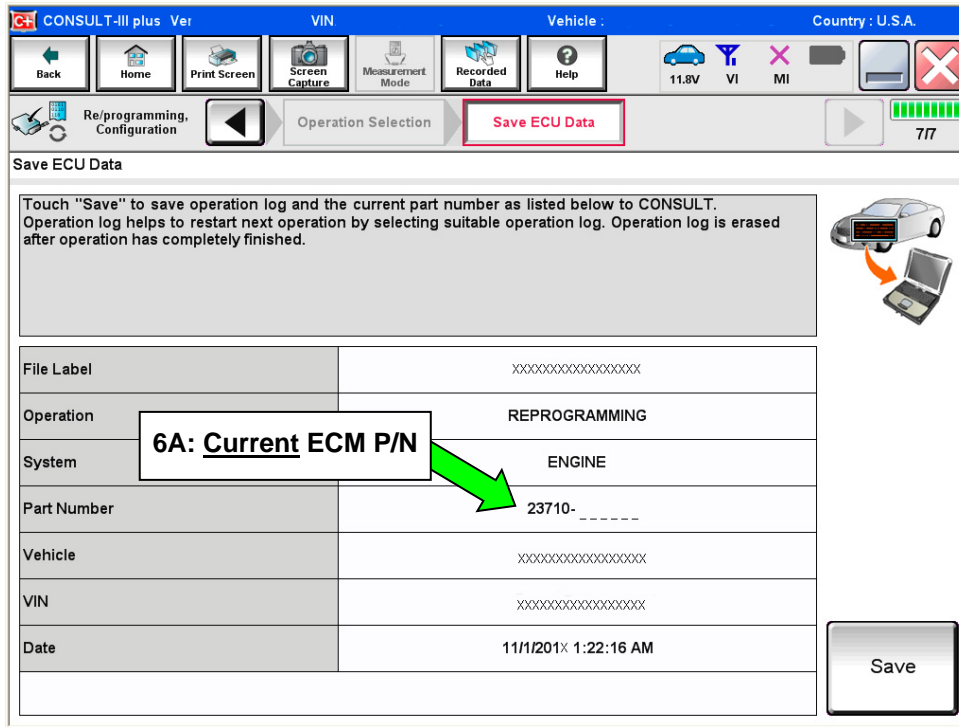
6. When you get to the screen shown in Figure 2, confirm this bulletin applies as follows.

A. Find the ECM **Part Number** and write it on the repair order.

**NOTE:** This is the current ECM Part Number (P/N).

5. Follow the on-screen instructions and navigate the C-III plus to the screen shown in Figure 2 on the next page.

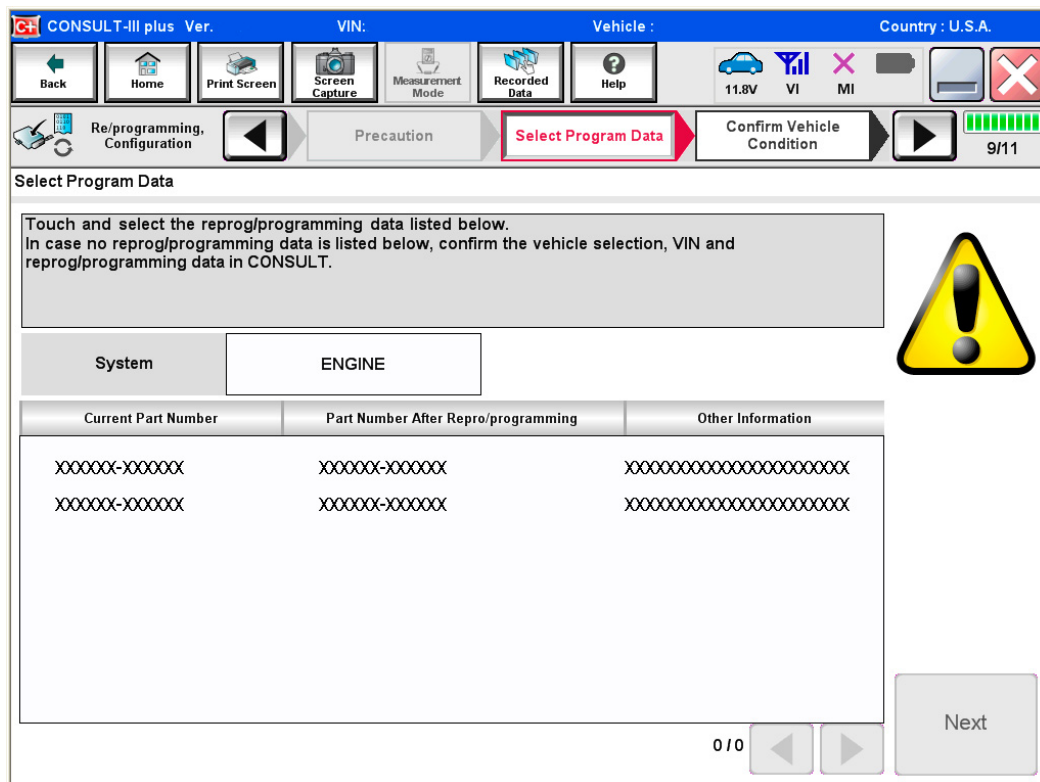
- In some cases, more than one new P/N for reprogramming is available.
  - In this case, the screen in Figure 3 displays.
  - Select and use the reprogramming option that **does not** have the message “Caution! Use ONLY with NTBXX-XXX”.
- If you get this screen and it is blank (no reprogramming listed), it means there is no reprogramming available for this vehicle. Close C-III plus and refer back to ASIST for further diagnosis.

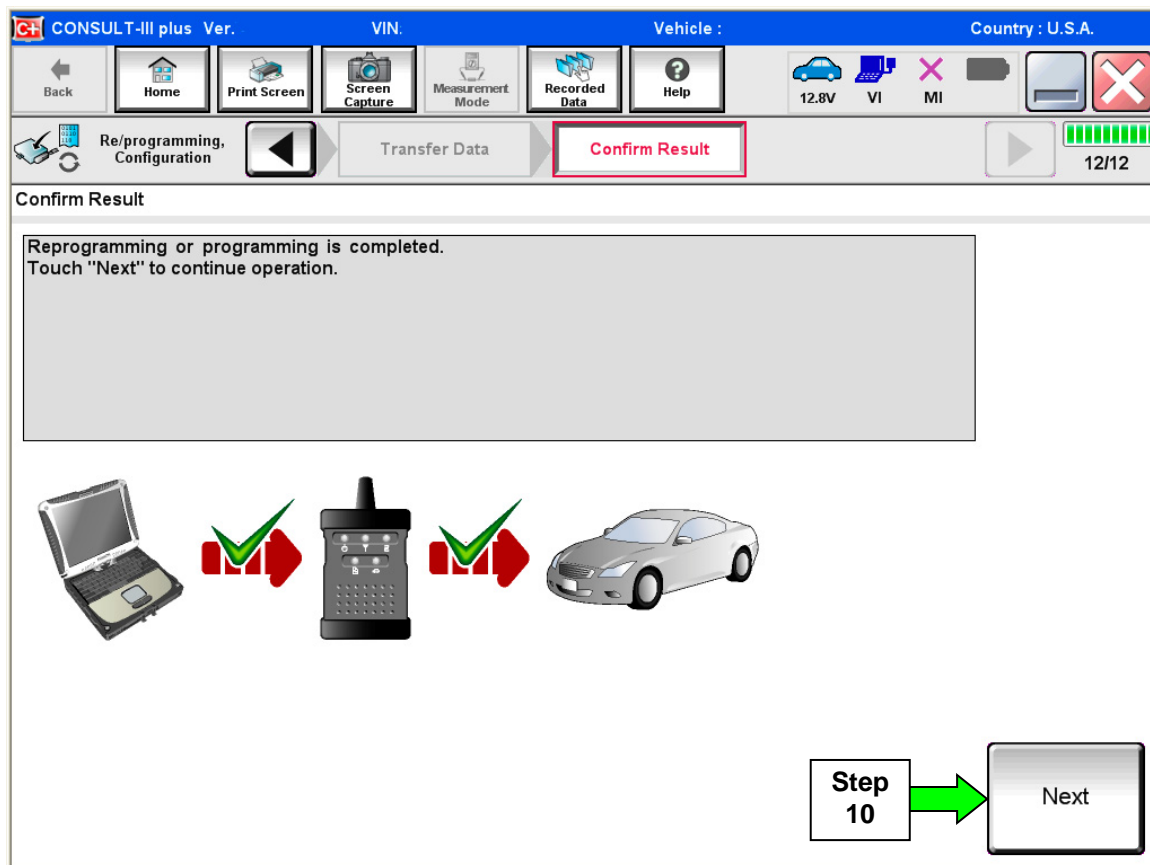
8. When the screen in Figure 4 displays, reprogramming is complete.

**NOTE:** If the screen in Figure 4 does not display (indicating that reprogramming did not complete), refer to the information on page 7.

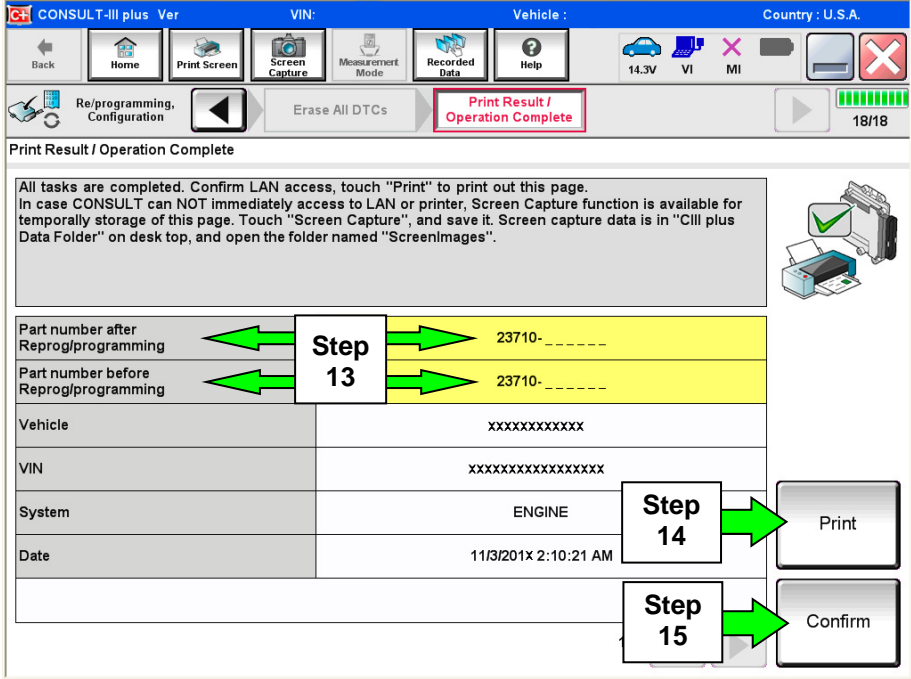
- 12. When the entire reprogramming process is complete, the screen in Figure 7 will display.
- 13. Verify the before and after part numbers are different.
- 14. Print a copy of this screen (Figure 7) and attach it to the repair order for warranty documentation.
- 15. Select **Confirm**.
