TECHNICAL BULLETIN

415-00

Service Action: InControl Touch Pro Phase 2.5 Software Update

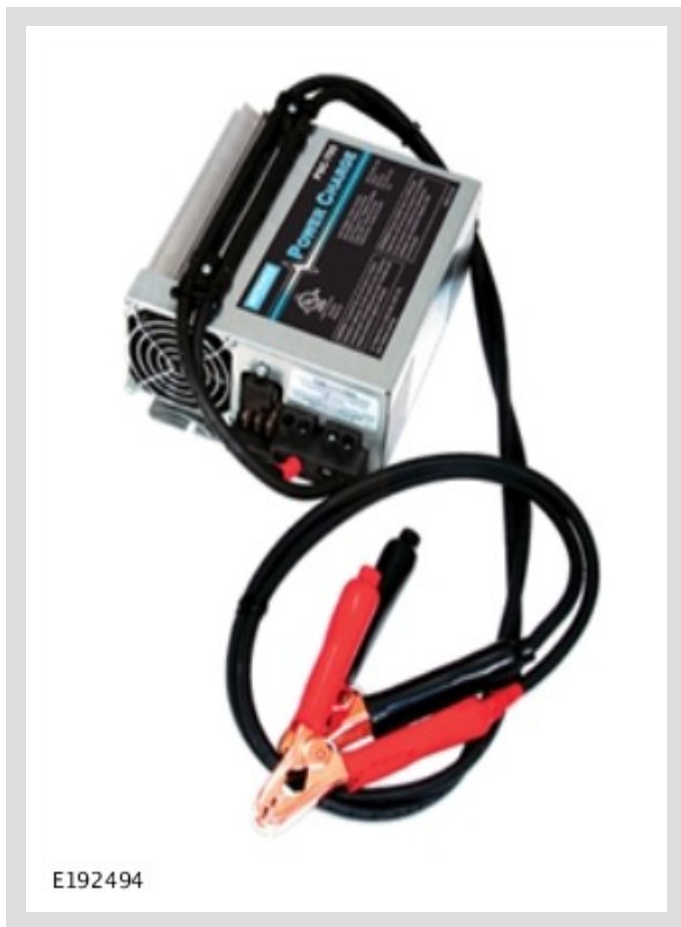
Jaguar Land Rover-approved Midtronics Battery Power Supply

condition to be able to supply 13v consistently. If the voltage is compromised during the installation of software, the IMC may switch off.

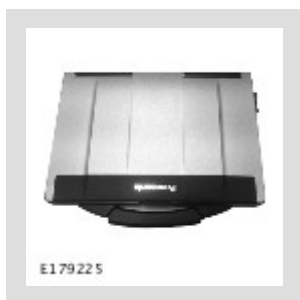
Jaguar Land Rover-approved diagnostic tool with latest SDD software, Calibration File, and InControl© Touch Pro™ Software

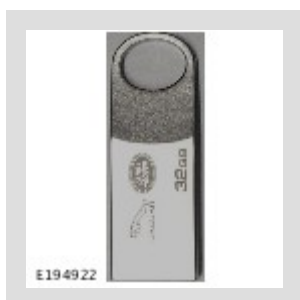
Jaguar Land Rover-approved USB memory device DTSE9G2/32GB

06 - Media not found USB flash drive not found in the vehicle. Remove the USB flash drive from the vehicle and reconnect again and select the 'Green Tick' when the Jaguar Land Rover-approved diagnostic equipment prompts 'Would you like to retry?'
