L615-A.02.16	To:	Official After Sales Network

Subject:	Engine Software Update	
	Date:	March, 25 2016	
	Pages	13

SW Update

Gallardo Spyder.

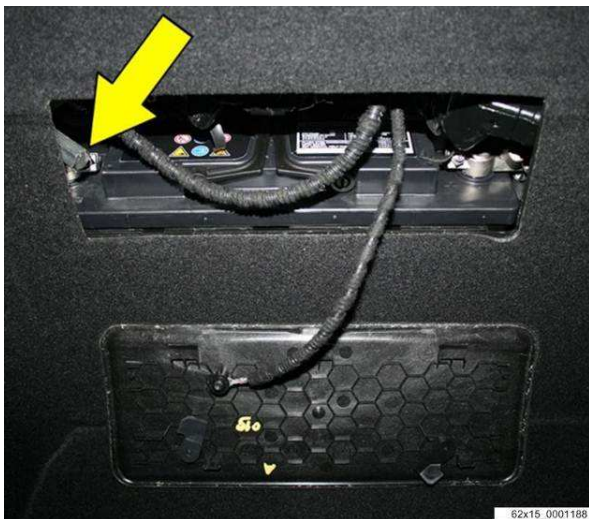
1. Open the trunk and remove the Battery inspection lid.
Disconnect the battery terminal clamp from the negative post.

Secure the clamp once it has been in order to prevent it from accidentally touching the battery post.

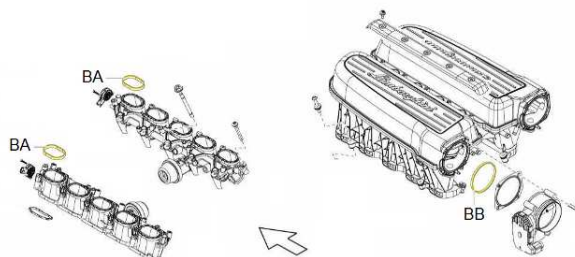
2. Take apart the intake manifold following the instructions detailed in the workshop manual posted on the Dealer Portal.

The items listed in the following template must be replaced before reassembling:

Ref.	Desc	P/N
BA	Seal ring	07L129717E
BB	Seal ring	07L133073F

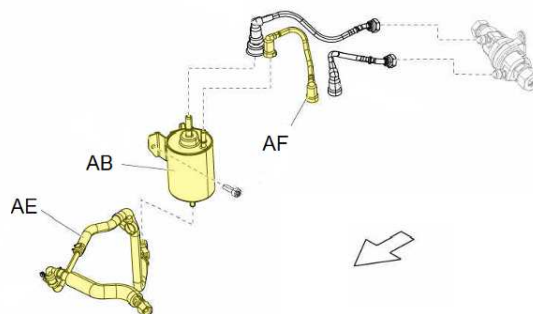
3. Dismantle the fuel filter and low pressure lines following scrupulously the instructions detailed in the Workshop Manual available on the Portal.

The items listed in the following template must be replaced before reassembling:

Ref.	Des.
AB	Fuel Filter
AE	Pipe
AF	Pipe

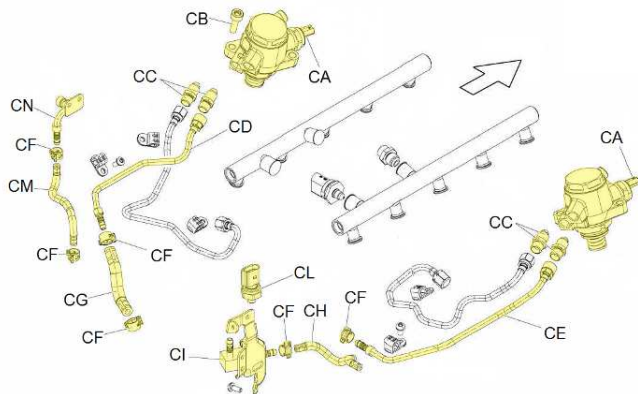
4. Disassemble the feeding pipes and the high pressure pumps following scrupulously the instructions reported in the Workshop Manual.

The items in the following template must be replaced before reassembling:

Ref.	Des.
CA	High pressure pump
CB	M8X30 Screw
CC	Union pipe
CD	Pipe
CE	Pipe
CF	Clamp
CG	Pipe
CH	pipe
CI	Union
CL	pressure sensor
CM	Pipe
CN	Union

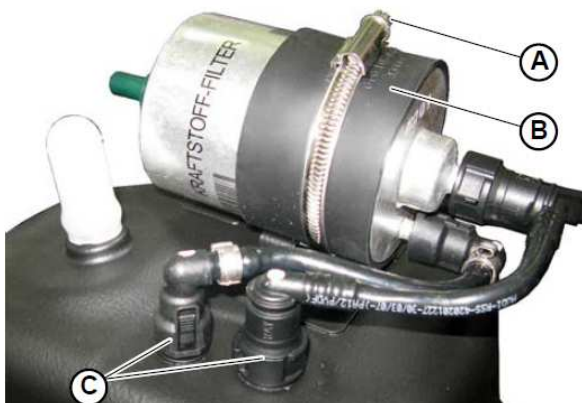
5. Install Low pressure lines together with the new fuel filter and the protection tube (B).

Fasten the clamp (A). to secure the filter

Connect the low press. lines and check the terminals are correctly inserted (C).

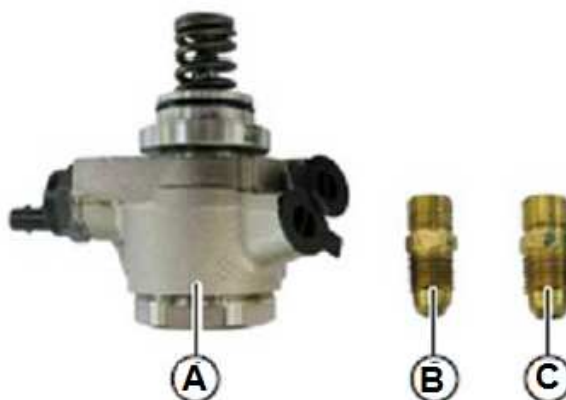
6. Connect the new high pressure pump (A) to the supplied union (B,C).

Screw the new union to the pumps without tightening.

Always Replace the union after every disassembly.
Use always new components. The Reemployment of used parts may cause damages to the vehicles.

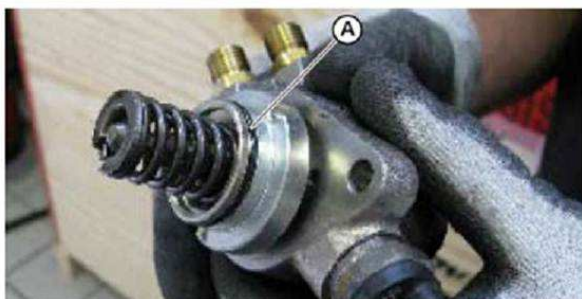
7. Soak with engine oil the seal ring (A) before installing the pump.

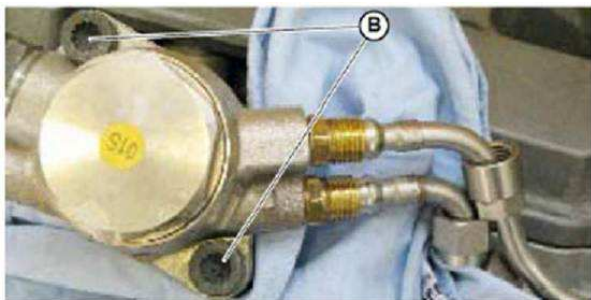
8. Install the pump and fasten them with the supplied screws (B). Alternate to each fasteners 2 turns of screws making the pumps perfectly adhere to their lodge.

Check the pumps are correctly installed on their own lodges, then tighten the fasteners.

Torque: **22Nm**.

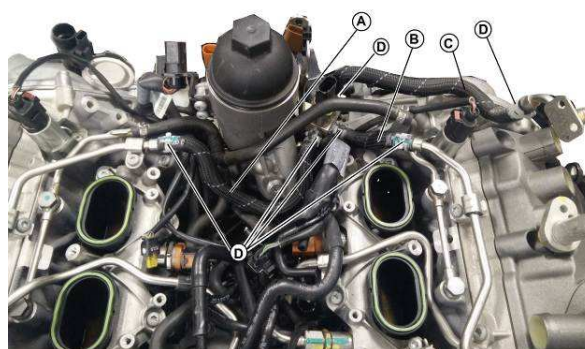
14. Fasten to the engine the feed lines which were previously installed at step 5 by the Union (B).

Union tightening.
Torque: **28Nm**

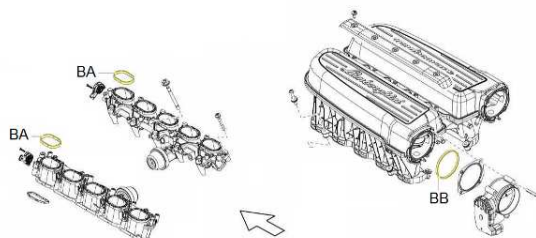
The items here below must be replaced before the re-assembly get started:

Ref.	Des.
BA	Seal ring
BB	Seal ring

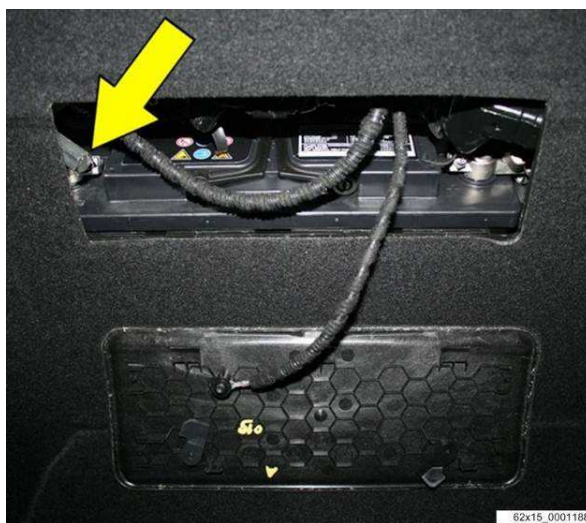
16. Access to the trunk and connect again the battery clamp to the negative post:

Clamp nut Tightening.
Torque: **5Nm**.
