WF86 - Re-programming DME Control Unit (Workshop Campaign)

Vehicle type: Boxster (981)/Boxster S (981)/Boxster GTS (981)
Cayman (981)/Cayman S (981)/Cayman GTS (981)

Subject: DME control unit

Remedial action: Re-program the DME control unit using the PIWIS Tester with test software version **16.300** (or higher) installed.

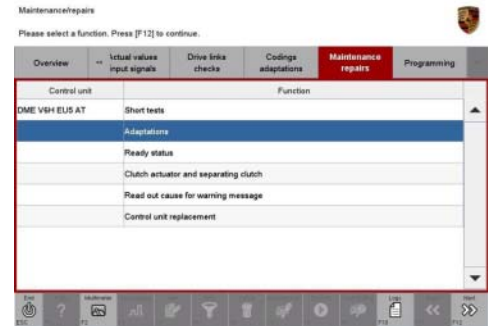
*DME - Adaptations*

- 2 Once the DME control unit has been found and is displayed in the overview, select the ⇒ **'Maintenance/repairs'** menu.
- 3 Select menu item ⇒ **'Adaptations'** and press **•>>** to confirm your selection ⇒ *DME - Adaptations*.
