WG14 - Re-programming DME Control Unit (Workshop Campaign)

Vehicle type: **Cayenne Turbo S (92A)**

Subject: **DME control unit**

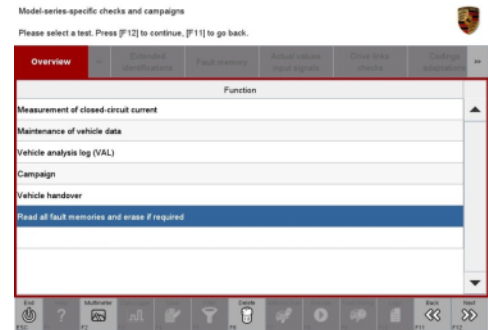
Erasing fault memories

- 2 Select the function "Read all fault memories and erase if required" and press •F12" ('Next') to confirm your selection ⇒ *Erasing fault memories*.
The fault memories of the control units are read out.
- 3 Once you have read out the fault memories, erase the fault memory entries by pressing •F8" .
- 4 Press •F12" ("Yes") in response to the question as to whether you really want to delete all fault memory entries.

The faults stored in the fault memories of the various control units are deleted.

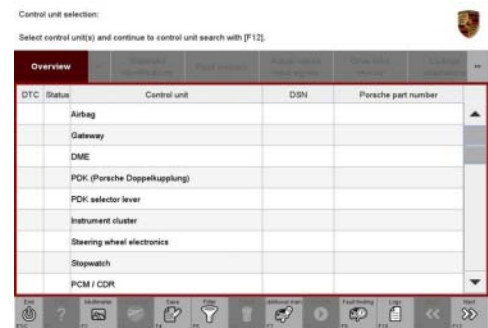
Control unit selection

- 5 Once you have erased the fault memories, select the ⇒ **'Overview'** menu to return to the control unit selection screen ⇒ *Control unit selection*.

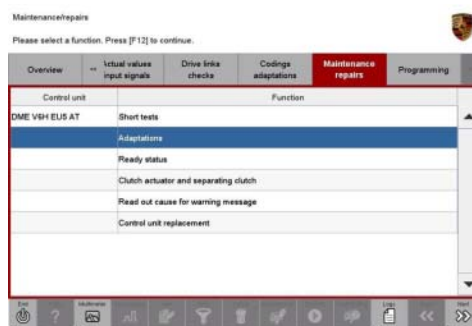
DME - Adaptations

- 3 Select menu item ⇒ **'Adaptations'** and confirm your selection by pressing •F12" ('Next') ⇒ *DME - Adaptations*.

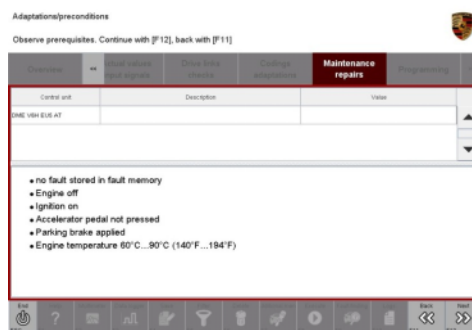
Adaptation preconditions

- 4 Comply with the displayed preconditions and press •F12" ('Next') to confirm ⇒ *Adaptation preconditions*.

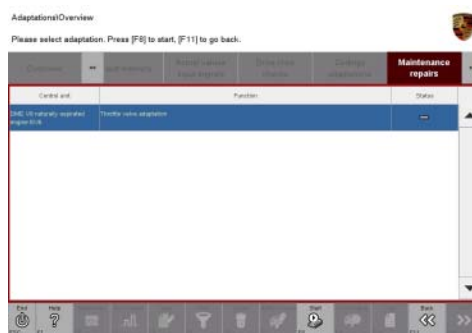
Throttle valve adaptation

- 5 Select the ⇒ **'Throttle valve adaptation'** function so that the corresponding text line turns blue and press •F8" ('Start') to start throttle valve adaptation ⇒ *Throttle valve adaptation*.

- 6 Follow the instructions on the PIWIS Tester while throttle valve adaptation is being performed. Once throttle valve adaptation is complete, a tick will appear in the "Value" field in the PIWIS Tester display.
If throttle valve adaptation is **not** completed successfully, the adaptation must be **repeated**.
- 7 Press •F8" ('Stop') to end throttle valve adaptation.
- 8 Press •F11" ('Back') to return to the start page of the ⇒ **'Adaptations'** menu.

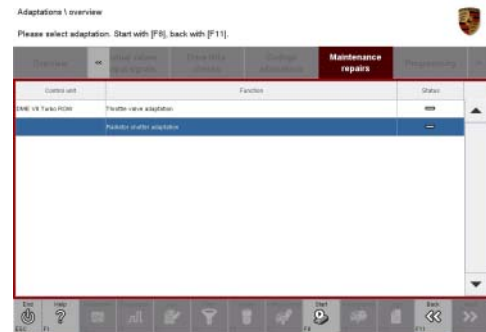
Radiator shutter adaptation

- 1 Select the ⇒ **'Radiator shutter adaptation'** function so that the corresponding text line turns blue and then press •F8" ('Start') to start radiator shutter adaptation ⇒ *Radiator shutter adaptation*.

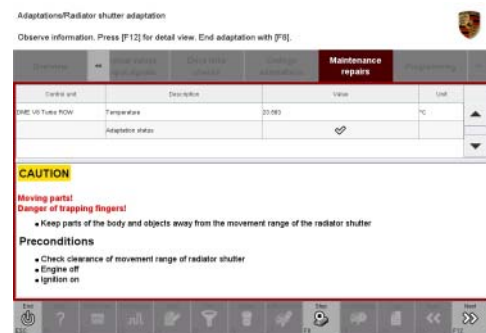
PIWIS instructions

- 2 Follow the instructions on the PIWIS Tester while radiator shutter adaptation is being performed ⇒ *PIWIS instructions*.

Once adaptation is complete, a tick will appear in the "Value" field on the PIWIS Tester display.

If radiator shutter adaptation is **not** completed successfully, the adaptation must be **repeated**.

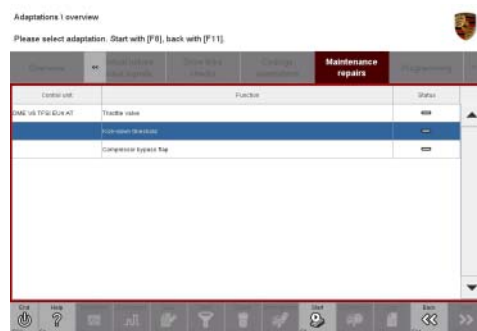
Kickdown threshold adaptation

- 1 Select the ⇒ **'Kickdown threshold'** function so that the corresponding text line turns blue and press •F8" ('Start') to start kickdown threshold adaptation ⇒ *Kickdown threshold adaptation*.

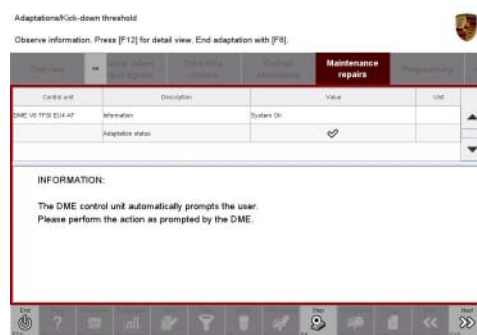
PIWIS instructions

- 2 Read and follow the instructions on the PIWIS Tester in order to perform kickdown threshold adaptation ⇒ *PIWIS instructions*.

Once kickdown threshold adaptation is complete, a tick will appear in the "Value" field on the PIWIS Tester display.

If kickdown threshold adaptation is **not** completed successfully, the adaptation must be **repeated**.

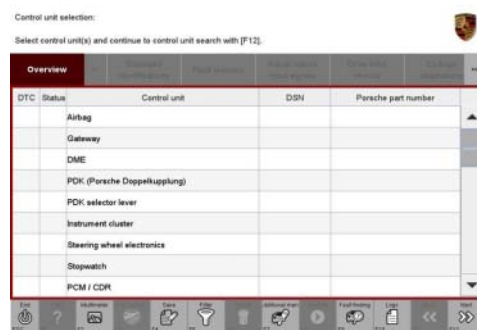
Control unit selection

- 3 End kickdown threshold adaptation by pressing •F8" ('Stop').
- 4 Press •F11" ('Back') to return to the start page of the ⇒ **'Maintenance/repairs'** menu.
- 5 Select the ⇒ **'Overview'** menu and press •F11" ('Back') to return to the control unit selection screen ⇒ *Control unit selection*.
