PCM3.0 – Navigation Update (data status: model year 2016)

Concern: **New maps with data status: model year 2016 (G)**

Model Year: **As of 2009 up to 2010**

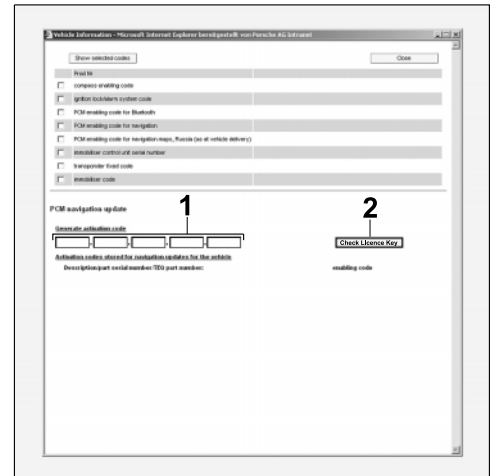
Figure 2

Enter the license key in the input field ⇒ *Figure 2-1*.

Activate the “Check license key” field ⇒ *Figure 2-2* by clicking with the mouse.

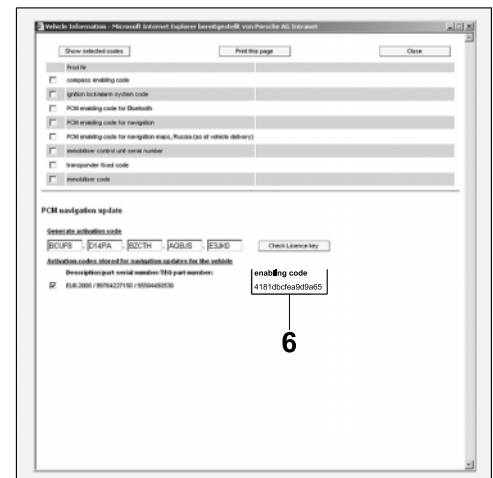
Figure 4

Take note of the displayed enabling code ⇒ *Figure 4-6-*.
