SERVICE BULLETIN

Classification: AT14-020b	Reference: NTB14-118b	Date: April 7, 2016
------------------------------	--------------------------	------------------------

JUDDER ON DECELERATION UNDER 15 MPH

APPLIED VEHICLES: 2014-2015 Sentra (B17)
2015 Versa Note (E12)
2015 Versa Sedan (N17)

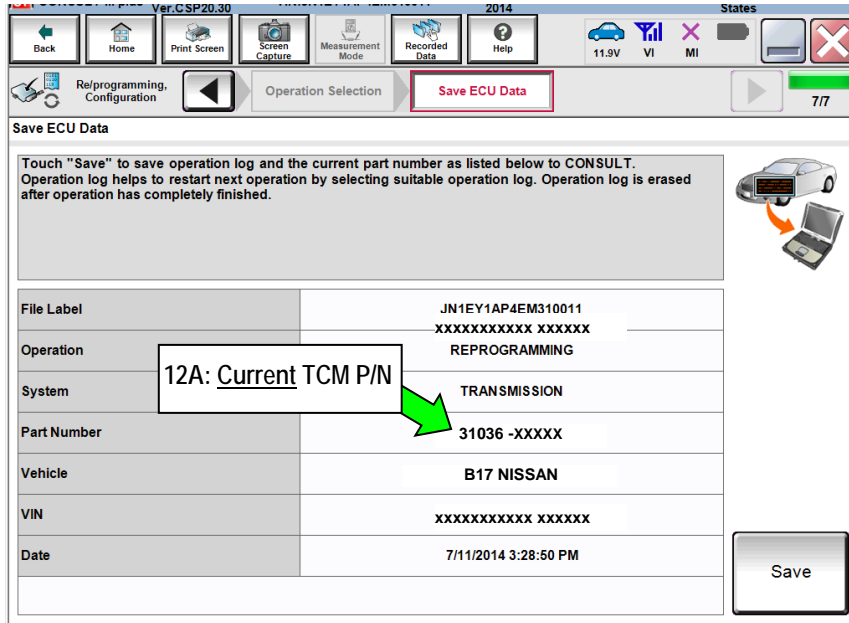
12. When you get to the screen shown in Figure 2, confirm this bulletin applies as follows.

A. Find the TCM **Part Number** and write it on the repair order.

NOTE: This is the current TCM Part Number (P/N).

11. Follow the on-screen instructions and navigate the C-III plus to the screen shown in Figure 2 on the next page.

B. Compare the P/N you wrote down to the numbers in the **Current TCM Part Number** column in **Table A** below.

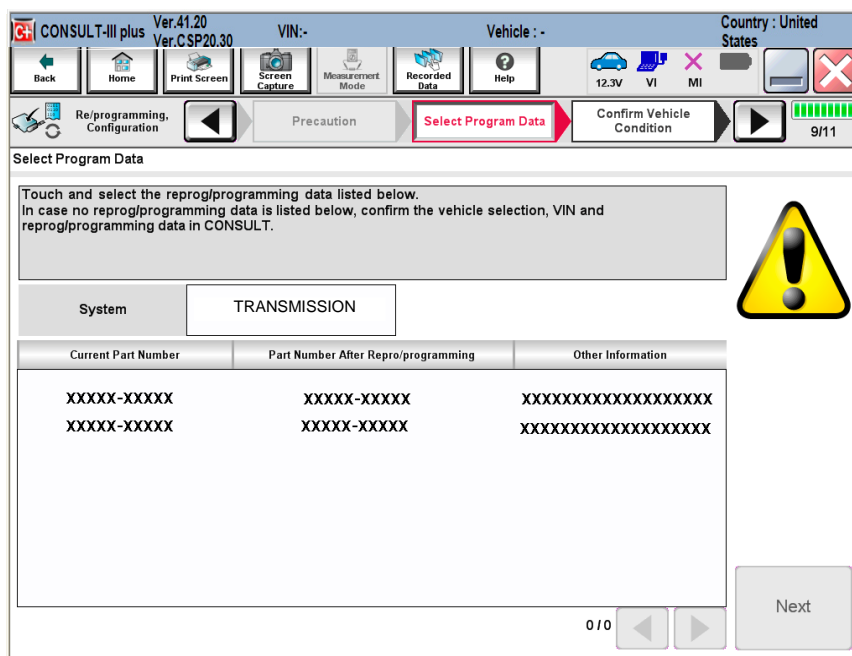
- In some cases, more than one new P/N for reprogramming is available.
 - If more than one P/N is available, the screen in Figure 3 displays.
 - Select and use the reprogramming option that **does not** have the message “Caution! Use ONLY with NTBXX-XXX”.
- If you get this screen and it is blank (no reprogramming listed), it means there is no reprogramming available for this vehicle. Close C-III plus and refer back to ASIST for further diagnosis.

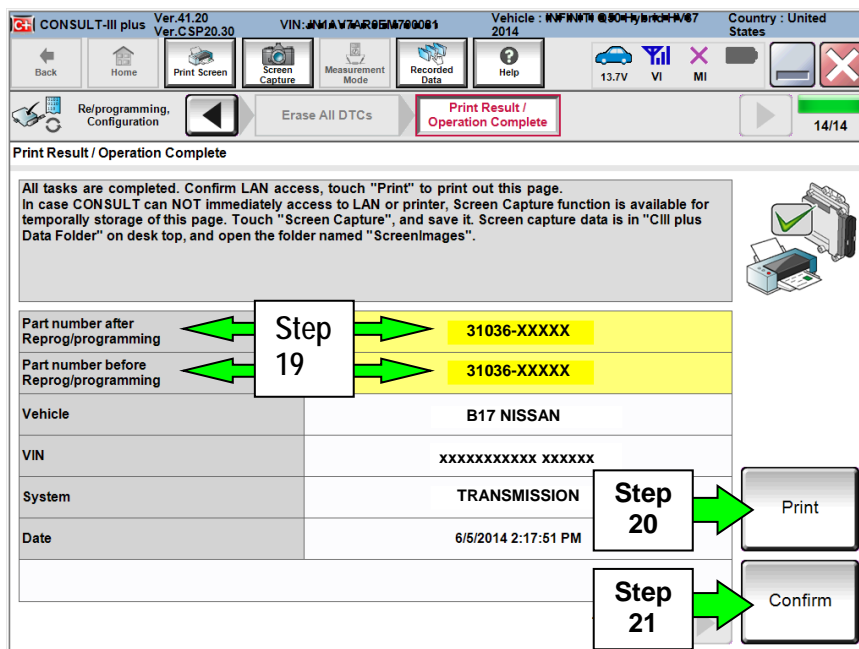
18. When the entire reprogramming process is complete, the screen in Figure 7 will display.

19. Verify the before and after part numbers are different.

20. Print a copy of this screen (Figure 7) and attach it to the repair order for warranty documentation.
