SERVICE BULLETIN

2015 JUKE; MIL ON WITH DTC FOR REAR OXYGEN SENSOR

APPLIED VEHICLE: 2015 Juke (F15)

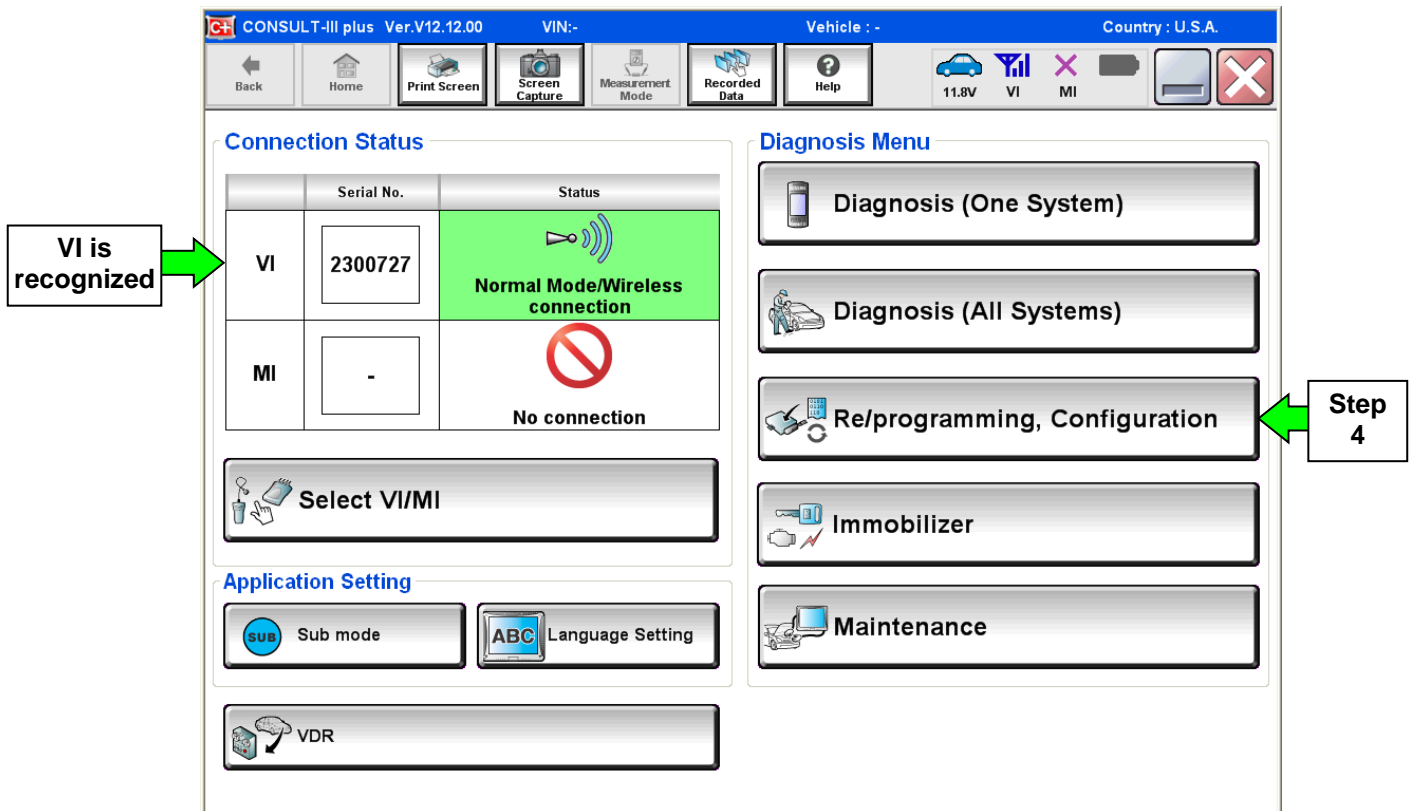
Figure 1

1. Connect the CONSULT PC to the vehicle to begin the reprogramming procedure.
2. Start C-III plus.
3. Wait for the plus VI to be recognized / connected.
 - The serial number will display when the plus VI is recognized / connected.
4. Select **Re/programming, Configuration**.
