NTB16-030

2016 ALTIMA; MIL ON WITH DTC P0101

APPLIED VEHICLES: 2016 Altima (L33)

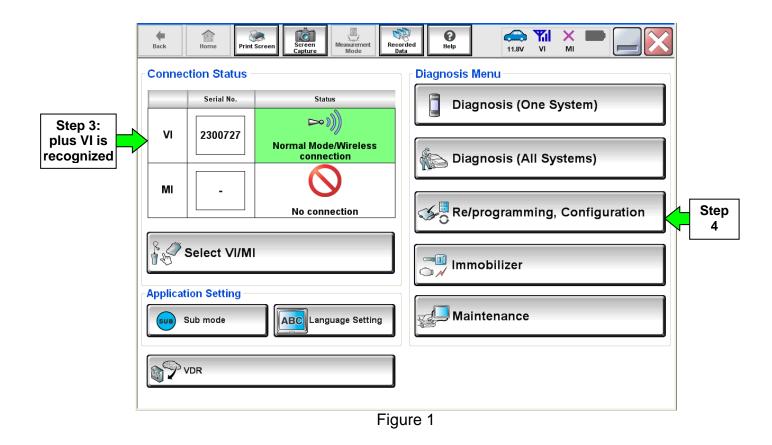
- 1. Connect the CONSULT PC to the vehicle to begin the reprogramming procedure.
- 2 Open / start C-III plus.
- 3. Wait for the plus VI to be recognized.
 - The Serial No. will display when the plus VI is recognized.
- 4. Select Re/programming, Configuration.

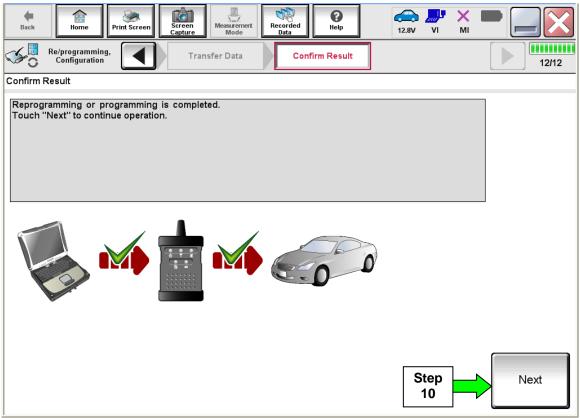
8. When the screen in Figure 4 displays, reprogramming is complete.

- 9. Disconnect the GR8 (battery charger) from the vehicle.
- 10. Select Next.

NOTE: If the screen in Figure 4 does not display (reprogramming does not complete), refer to ECM recovery on the next page.
