Service Bulletin

Subject: (Volt) High Voltage Drive Motor Battery TAC Restriction and Exchange Program

Models: 2016 Chevrolet Volt

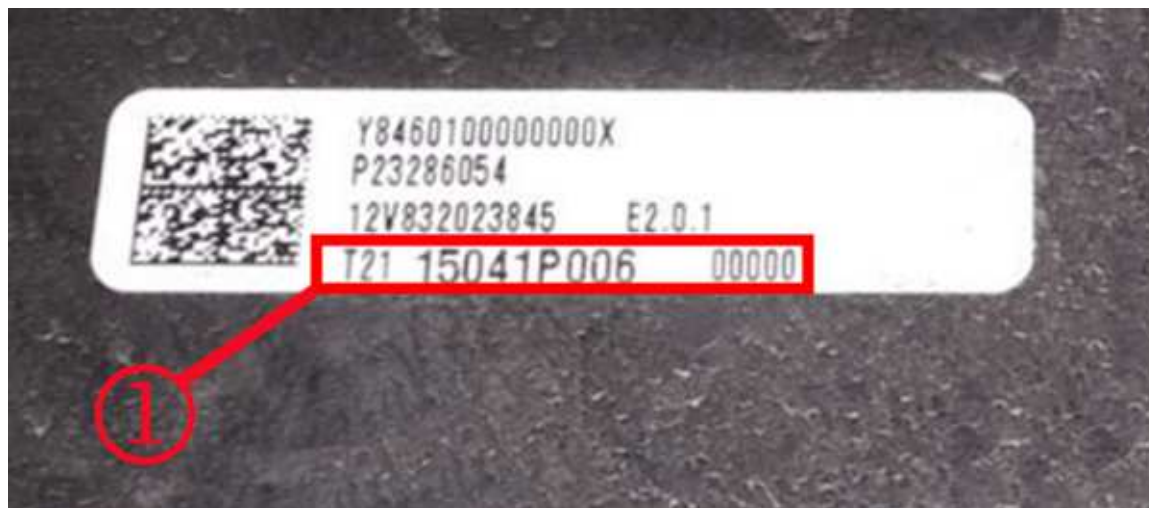
6.2 The battery has a battery identification tag that is located on the right side of the battery. Locate the tag and record the 16 digit battery identification number (BIN). The BIN is the bottom most number on the label and it starts with a "T" indicator (See Photo Below). If the battery is not out of the vehicle yet, you can find the BIN by installing the MDI and using GDS 2. Access the Battery Energy Control Module and look under the identification information section and the sixteen digit number will be listed under the parameter: Hybrid/EV Battery Pack Identification Number.
