MODEL
2015MY
Sedona (YP)
SX, SXL models
only

NUMBER
086 (REV 1, 01/29/2015)

TECHNICAL SERVICE BULLETIN

SUBJECT: DDM / ADM SYSTEM LOGIC IMPROVEMENT
/PARASITIC DRAW REDUCTION

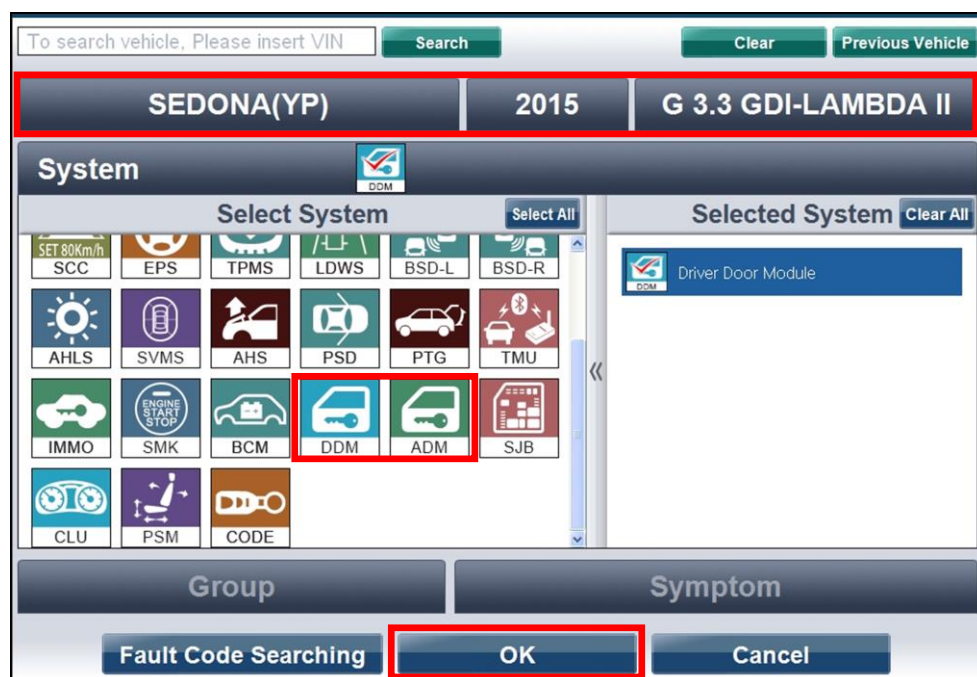
- With the ignition key ON, turn ON the VCI and GDS/KDs. Access the GDS vehicle identification number (VIN) screen and configure the vehicle using the **VIN AUTO DETECT** Function.
- Select **DDM /ADM** System and click **OK**.
