SERVICE BULLETIN

APPLICABILITY: 2015MY Legacy and Outback Models
Equipped with 6.2" Clarion Display Audio

NUMBER: 15-188-15R
DATE: 09/24/15

SUBJECT: Reprogramming File Availability to Improve Audio Unit Performance

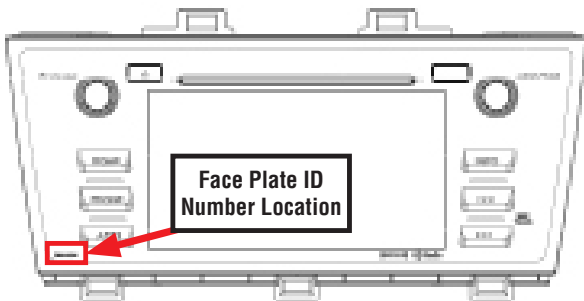
CB604UL, CB614UL and CB624UL

The audio unit model number is displayed on the lower left of the faceplate as shown below.

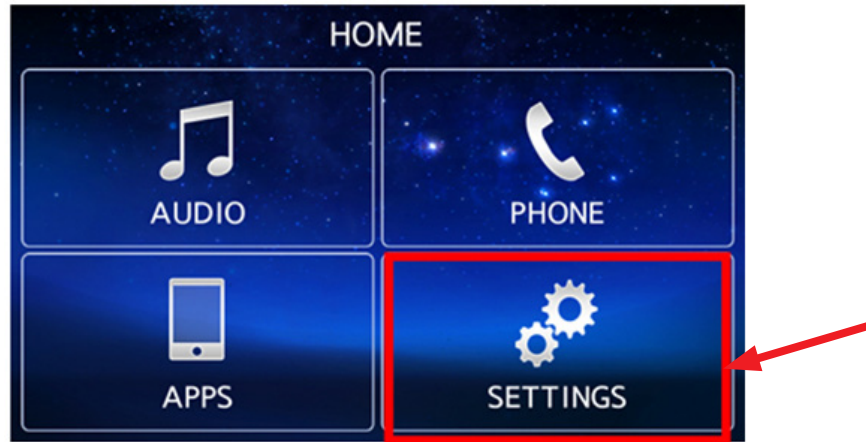
- Switch the ignition and audio unit **ON**.
- Press the **HOME** button.
- Touch “**SETTINGS**” soft key on the HOME screen.

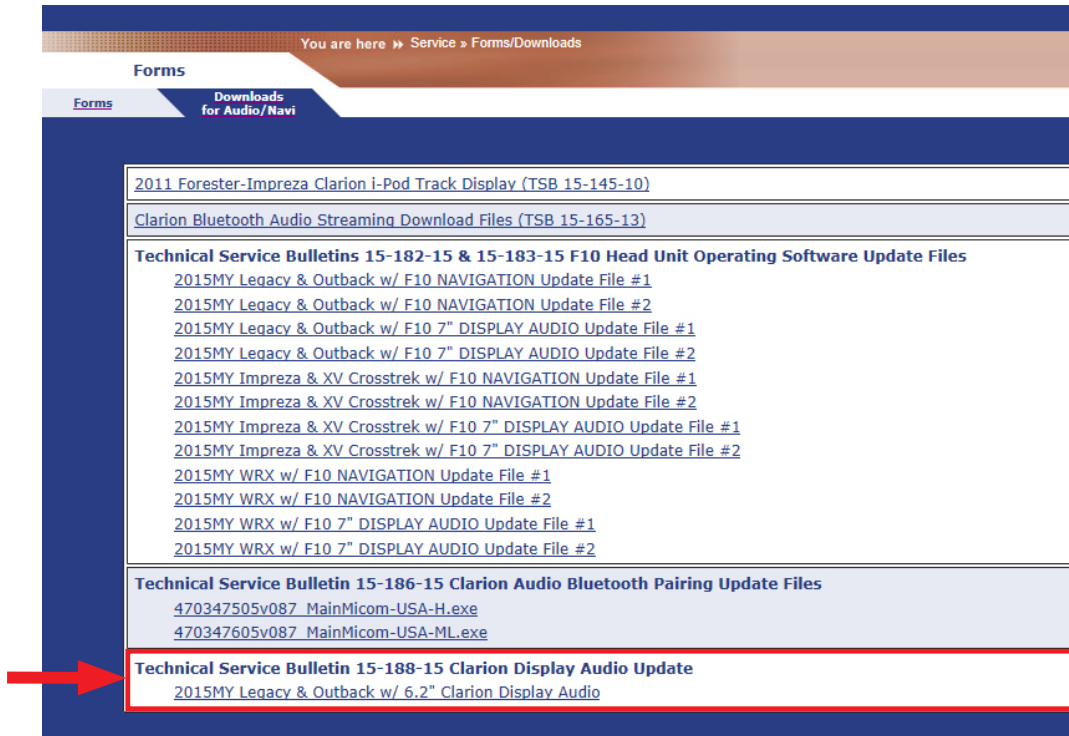
The screenshot shows a web browser interface with a blue header and a white content area. The breadcrumb trail reads "You are here >> Service > Forms/Downloads". Below this, there are tabs for "Forms" and "Downloads for Audio/Navi". The main content area lists several technical service bulletins and update files. A red arrow points to the following link:

[Technical Service Bulletin 15-188-15 Clarion Display Audio Update](#)
2015MY Legacy & Outback w/ 6.2" Clarion Display Audio

The Subarunet page shown above will display and contain links to the Clarion update files.

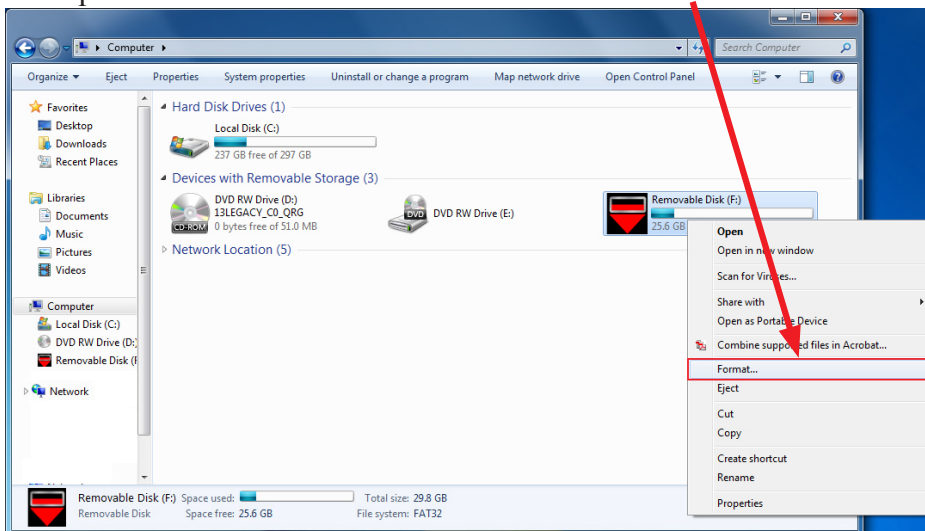
- Right click the picture for “**Removable Disk**” then select “**Format**”.

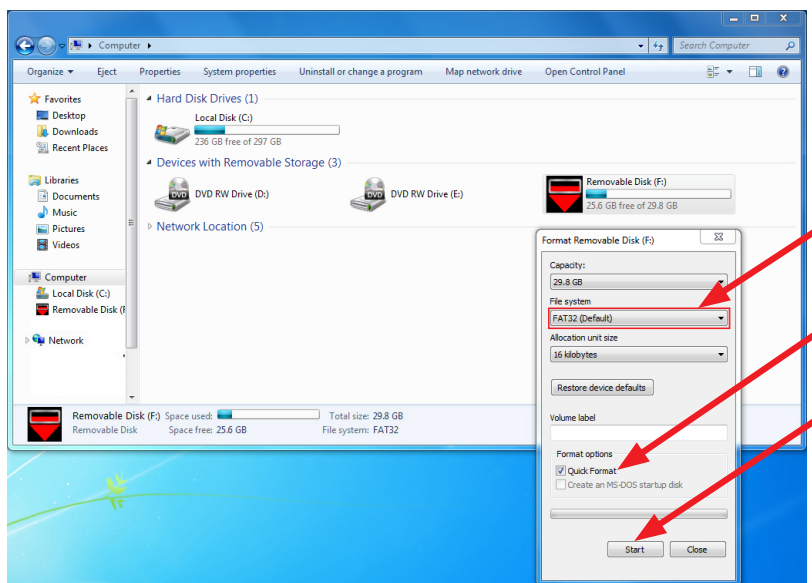
- When the “Format” dialog box appears, make sure the option labeled “File System” is set to **FAT32** and the **Quick Format** box is checked as well. Then, click the “**Start**” button.

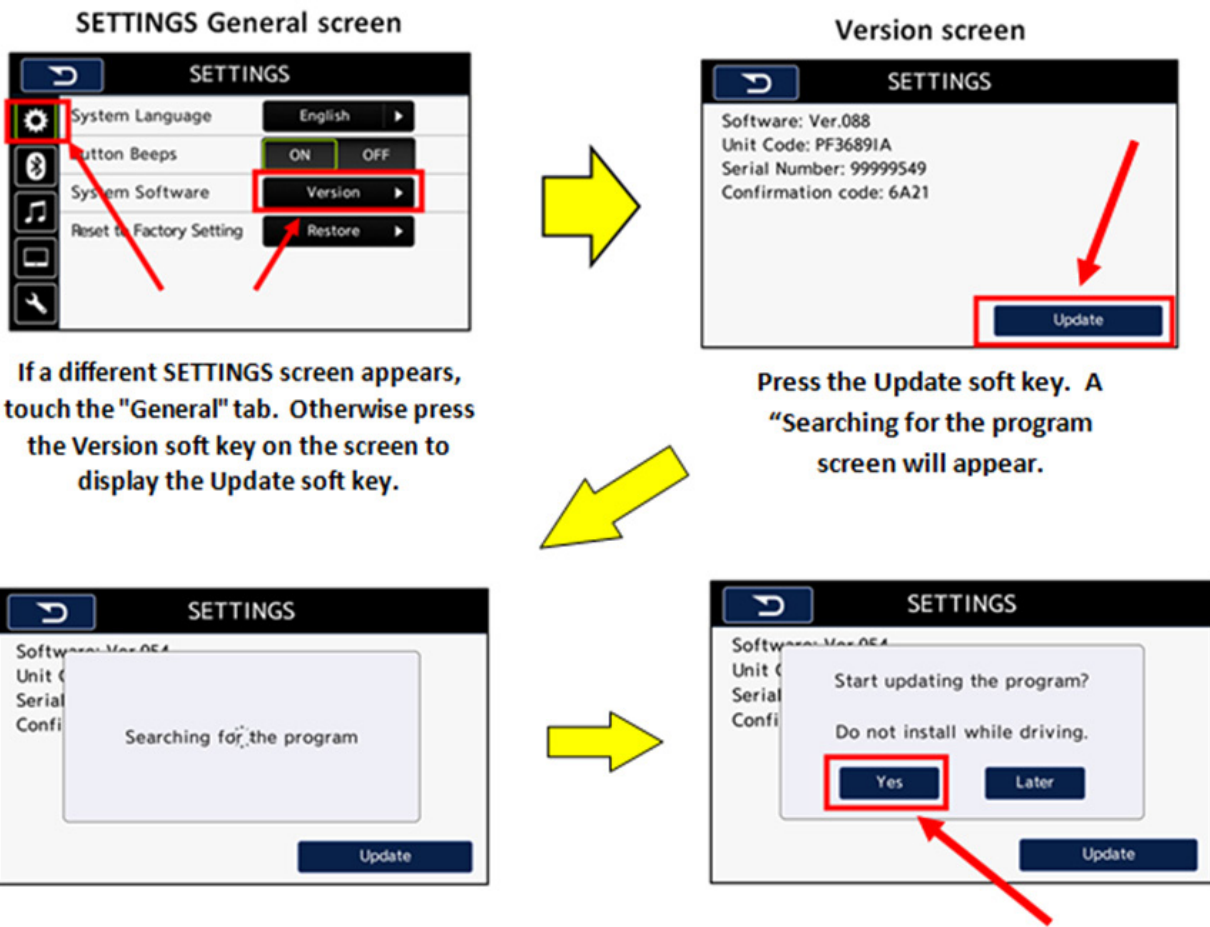
4-3:

- After the "Searching" screen changes to the "Start updating" screen, press **Yes** to begin the updating process.

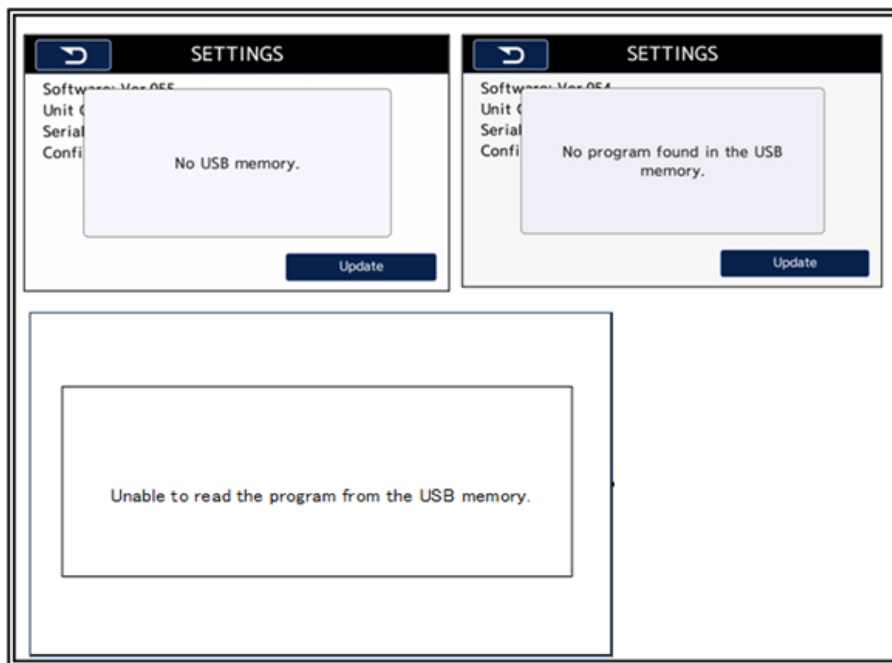
NOTE: If any of the three error screens shown below appear after the Searching screen instead of the Start updating screen, check the USB memory then start over from 4-3.

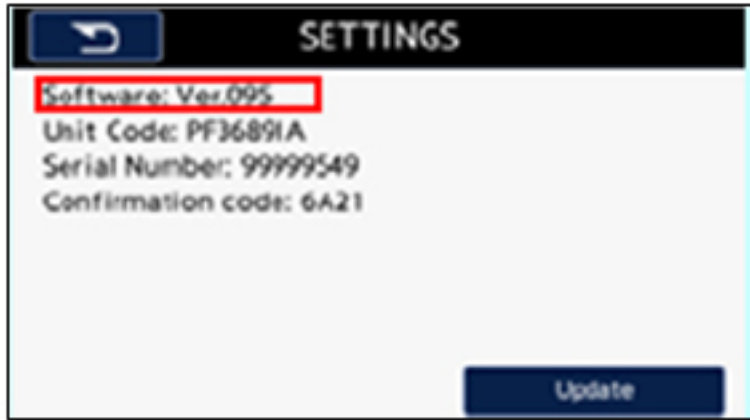
4-8: Confirm the Version is **Ver.095** or higher to complete the procedure.
