July 6, 2016

04208 Version 1

Product Update: 2011–12 Odyssey Software Update for Lock-up Clutch Function

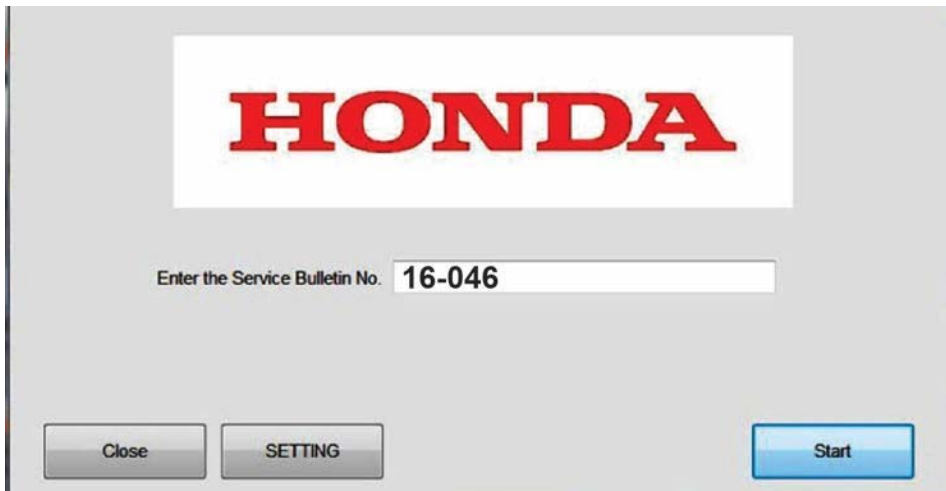
4. Enter the service bulletin number 16-046, select Start, then follow the on-screen prompts.
