**August 3, 2016**

04494 Version 1

## 2015 CR-V DTC P1890

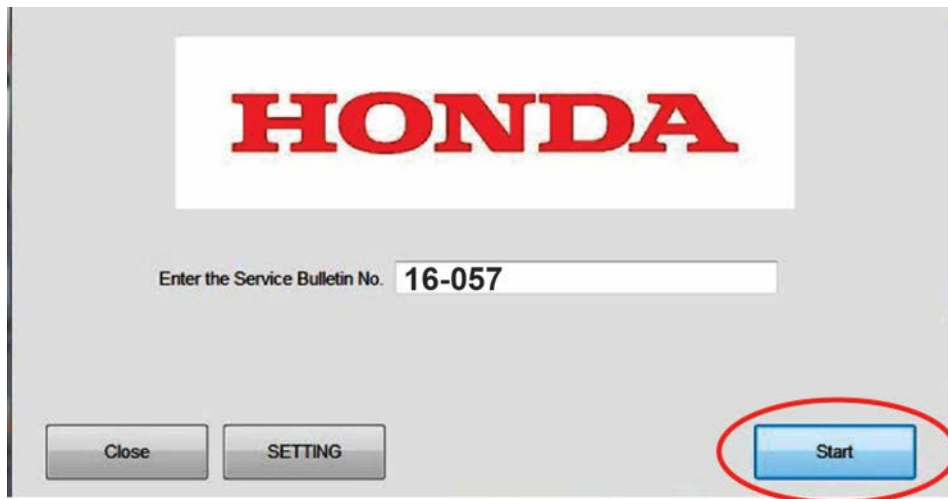
3. Enter the service bulletin number 16-057, select **Start**, then follow the on-screen prompts.
