Subject: AUDIO, NAVIGATION AND PHONE CONCERNS WITH MAZDA CONNECT INFOTAINMENT SYSTEM	Bulletin No: 09-024/16
	Last Issued: 07/05/2016

DESCRIPTION

REPAIR PROCEDURE

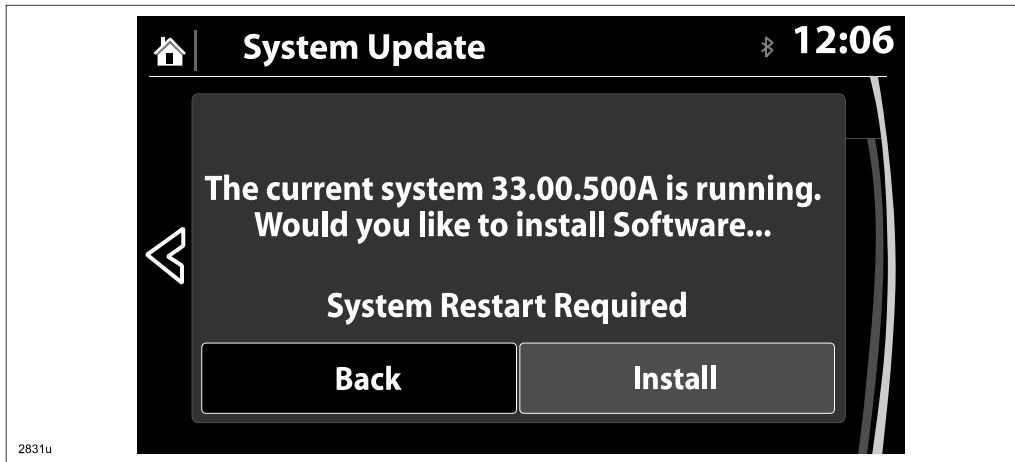
27. Select "Install" on the screen below.

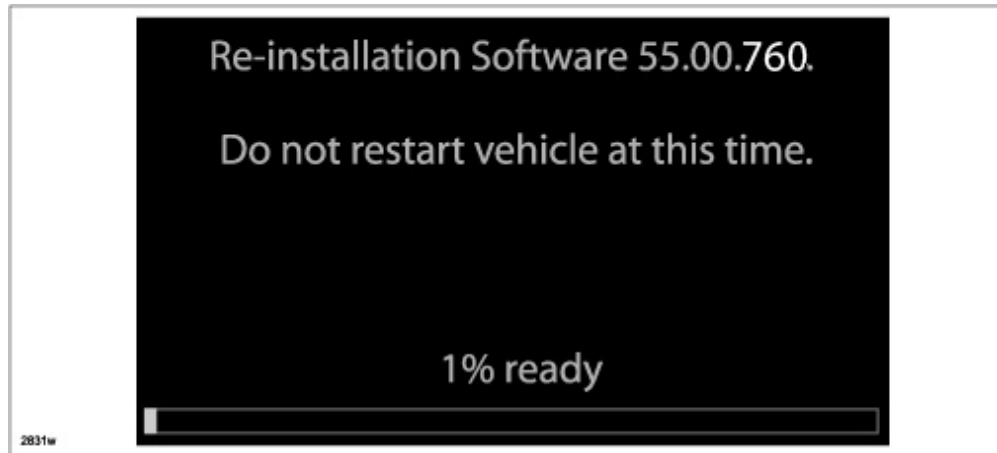
29. Reinstallation will start from 0% and as the reflashing process takes place, the progress bar will gradually increase to 100%.

NOTE: It may be difficult to read the display at times as it becomes dark, but “Do not restart vehicle at this time” is displayed.

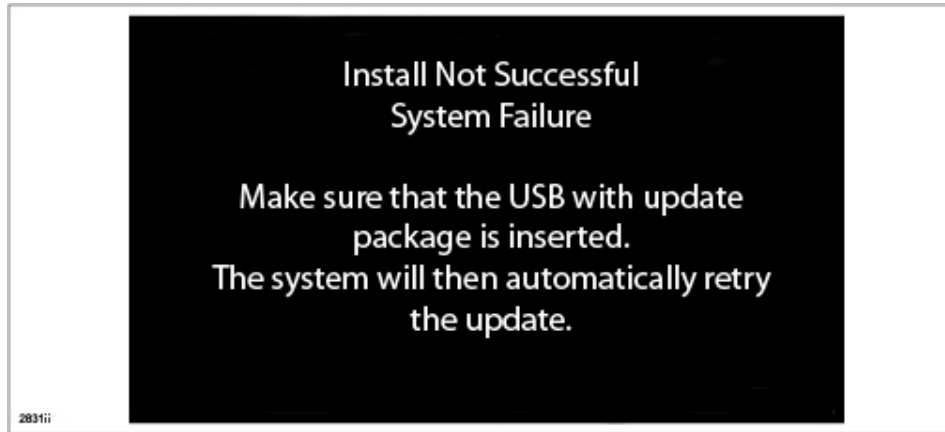
g. Confirm the screen shown below appears.
