**August 30, 2016**

04676 Version 1

## Warranty Extension: 2010 Accord Crosstour Software Update for Lock-up Clutch Function

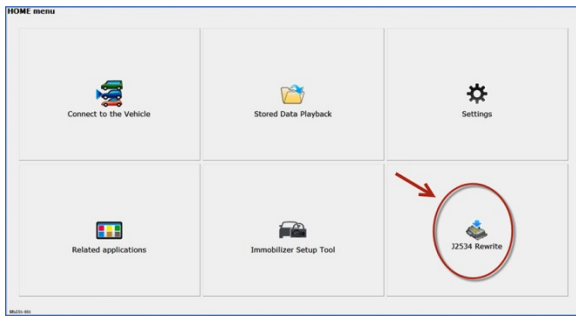
3. Select **J2534 Rewrite**.

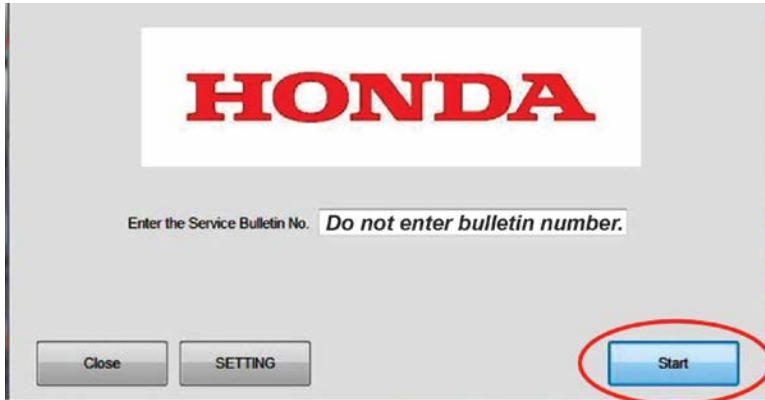
4. Select **Start**, then follow the screen prompts.

NOTE: **Don't enter a bulletin number.**
