03585 Version 4

Audio Unit Software Update

HONDA

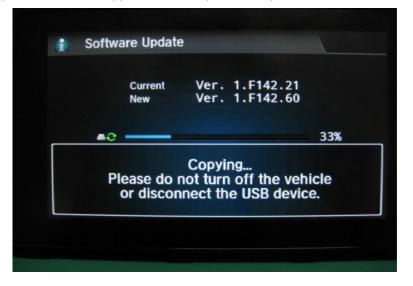
The main software update screen will appear and the update is copied from the USB device.

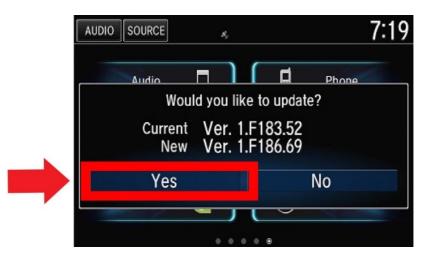
- 1. Connect the USB update device once the audio unit has booted up and the **HOME** screen appears.
- Once the USB device is inserted, a pop-up screen appears with the current and new software versions displayed. (This may take a minute or two) Select Yes.

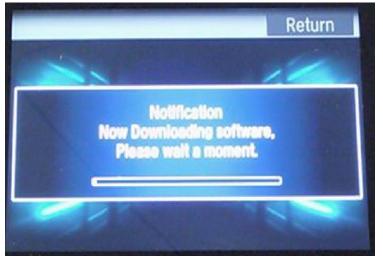
The system software update screen appears and the software should finish downloading.

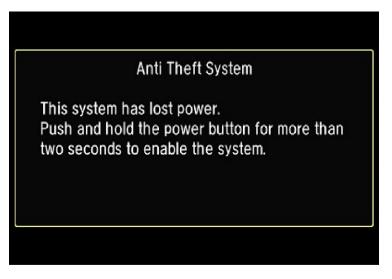
- 3. The **Anti Theft System** screen appears. Push and hold the Audio icon for more than 2 seconds to enable the system.
 - NOTE: If nothing is done for 30 seconds the screen goes black. Select the Day/Night button or BACK icon to return to the screen.

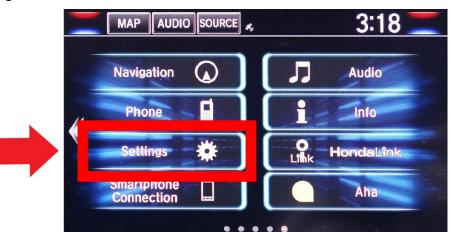
- Have the service advisor inform the customer that the Factory Data Reset will remove any saved settings.
- Do the Factory Data Reset procedure only when directed to in the applicable software update procedure.
- Do the Factory Data Reset while the USB update device is connected.
- 1. Select **Settings** on the **HOME** screen.

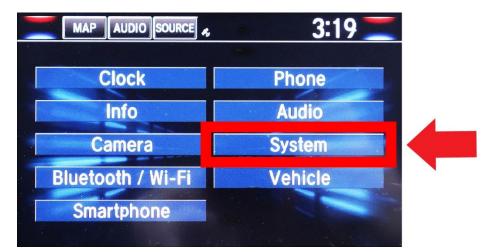
2. Select System.

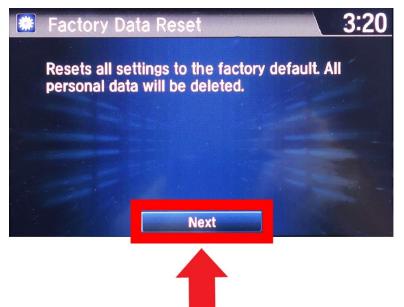
4. Select **Next** on the pop-up screen.

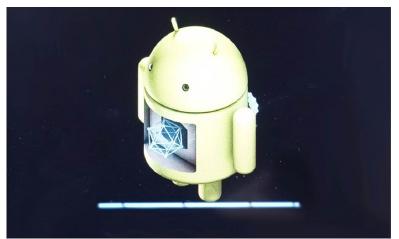
7. An Android loading screen appears. After the loading has completed, go back to the applicable software update procedure.
