Nonlinear Acceleration (2WD ONLY)

Service Category Engine/Hybrid System

Section Engine Control

YEAR(S)	MODEL(S)	ADDITIONAL INFORMATION
2013 - 2014	LS460

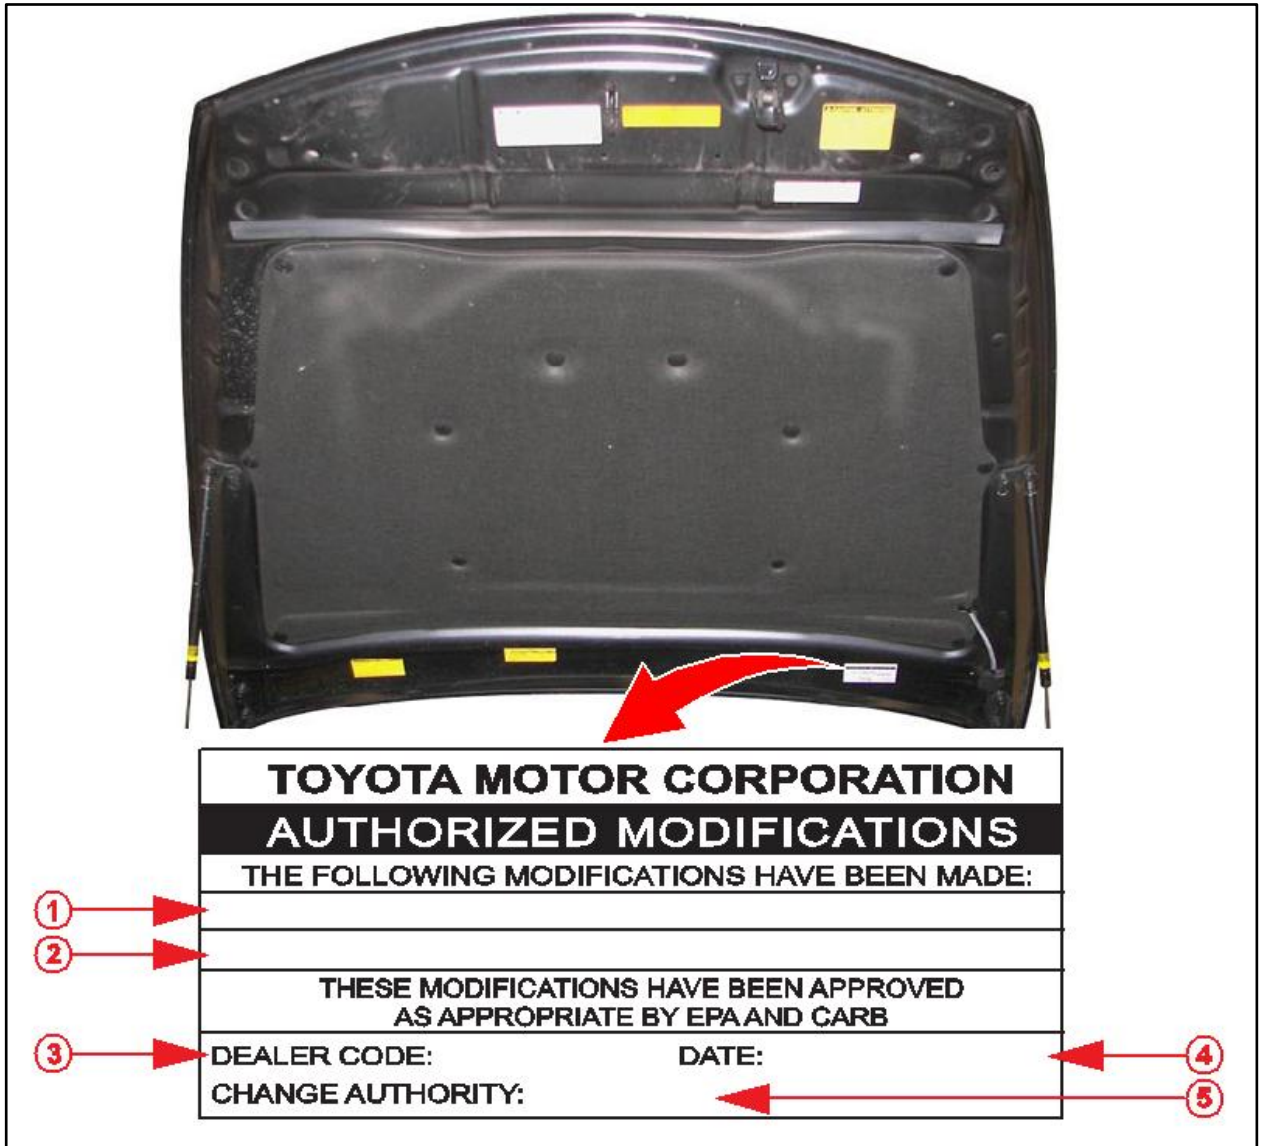
- Check for the Authorized Modifications Label affixed to the vehicle in the location shown in Figure 1. Confirm if the ECM (PCM) calibration has been updated. If the calibration ID listed is NOT the latest ECM (PCM) calibration – go to step 3. If the calibration ID is the latest, go to step 5.

1	Replacement ECM (PCM) Part Number (i.e., 89661-50C04)
2	New Calibration ID(s) (i.e., 35065100)
3	Dealer Code

4	Date Completed
5	This SB Number

- Install the Authorized Modifications Label.
 - Using a permanent marker, enter the following information on the label:
 - ECM part number [*Refer to the **Parts Information** section for the **NEW PART NUMBER***]
 - Calibration ID(s) [*Refer to the **Calibration Information** section for the **NEW CALIBRATION***]
 - Dealer Code
 - Repair Date
 - Change Authority [**This bulletin number**]
 - Affix the Authorized Modifications Label to the vehicle at the location shown in Figure 1. The Authorized Modifications Label is available through the MDC, P/N 00451-00001-LBL.
- Test drive the vehicle to confirm that the non-linear acceleration or hesitation is no longer present.
