Navigation and MID Distance Do NOT Match

Service Category Vehicle Interior

Section Meter/Gauge/Display

YEAR(S)	MODEL(S)	ADDITIONAL INFORMATION
2016	Land Cruiser

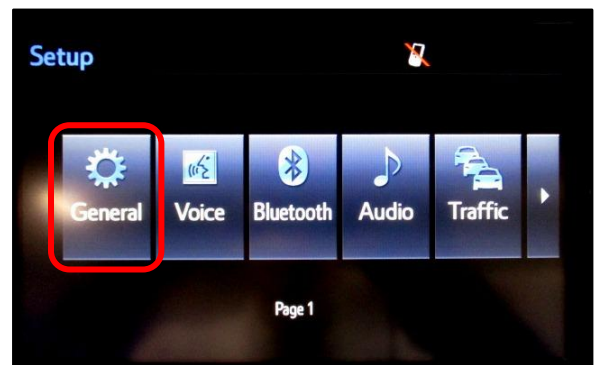
Figure 1.

Scroll down the list until *Software Update* is displayed.

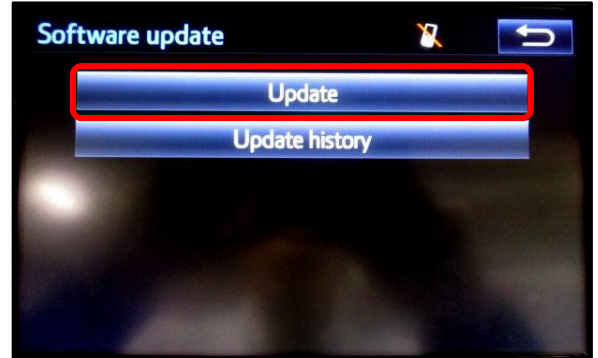
Figure 3.

5. Select *Update* on the *Software Update* Screen.

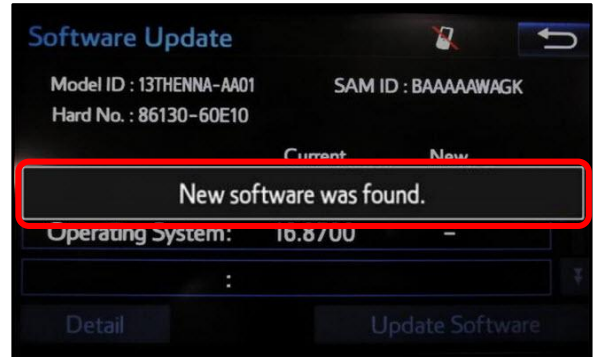
Figure 4.

6. Insert the USB Drive with the appropriate software into the USB Port.

If software has been detected properly, a "New software was found" pop-up will be displayed.

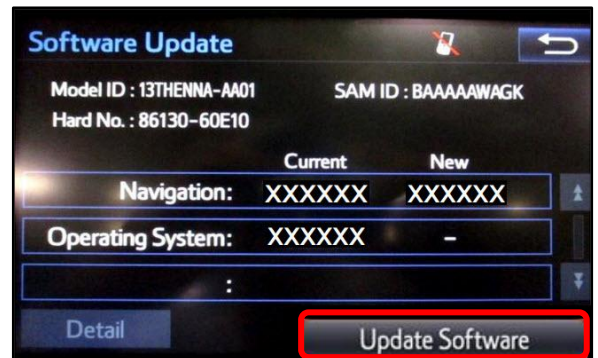
Figure 5.

NEW SOFTWARE VERSION INFORMATION		
TYPE	Entune™ PREMIUM AUDIO	
	CURRENT VERSION	NEW VERSION
Navigation	V1AA1600	V1AA8890
Operating System	16.8700	16.8700

7. Check to see if NEW software is available on the *Software Update* screen.

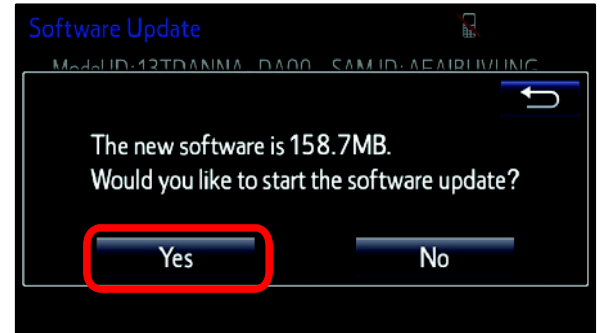
Figure 6.

8. Select Yes on the “Would you like to start the software update?” pop-up.

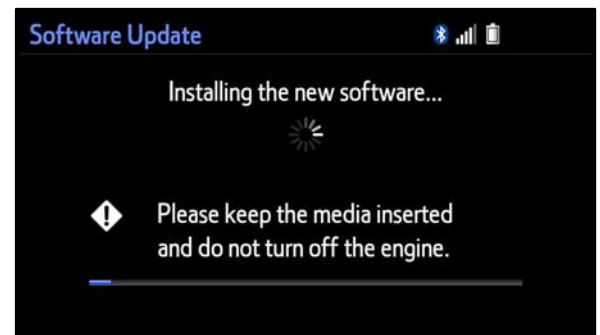
Figure 7.

9. The software update begins and will take about 10 minutes.

- Do NOT turn OFF the engine or ACC before the software is ready for updating.
- Do NOT pull the USB Drive SST out of the vehicle USB port.

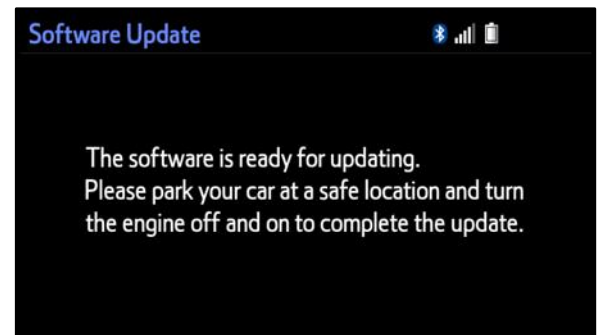
Figure 8.

10. Cycle the ignition OFF and ON to complete the update.

After the ignition is turned OFF and ON the update will take several minutes to complete.

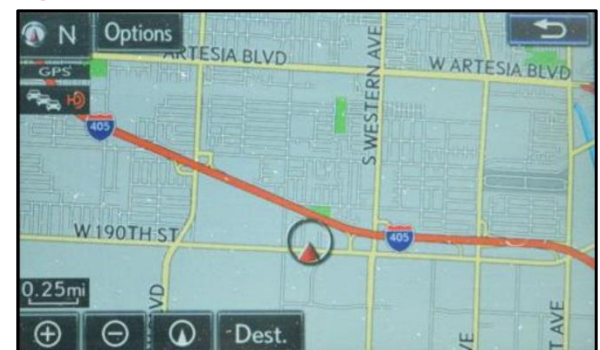
Figure 9.

11. Do NOT remove the USB Drive SST or turn OFF the ignition until the navigation screen is present.

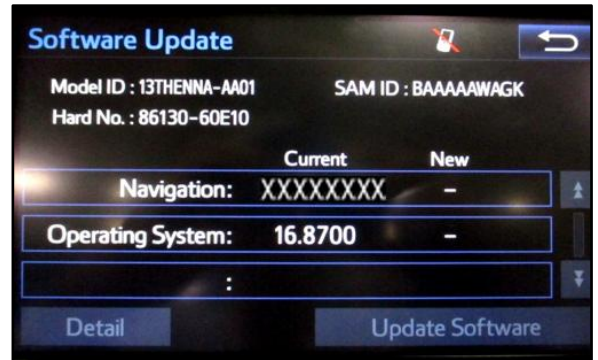
Figure 10.

1. Perform steps 3 – 7 of the Software Update procedure to re-enter the Software Update screen.
2. Verify that the software information is updated on the Software Update screen.

NEW SOFTWARE VERSION INFORMATION		
TYPE	Entune™ PREMIUM AUDIO	
	CURRENT VERSION	NEW VERSION
Navigation	V1AA8890	–
Operating System	16.8700	–
