MODEL  
2014~2015MY Forte (YD)  
2014MY Sportage (SL)

NUMBER  
065 (REV 3, 06/29/2016)

## TECHNICAL SERVICE BULLETIN

SUBJECT: COMBINED TSB /SERVICE ACTION: MIL ON WITH DTC C1212 -  
LOGIC IMPROVEMENT (SA 216)

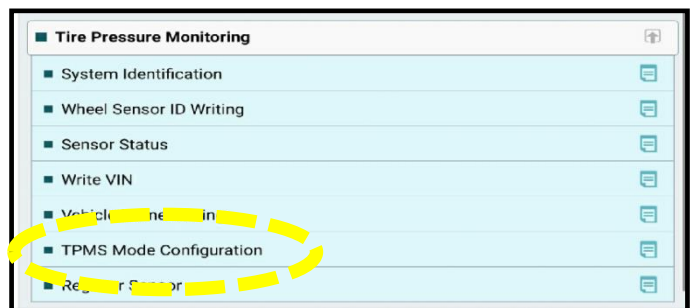
- After Register Sensor operation is complete, access **Vehicle S/W Management > TPMS Mode Configuration >** follow instructions.
