GROUP Electrical	MODEL 2014~15MY Sportage (SL) Forte (YD) Optima (QF/TF) Optima Hybrid (TF HEV) Sorento (XMa)
	NUMBER 085 (REV 1, 6/23/2016)	DATE May 2015
TECHNICAL SERVICE BULLETIN		
SUBJECT: UVO SOFTWARE UPGRADE – MEDIA BUTTON INOPERATIVE

This bulletin provides the procedure for upgrading the UVO system of some 2014~2015MY Sportage (SL), Forte (YD), Optima (TF/QF), Optima Hybrid (TF HEV) and Sorento (XMa) vehicles, which may exhibit an inoperative UVO media button. In addition to correcting the media button concern, this software upgrade also contains the following updates:

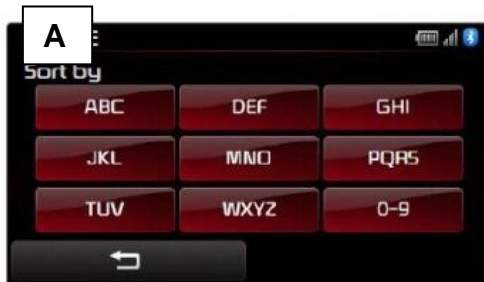
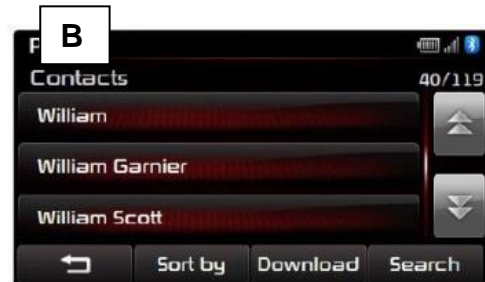
- Improvements to the Voice Recognition engine
- Bluetooth Audio streaming is no longer an option to turn on and off. If a device is paired through Bluetooth, it will automatically stream
- Contacts Sync is no longer an option to turn on and off. Contacts will sync automatically
- “Recent Calls” now has the sort category “All”
- Pressing the **Contacts** button on the Phone screen will lead to letter groupings (A) first instead of going straight to the beginning of the contacts list
- Getting to the contacts list screen is the only way to access the **Download** button (B) for manual phonebook download

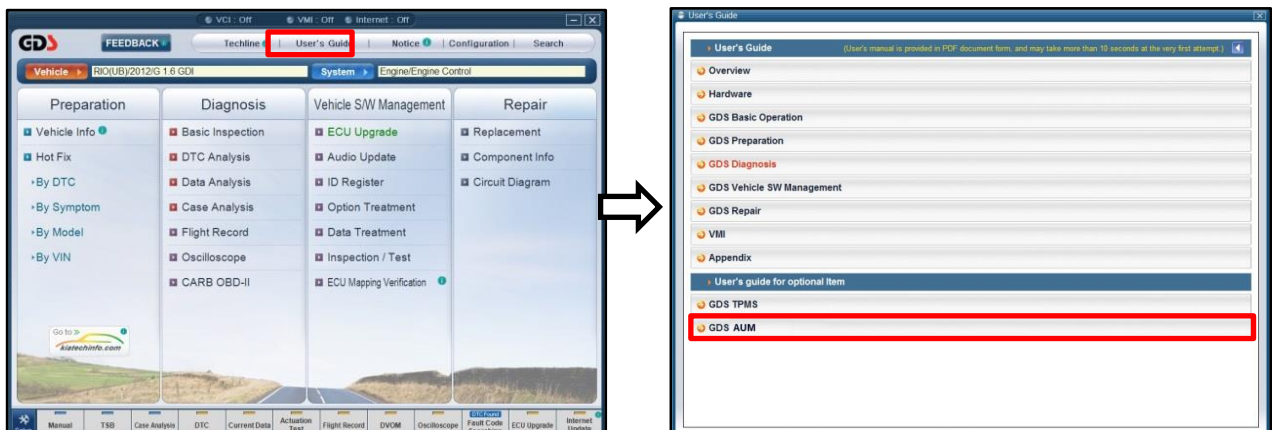
1. Start the vehicle or connect the Midtronics GR8-1299 charger.
2. Record the customer's radio presets before performing the upgrade.
3. Refer to TSB SST 032 for detailed information on AUM operation or click on **User's Guide > GDS AUM** on the GDS main screen, as shown below, and follow the on-screen instructions.

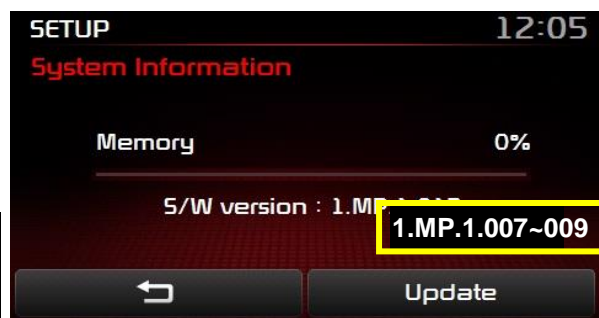
4. Press **Setup > System > System Information**, and verify the original software version matches the information shown in the table below.

Model	Software Version
Sportage (SL)	1.MP.1.007~008
Forte (YD)	1.MP.1.007~008
Optima (TF/QF)	1.MP.1.007~008
Optima Hybrid (TF HEV)	1.MP.1.007~009
Sorento (XMa)	1.MP.1.008

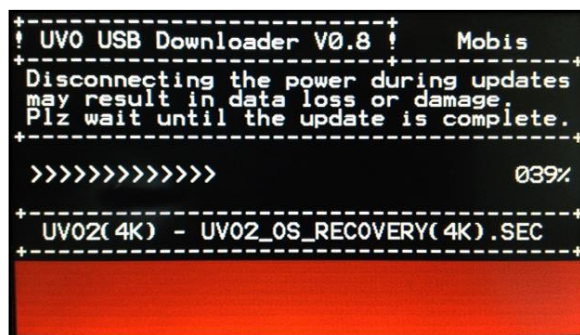
6. The head unit will enter the UVO USB Downloader mode and begin downloading the upgrade from the AUM.

Do NOT turn the vehicle ignition or the head unit **OFF** while the update is in progress.

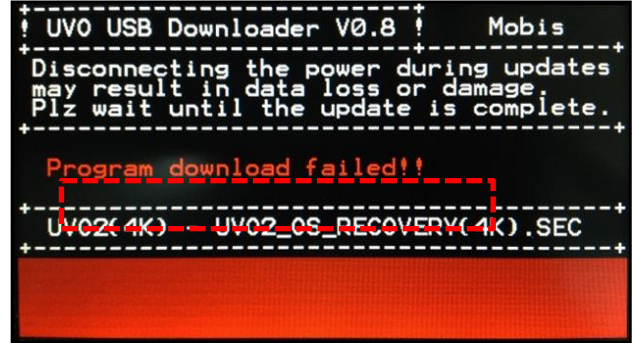
- 6a. If the “**Program download failed**” message is displayed on the screen, press **Reset** button and restart the procedure from step 4.

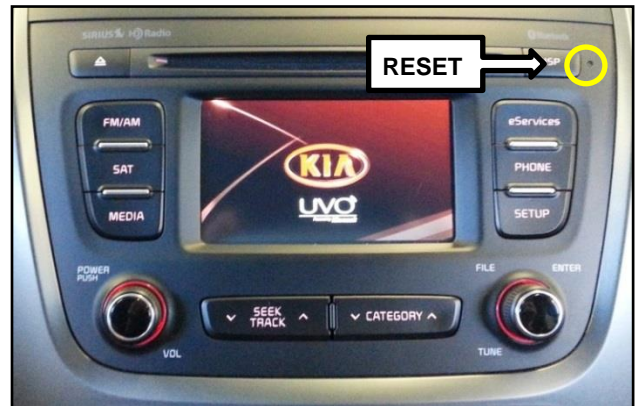
- 7. When the download shows 100% complete, press the **RESET** button, using a ball point pen, to restart the system.

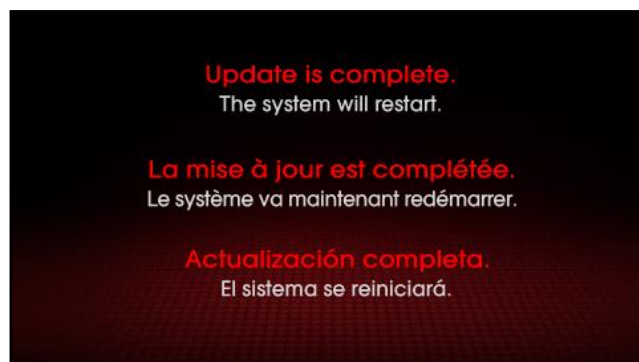
9. After update is complete, the UVO system will be restarted automatically.

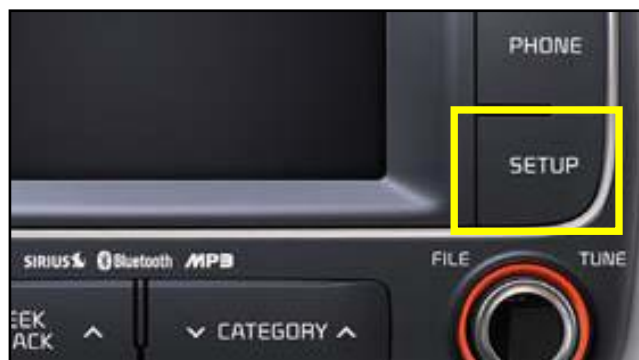
10. After the system has restarted, press the **SETUP** button on the head unit.

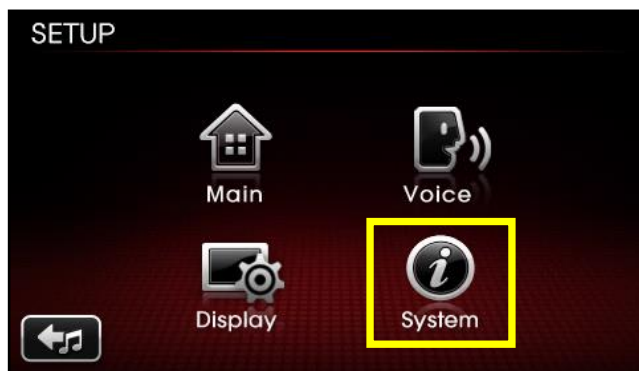
11. Touch **System** on the screen.

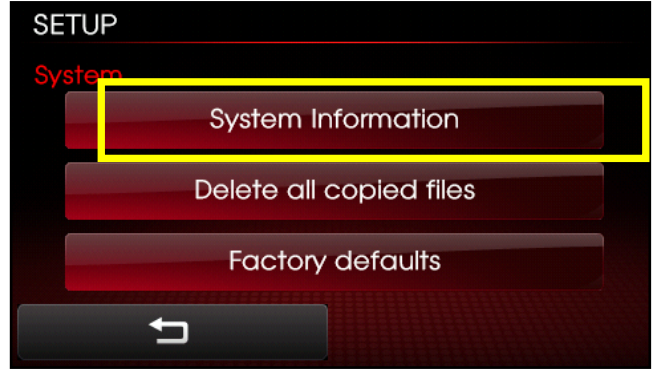
12. Touch **System Information** on the screen.

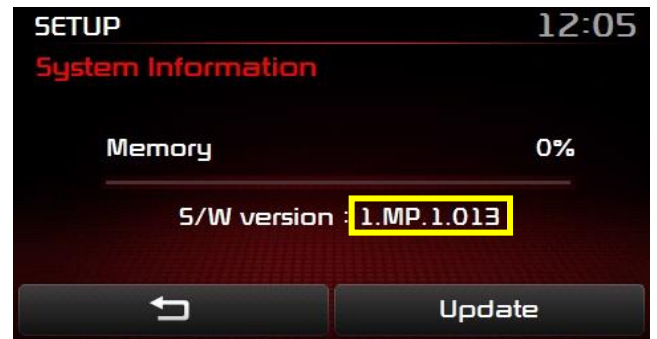
13. Check to ensure the new software version matches the information shown in the table below.

New Software Version
1.MP.1.013
