GROUP <b>ENG</b>	MODEL <b>2015MY Soul (PS) w/1.6L engine</b>
	NUMBER <b>156</b>	DATE <b>August 2016</b>
<b>TECHNICAL SERVICE BULLETIN</b>		
<b>SUBJECT: ECM UPGRADE – MIL ON WITH DTC P0128</b>

286.PS 1.6GDI DTC(P0128) Logic Improvement

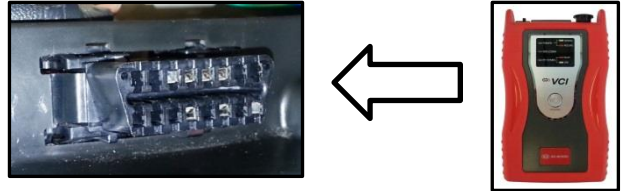
3. Connect the Main 16-pin DLC cable (GHDM – 241000) to the VCI.
4. Connect the Main 16-pin DLC cable (GHDM – 241000) to the OBD-II connector, located under the driver's side of the instrument panel.

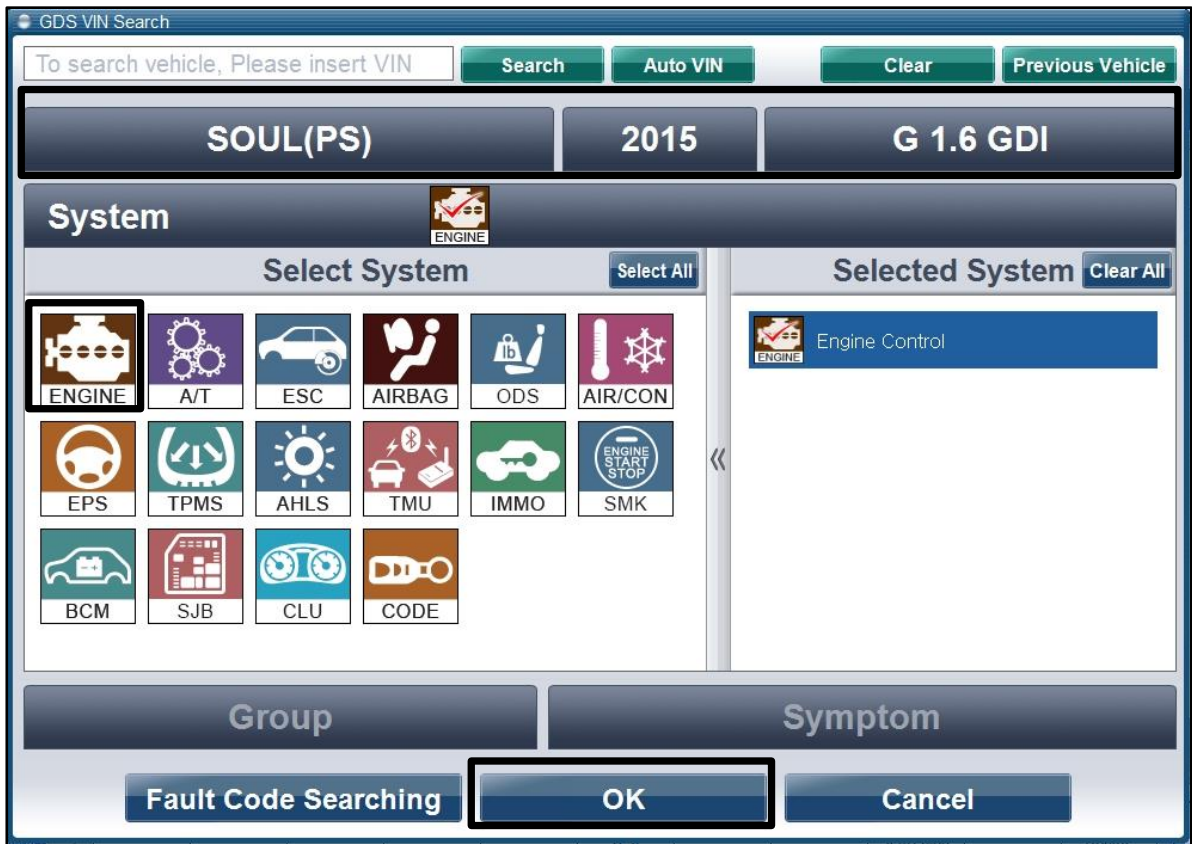
5. With the ignition key ON, turn ON the VCI and GDS. Access the GDS vehicle identification number (VIN) screen and configure the vehicle using the **VIN AUTO DETECT** Function.
6. Select **ENGINE** system, and click **OK**.

7. Select **ECU Upgrade** from the bottom right-hand corner. Next select **Auto Mode**, and then **Engine**. Perform the ECM upgrade in accordance with normal GDS ECM upgrade procedure.
